Home Inspection Report

7060 Via Anacapa, San Jose

Trevor Edwards
August 27, 2025

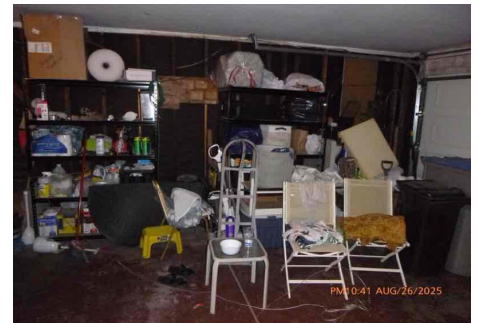
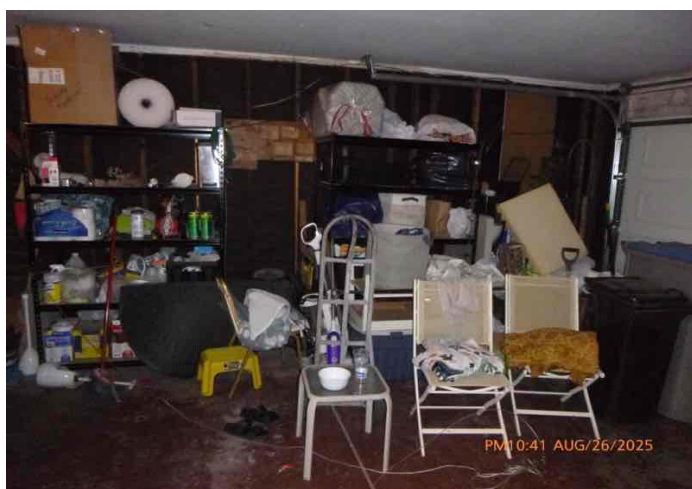
Photo 11

1. Storage of personal belongings within the interior of the garage prevented a full visual inspection of the area. Therefore, the area was not fully inspected. With removal of all personal items and a complete inspection, conditions in need of attention may be discovered. (See Photo 11)
2. Water damage was noted at the garage rear entry door. We recommend the services of a licensed general contractor and/or structural pest control company regarding repairs. (See Photo 8)
3. The driveway has cracked, heaved, or uneven sections, creating a potential trip hazard. We recommend repairing or resurfacing the affected areas to improve safety and prevent further deterioration. (See Photo 2)

Storage of personal belongings within the interior of the garage prevented a full visual inspection of the area. Therefore, the area was not fully inspected. With removal of all personal items and a complete inspection, conditions in need of attention may be discovered. (See Photo 11)

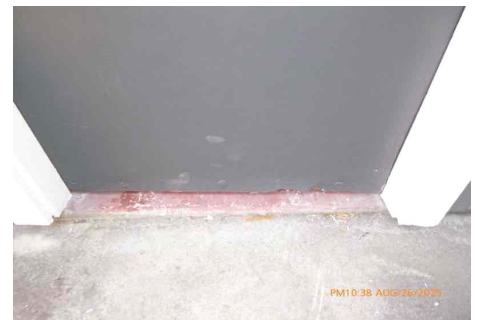
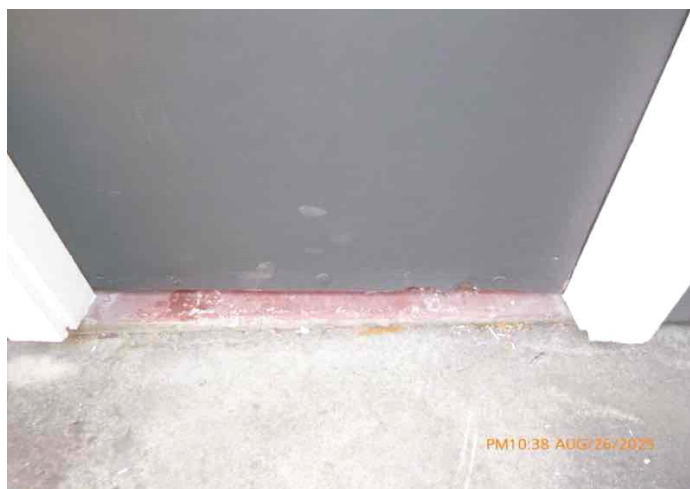
Photo 08

- ! 1. Water damage was noted at the garage rear entry door. We recommend the services of a licensed general contractor and/or structural pest control company regarding repairs. (See Photo 8)

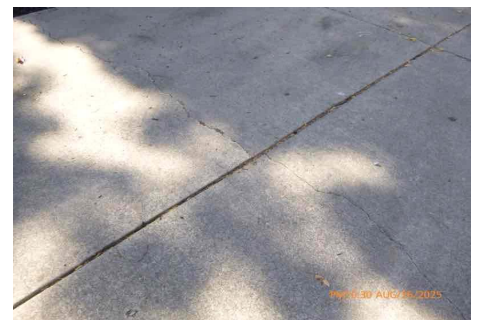
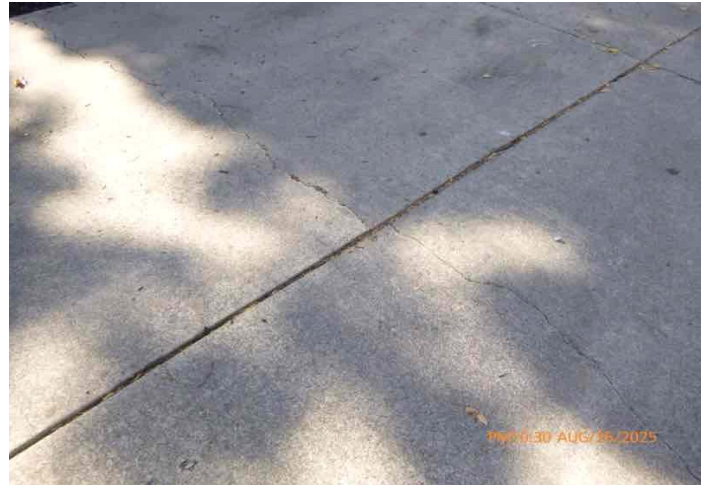
Photo 02

- ! 2. The driveway has cracked, heaved, or uneven sections, creating a potential trip hazard. We recommend repairing or resurfacing the affected areas to improve safety and prevent further deterioration. (See Photo 2)

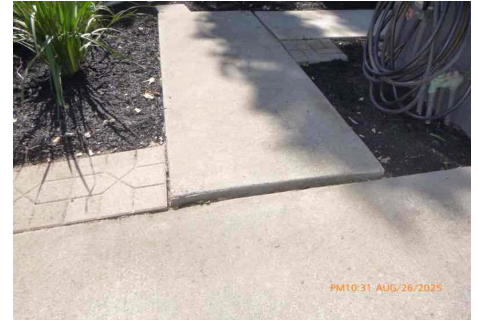
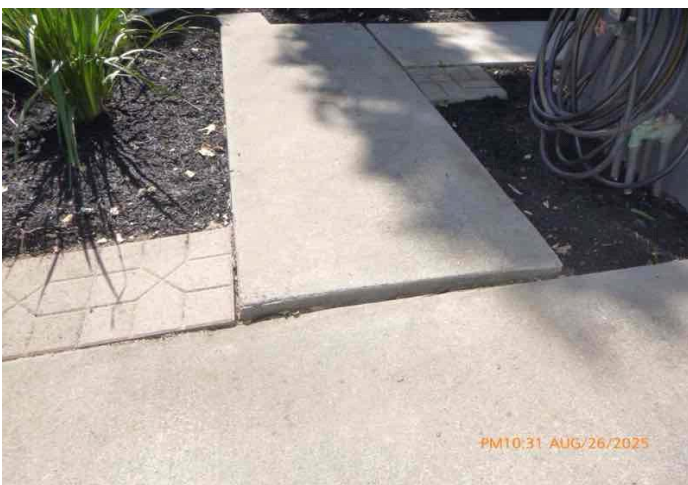
Photo 05

4. The cracked, heaved, or uneven walkway sections at the front pose a potential trip hazard. We recommend corrective action to improve safety and reduce the risk of injury. A qualified contractor should assess the affected areas and perform necessary repairs to ensure a level walking surface. (See Photo 5)

- ! 3. The cracked, heaved, or uneven walkway sections at the front pose a potential trip hazard. We recommend corrective action to improve safety and reduce the risk of injury. A qualified contractor should assess the affected areas and perform necessary repairs to ensure a level walking surface. (See Photo 5)

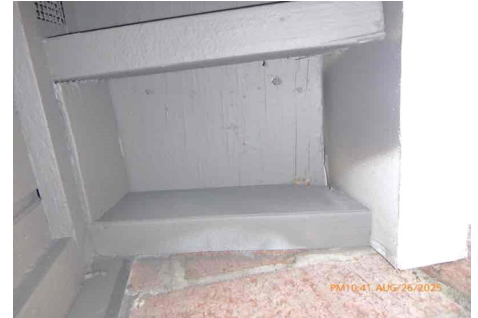
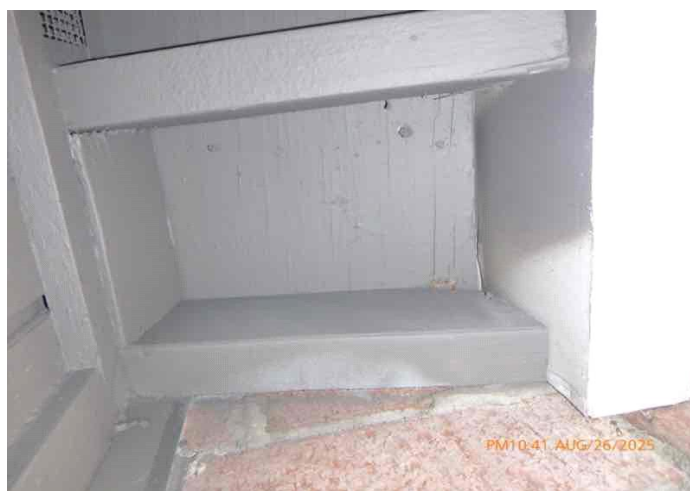
Photo 10

5. Water damage was observed to the roof eaves/sheathing at the right side of the structure. We recommend the services of a licensed general contractor and/or structural pest control company. (See Photo 10)

- ! 4. Water damage was observed to the roof eaves/sheathing at the right side of the structure. We recommend the services of a licensed general contractor and/or structural pest control company. (See Photo 10)

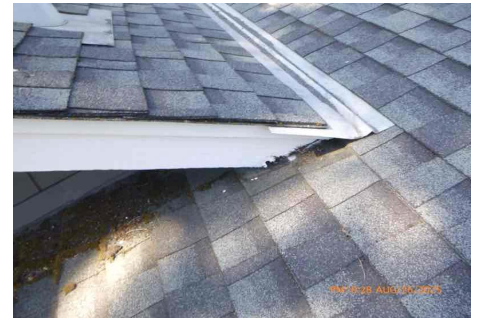
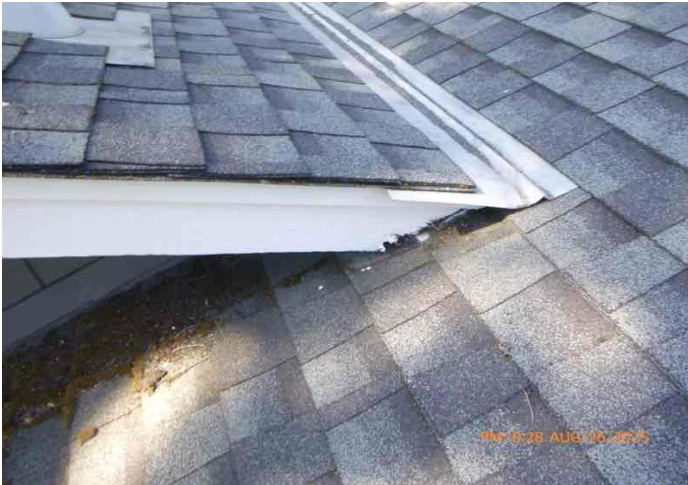
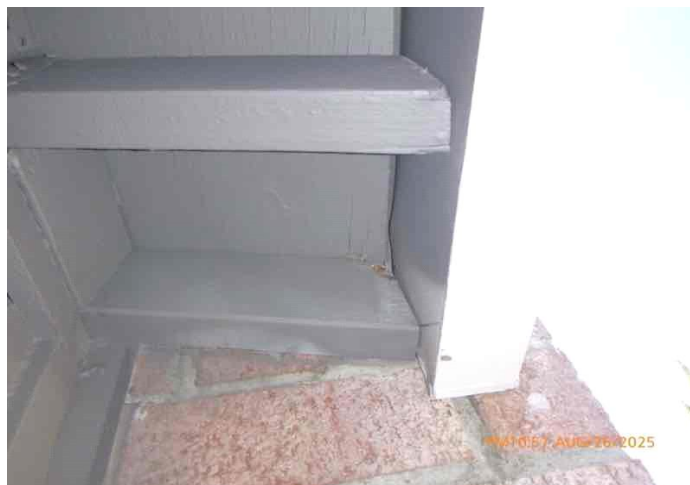
Photo 01

6. Water damage was observed to the rafters at the front and right sides. We recommend the services of a licensed general contractor and/or structural pest control company. (See Photo 1) (See Photo 14)

- ! 5. Water damage was observed to the rafters at the front and right sides. We recommend the services of a licensed general contractor and/or structural pest control company. (See Photo 1) (See Photo 14)

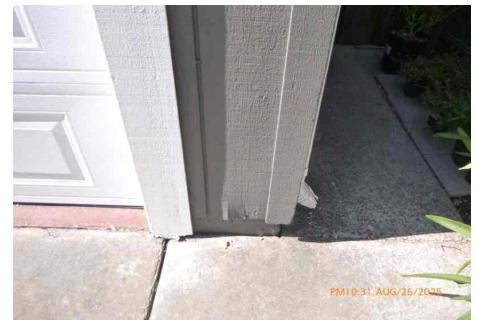
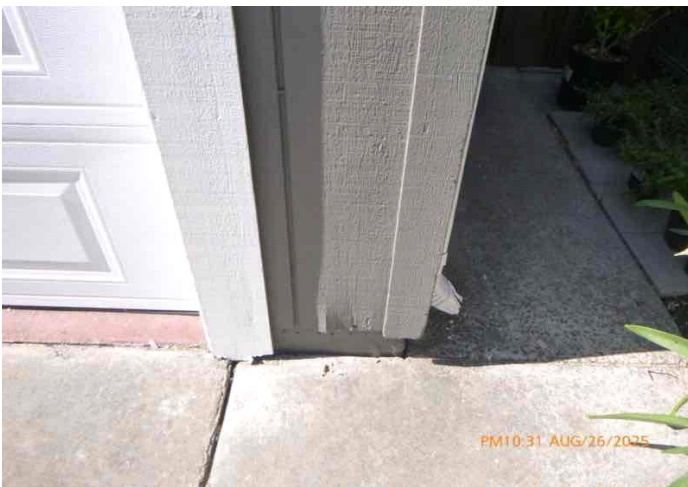
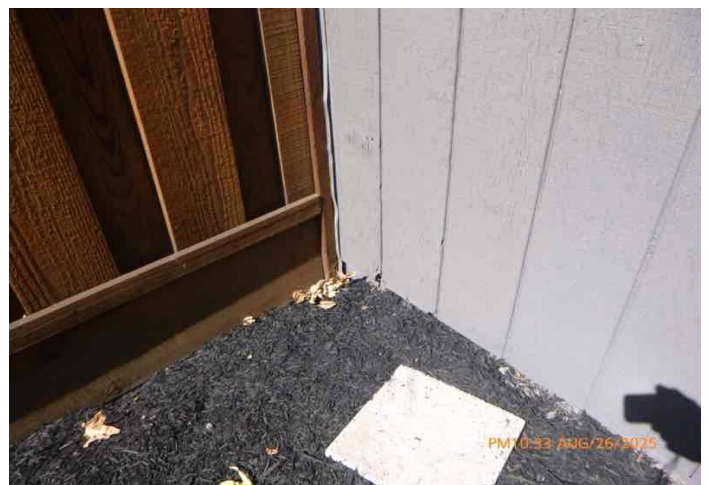
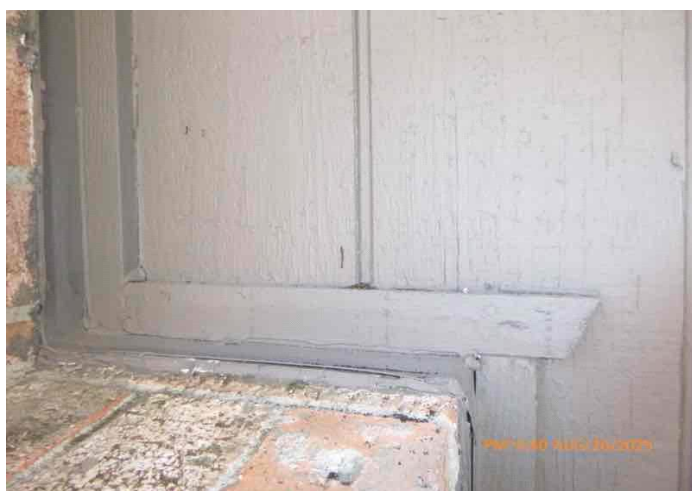
Photo 03

7. Water damage was observed to the wood siding at the front, left, and right sides exterior walls. We recommend the services of a licensed general contractor and/or structural pest control company. (See Photo 3) (See Photo 6) (See Photo 9)

- ! 6. Water damage was observed to the wood siding at the front, left, and right sides exterior walls. We recommend the services of a licensed general contractor and/or structural pest control company. (See Photo 3) (See Photo 6) (See Photo 9)

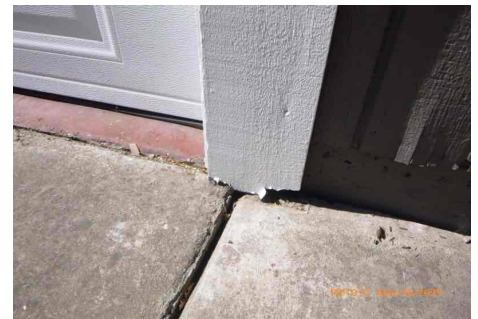
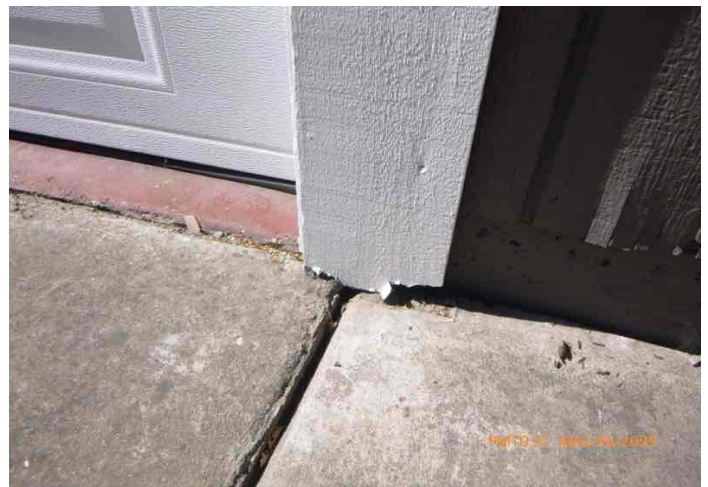
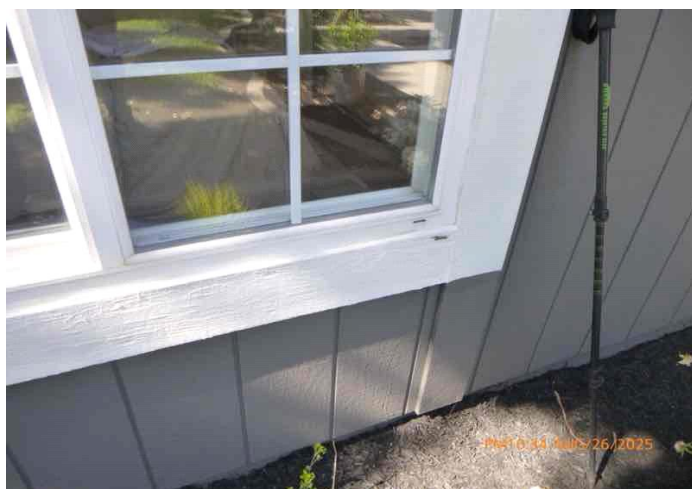
Photo 04

8. Water damage was observed to the exterior trim at the front. We recommend the services of a licensed general contractor and/or structural pest control company. (See Photo 4) (See Photo 7)

- ! 7. Water damage was observed to the exterior trim at the front. We recommend the services of a licensed general contractor and/or structural pest control company. (See Photo 4) (See Photo 7)

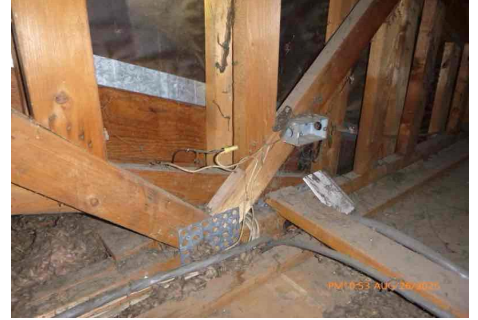
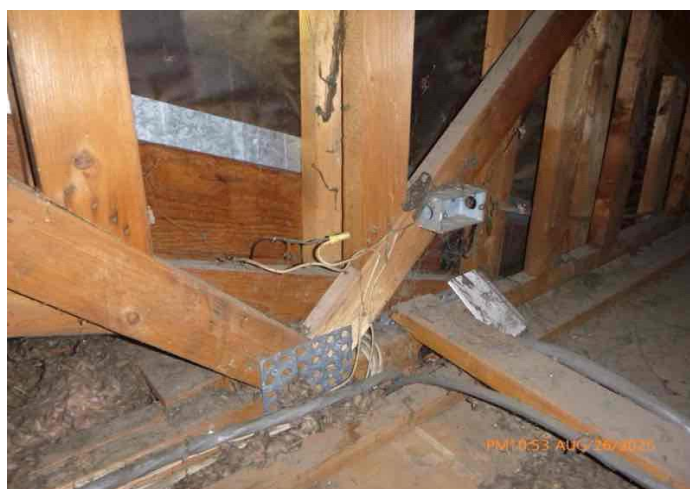
Photo 12

9. Running splices, which are improper connections outside of a junction box, were observed in the attic. We recommend connections be joined with approved connectors inside a junction box to prevent accidental contacts or mechanical damage. (See Photo 12)

- ! 1. Running splices, which are improper connections outside of a junction box, were observed in the attic. We recommend connections be joined with approved connectors inside a junction box to prevent accidental contacts or mechanical damage. (See Photo 12)
- ! 2. The main panel was locked and was inaccessible at the time of our inspection. We recommend the lock be removed and circuitry and wiring in the panel be inspected by appropriate trades. (See Photo 15)
- 3. The accessible aluminum connectors inside the electrical main and/or branch panel are lacking the application of an anti-oxidant. We recommend that each accessible connection be covered with an anti-oxidant.

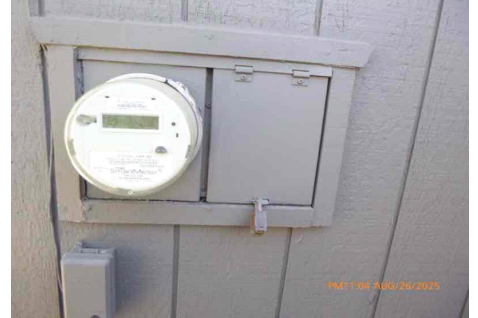
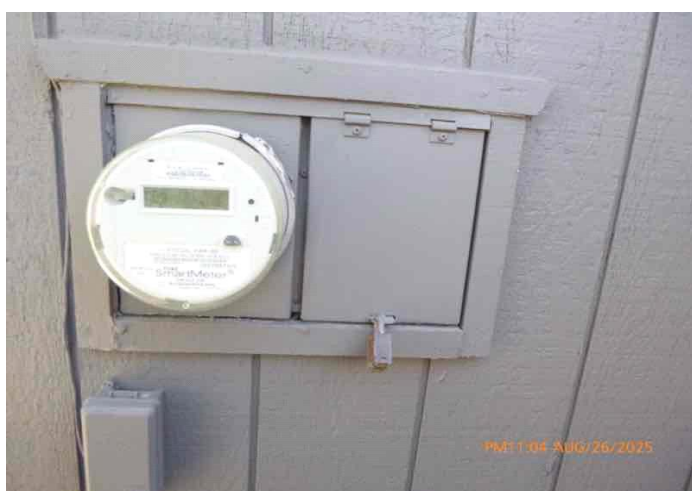
Photo 15

10. The main panel was locked and was inaccessible at the time of our inspection. We recommend the lock be removed and circuitry and wiring in the panel be inspected by appropriate trades. (See Photo 15)

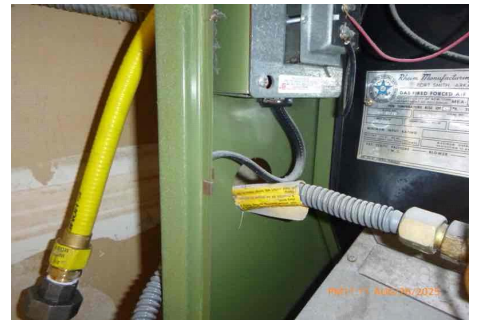
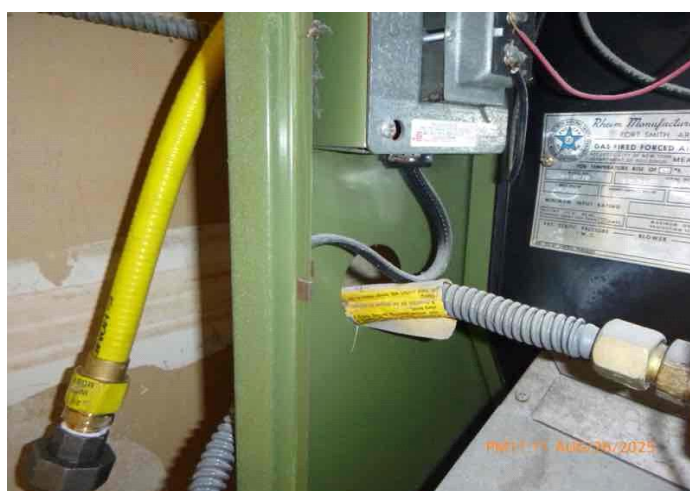
Photo 16

11. We noted a flexible gas line running through the furnace metal housing. We recommend consideration be given to installing rigid piping at the penetration of the housing and the installation of flexible supply piping at the exterior of the furnace. (See Photo 16)

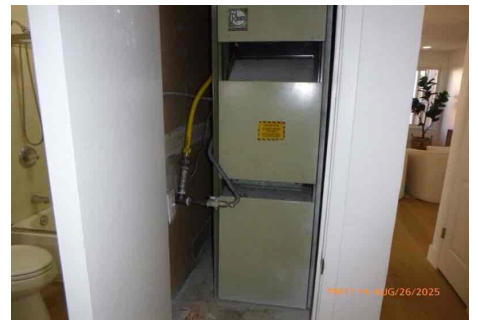
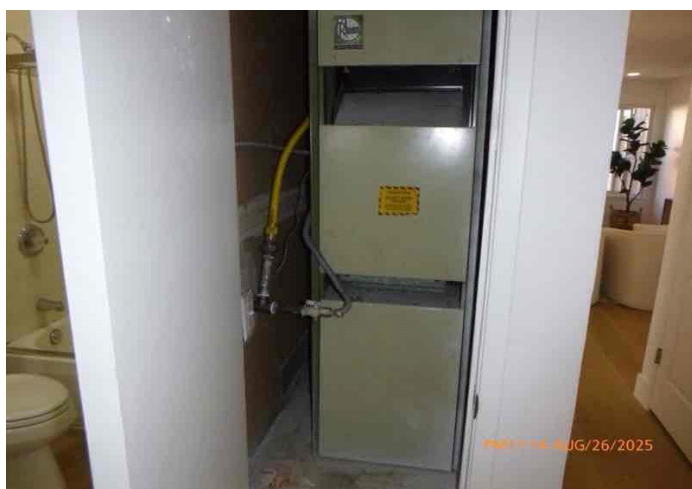
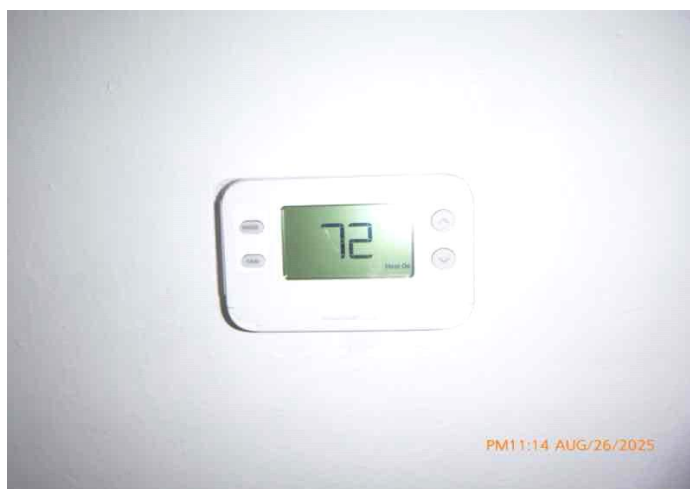
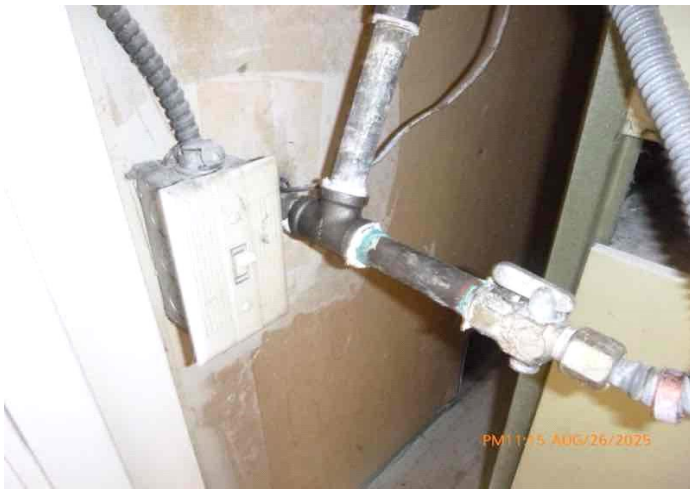
Photo 17

12. The heating system failed to respond to normal operating controls. We recommend a qualified HVAC contractor be retained to evaluate the system and determine what corrective measures are necessary. (See Photo 17) (See Photo 18) (See Photo 19)

- ! 1. We noted a flexible gas line running through the furnace metal housing. We recommend consideration be given to installing rigid piping at the penetration of the housing and the installation of flexible supply piping at the exterior of the furnace. (See Photo 16)
- ! 2. The heating system failed to respond to normal operating controls. We recommend a qualified HVAC contractor be retained to evaluate the system and determine what corrective measures are necessary. (See Photo 17) (See Photo 18) (See Photo 19)

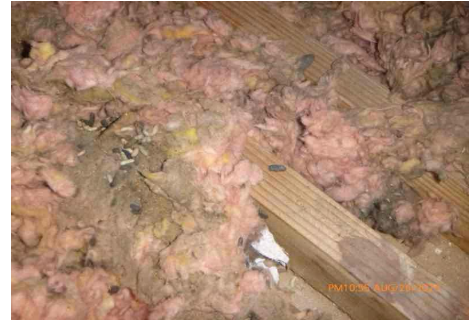
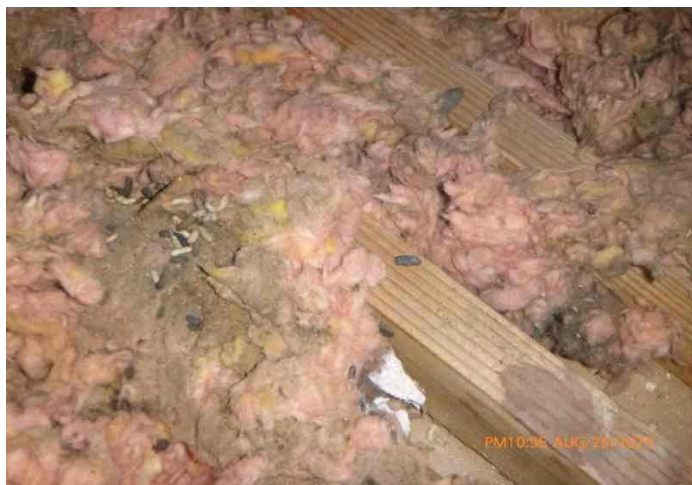
Photo 13

13. Evidence of vermin activity was observed within the attic structure. It is likely this evidence will extend into inaccessible areas. The owner is advised to contact the appropriate trade for further evaluation and remedial measures if necessary.
(See Photo 13)

- ! 1. Evidence of vermin activity was observed within the attic structure. It is likely this evidence will extend into inaccessible areas. The owner is advised to contact the appropriate trade for further evaluation and remedial measures if necessary. (See Photo 13)
2. The fireplace chimney should be cleaned and inspected prior to the close of escrow. (See Illustration 9J)
3. It may be desirable to replace the window screens where missing or damaged.
4. The interior wall or ceiling blemishes or minor holes and or cracks are cosmetic and can be repaired in the course of routine maintenance.

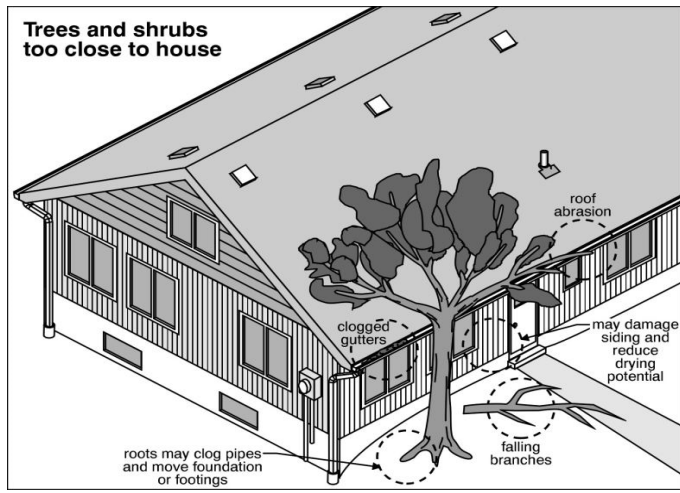
Illustration 3T

8. The screen for the sliding glass door is bent/damaged. We recommend the screen be repaired or replaced.
9. The tree proximity at the front could disrupt drainage pipes, cause mechanical damage to the exterior of the house or influence the foundation over time. For additional information and recommendations we recommend appropriate trades be consulted. (See Illustration 3T)
