WOOD DESTROYING PESTS AND ORGANISM INSPECTION REPORT

Building No. 7060	Street Via Anacapa	City San Jose	ZIP 95139	Date of Inspection 8/27/2025	Number of Pages Page 1 of 11
<div style="display: flex; align-items: center;"> <div> 510 Madera Avenue San Jose, CA 95112 (855) 331-1900 • Fax (925) 294-1818 </div> </div>					
Registration #: PR1452		HomeGuard #: 663792		Escrow #: 1115041931	
Ordered By: Omar Murillo Everhome Real Estate 40081 Mission Boulevard Fremont, CA 94539		Property Owner/Party in Interest: Sarah Mitscha 7060 Via Anacapa San Jose, CA 95139		Report Sent to:	
COMPLETE REPORT <input checked="" type="checkbox"/> LIMITED REPORT <input type="checkbox"/> SUPPLEMENTAL REPORT <input type="checkbox"/> REINSPECTION REPORT <input type="checkbox"/>					
General Description: This is a one story single family dwelling with wood exterior.				Inspection Tag Posted: Garage Other Tags Posted: None noted	
An inspection has been made of the structure(s) shown on the diagram in accordance with the Structural Pest Control Act. Detached porches, detached steps, detached decks and any other structures not on the diagram were not inspected.

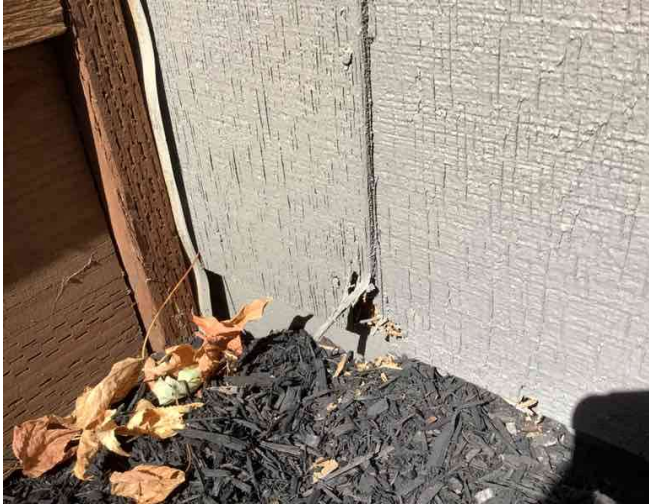
Photo 01

- 1A.** FINDING: The siding has been damaged by subterranean termites, fungus, or drywood termites at the exterior as indicated on the diagram. Refer to item(s) 1I, 1K for recommendations to control contributing moisture source and or infestation. (See Photo 1) (See Photo 3) (See Photo 12)

- 1K.** FINDING: Subterranean termites were noted at the exterior. (See Photo 1)

RECOMMENDATION: Cut off approximately 24 inches of the siding to eliminate the damage. Install Z-bar and new siding where removed. If damage extends into inaccessible areas, a supplemental report will be issued with any findings, recommendations, and bids to complete repairs. It should be noted that an exact match of the existing siding may not be possible.

RECOMMENDATION: Chemically treat the complete exterior soil at probable termite entry points with Termidor: Termidor HE (Fipronil:5-amino-1-(2,6-dichloro-4-(trifluoromethyl) phenyl)-4-((1R,S)-trifluoromethyl)sulfinyl)-1-H-pyrazole-3-carbonitrile and break down and brush away all subterranean termite migratory tubes. In conventional construction, this may include, rodding or trenching the soil around the foundation walls, drilling attached slabs such as patios, porches, sidewalks, or driveways that abut the structure and treat the area on the interior of the foundation where the termites were found. A ground stop device will be used to prevent drilling into concealed pipes, conduit or electrical wiring however if this were to happen it will be the owners responsibility and expense to repair any damage done. The holes drilled into any concrete slab, while performing the treatments, will be plugged with mortar. It will be the owners responsibility to have these areas repaired to match the existing surfaces as desired. NOTE: In order to perform this treatment the property must be vacant for the period during and 3 hours after the treatment has been completed.

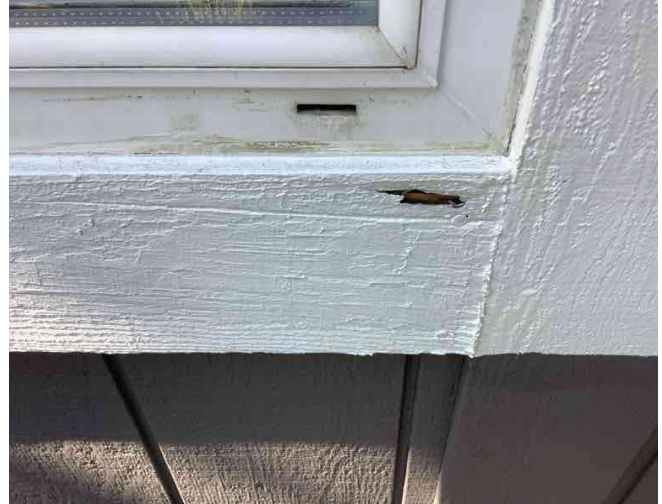
Photo 02

- 1B.** FINDING: The window trim has been damaged by drywood termites at the front exterior as indicated on the diagram. Refer to item(s) 1I for recommendations to control contributing moisture source and or infestation. (See Photo 2)

- 1I.** FINDING: Infestation by Drywood Termites was noted at the exterior, interior garage, and garage attic. (See Photo 2) (See Photo 4) (See Photo 9)

RECOMMENDATION: Remove and replace all the damaged wood members. If any damage is found to extend into any enclosed areas a supplemental report and bid will be issued.

RECOMMENDATION: Due to the nature of these infestations, it will be necessary to seal the entire structure and fumigate it with Vikane (sulfuryl fluoride), using Chloropicrin as a warning agent. The entire structure must be vacant for this process. It is the owners responsibility to make any preparations required by the fumigators or to have someone to do so at a separate expense and to have the gas turned back on when the fumigation is complete. "NOTICE: The charge for service that this company subcontracts to another registered company may include the company's charges for arranging and administering such services that are in addition to the direct costs associated with paying the subcontractor. You may accept HomeGuard Incorporated's bid or you may contract directly with another registered company licensed to perform the work. If you choose to contract directly with another registered company, HomeGuard Incorporated will not in any way be responsible for any act or omission in the performance of work that you directly contract with another to perform." HomeGuard Incorporated guarantees all fumigations for a period of three years from the date of completion.

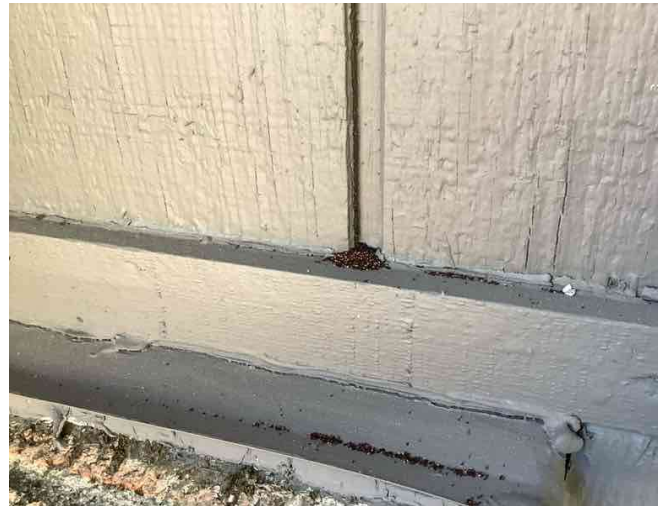
Photo 04

- 1J.** FINDING: Drywood termite pellets were evident as noted in the above recommendation. (See Photo 4) (See Photo 9) (See Photo 10)

RECOMMENDATION: Remove and/or mask over all accessible termite pellets. It is possible for the drywood termite pellets to sift down or reappear in these areas where they have been masked over.

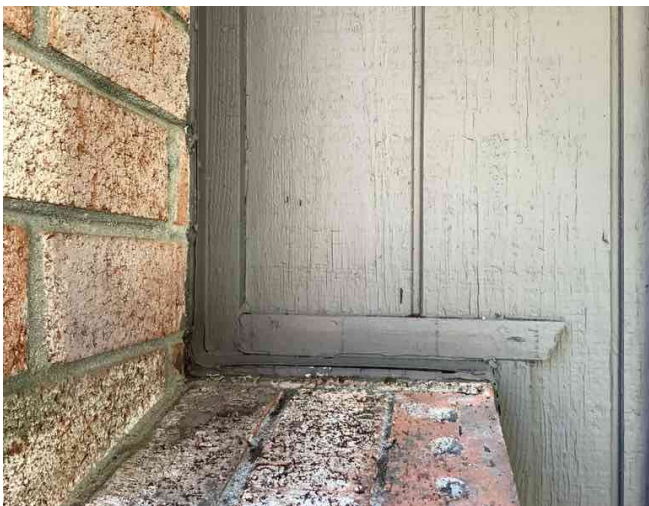
Photo 05

- 1C.** FINDING: The siding has been damaged by drywood termites at the right side exterior adjacent to the chimney. Refer to item(s) 1I for recommendations to control contributing moisture source and or infestation. (See Photo 5)

RECOMMENDATION: Remove and replace all the damaged wood members. If any damage is found to extend into any enclosed areas a supplemental report and bid will be issued.

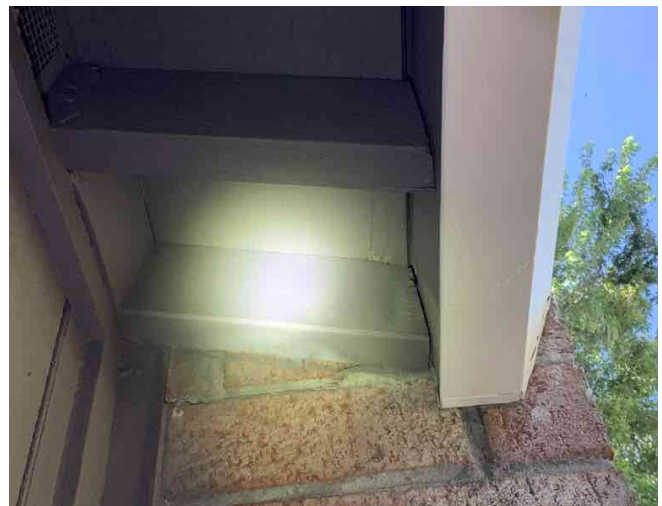
Photo 06

- 1D.** FINDING: The roof sheathing has been damaged by fungus where indicated on the diagram. The contributing moisture source appears to have been caused by a failure of the roof covering. (See Photo 6)

RECOMMENDATION: Remove and replace the damaged sheathing to correct this condition. This bid *Estimated Cost* includes repair of the roof covering if disturbed by our repairs. If existing gutters need to be removed to perform the repairs then our bid also includes reinstallation of original gutters. If it becomes necessary or desirable to install new gutters this will be done only if authorized and at an additional expense. The guarantees on the roof covering are limited to the areas where the repairs were performed.

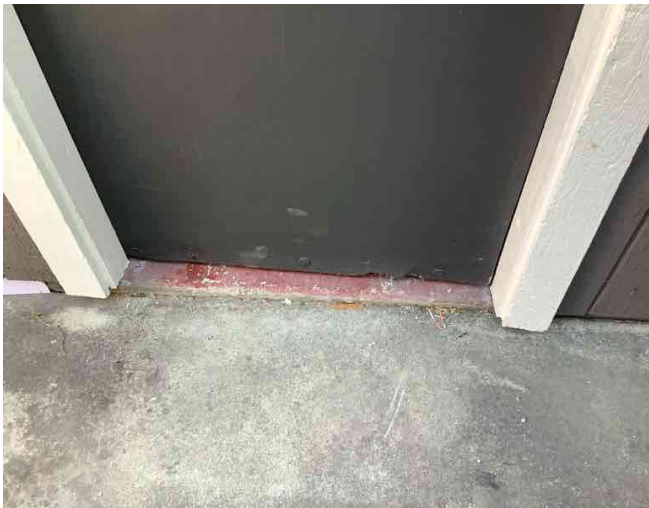
Photo 07

- 1E.** FINDING: The rear garage man door was found to be damaged by fungus. It appears the damage is a result of exposure to the weather. (See Photo 7)

RECOMMENDATION: Supply and install a new pre-hung door and jambs to correct this condition. Note: *Estimated Cost* The existing door knob and dead bolt if any will be re-installed in the new door unless prior arrangements are made. We at HomeGuard Incorporated are upgrade experts and can provide proposals that include upgraded fixtures, and doors or any other option you may desire. This bid is based on the installation of a readily available door of similar size. An exact match of the existing door may not be possible. If a more exact match is desired, additional fees may apply. Please note that if a special order door is needed to complete this item, there could be a three week delay in getting a replacement door.

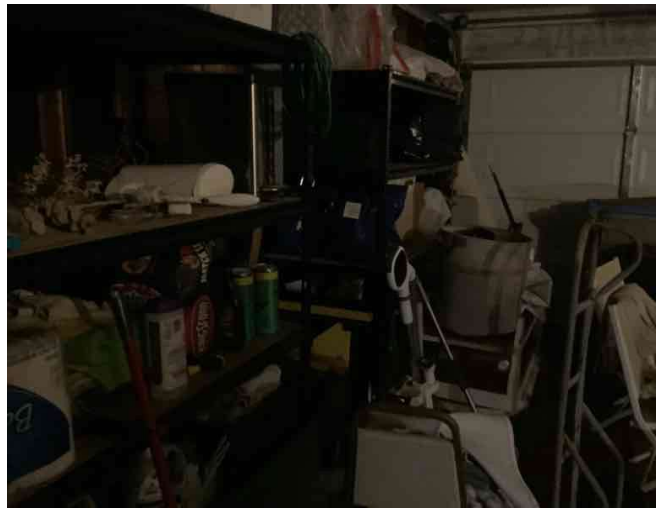
Photo 08

3A. FINDING: We were unable to inspect a portion of the interior of the garage due to stored personal property. (See Photo 8)

RECOMMENDATION: The owner should move the storage away from the garage walls to allow for *Estimated Cost* further inspection. All findings, recommendations, and bids will be issued in a supplemental report.

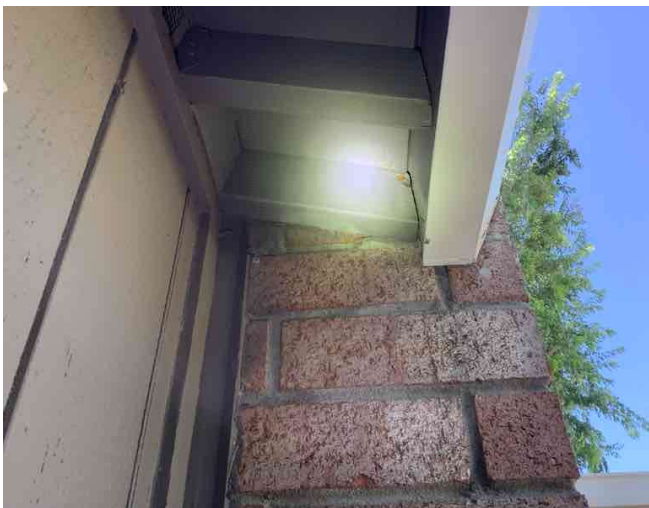
Photo 11

- 1F.** FINDING: The rafter tail(s) as indicated on the diagram are damaged by fungus. The contributing moisture source appears to be exposure to the weather. (See Photo 11)

RECOMMENDATION: Remove and replace the end of the damaged rafter tail(s) and install a new sister *Estimated Cost* section alongside for support.

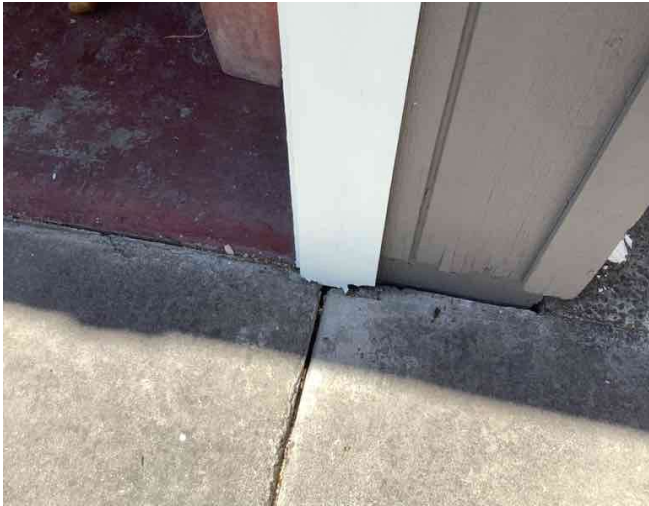
Photo 13

- 1G.** FINDING: The trim has been damaged by drywood termites at the front exterior garage as indicated on the diagram. Refer to item(s) 1I for recommendations to control contributing moisture source and or infestation. (See Photo 13)

RECOMMENDATION: Remove and replace all the damaged wood members. If any damage is found to *Estimated Cost* extend into any enclosed areas a supplemental report and bid will be issued.

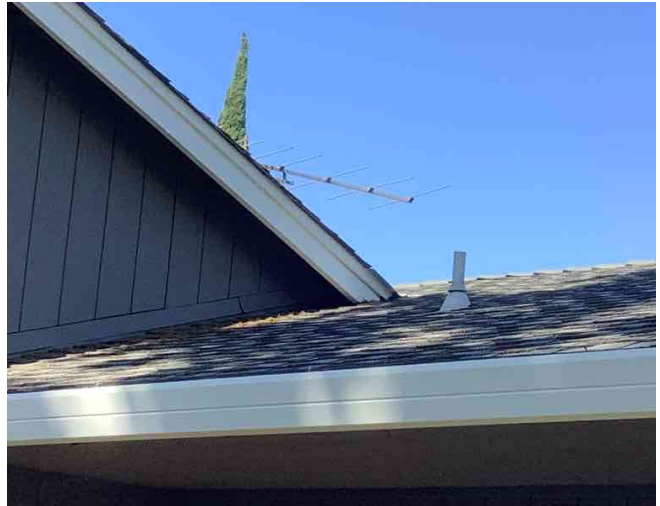
Photo 14

- 1H.** FINDING: The barge rafter(s) as indicated on the diagram are damaged by fungus. The contributing moisture source appears to be exposure to the weather. (See Photo 14)

RECOMMENDATION: Remove and replace a section of the damaged barge rafter(s) to correct this *Estimated Cost* condition. This bid includes repair of the roof covering if disturbed by our repairs. If existing gutters need to be removed to perform the repairs then our bid also includes reinstallation of original gutters. If it becomes necessary or desirable to install new gutters this will be done only if authorized and at an additional cost. The guarantees on the roof covering are limited to the areas where the work was performed.
