Roof Inspection Report

7060 Via Anacapa, San Jose

Kenneth Carlin
August 27, 2025

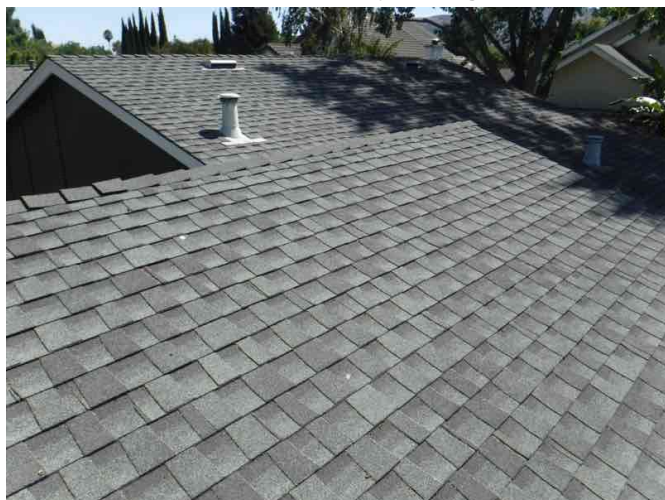
Photo 01

The roof is a dimensional composition shingle, grey in color, the number of roof layers is unknown. The estimated remaining serviceable life of the roof is 10-15 years. The pitch of the roof appears to be 4:12. The overall condition of the roof is good.

1. A bird's-eye view of the roof: (See Photo 1) (See Photo 2)
