Subject: Residential Structural Evaluation
207 Oxfordshire Lane
Chapel Hill, North Carolina

Project No.: DM-26581

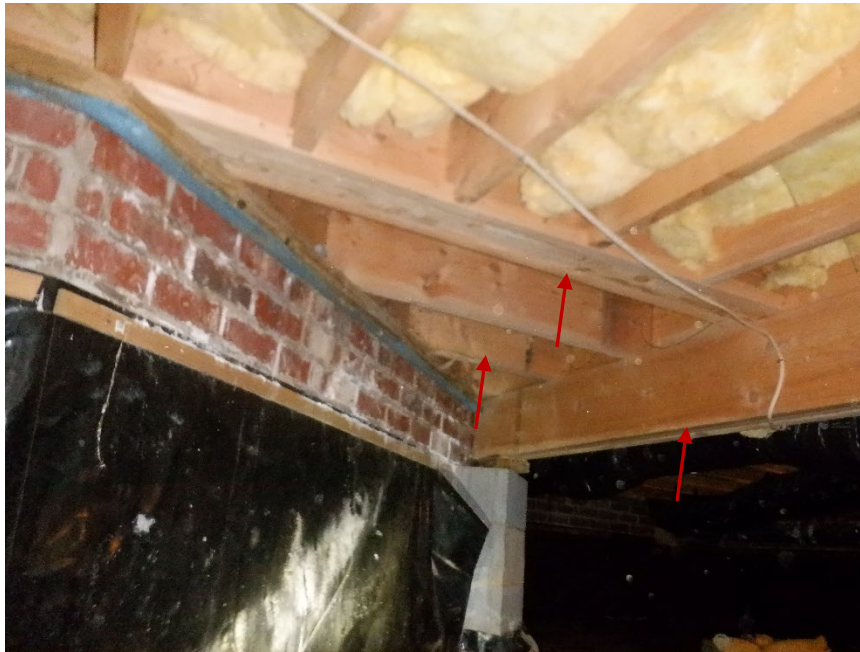
- b. Termite damage was observed on the floor framing beneath the angled wall at the rear of the home where the door goes out onto the rear open deck. There was minor surface damage probed at two of the floor system girder beams, and some short floor joists, in this location and moderate termite damage to the end of a longer floor joist that runs left-to-right and damage to blocking at the end of this joist. Where termite damage was observed at two of the floor system girders, we were only able to probe the exterior surfaces of the girder members and not in between the members.

Photograph Number 1 - View of area of floor system where minor termite damage was observed.

Where termite damage was observed at the two sections of floor system girder beams at the rear of the crawl space, the outer surfaces that we were able to probe did not indicate damage to the girder that has adversely affected it structurally. Additionally, the short sections of floor joists that had minor damage were also not structurally affected. The longer joist that had damage at its end should be repaired. We recommend sistering a new full-length joist alongside the damaged joist. We also recommend removing and replacing the damaged block at the end of this joist. Once the block is removed, we recommend probing the rim band that is behind it to evaluate its condition as well and then performing any necessary spot repairs.

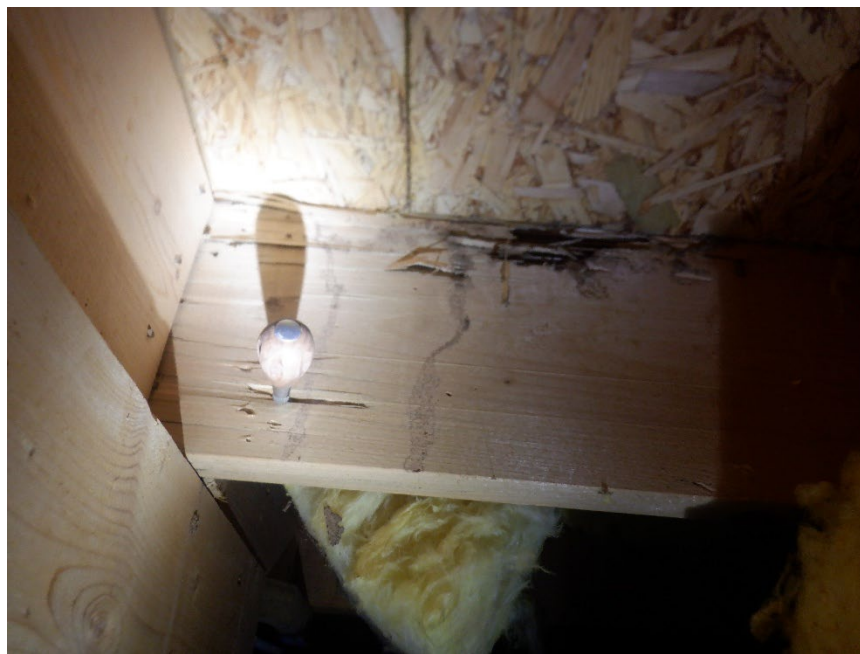
Photograph Number 2 - View of termite damaged end of floor joist where a full length "sister" joist should be installed as a repair.

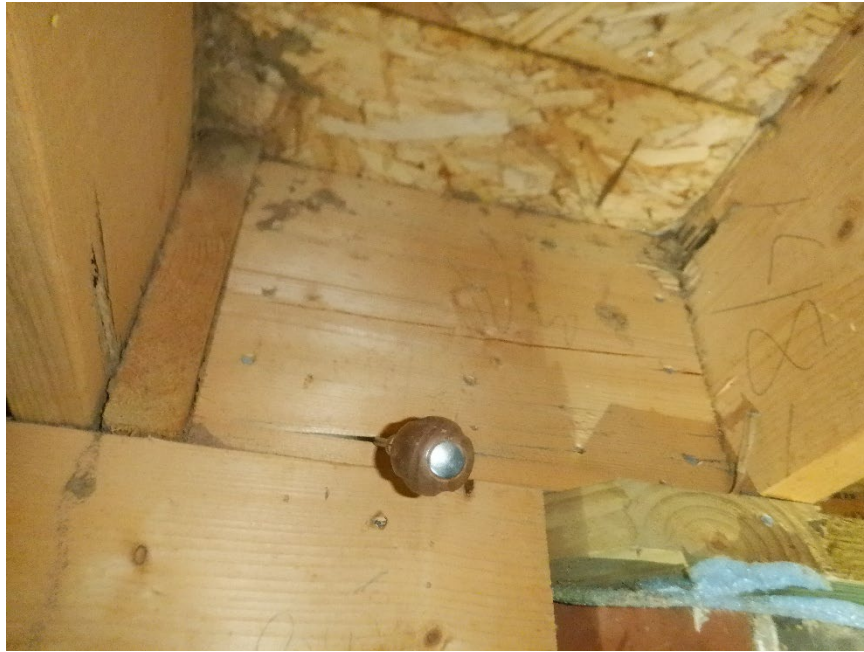
Photograph Number 3 - View of termite damaged block located at end of the joist that needs repair.
Remove, probe framing behind it and repair as needed.
