BUILDING ANALYSIS REPORT

Property Location: *2064 Kettle Creek Ct
De Pere, WI 54115*

Date of Inspection: *8/20/2025*

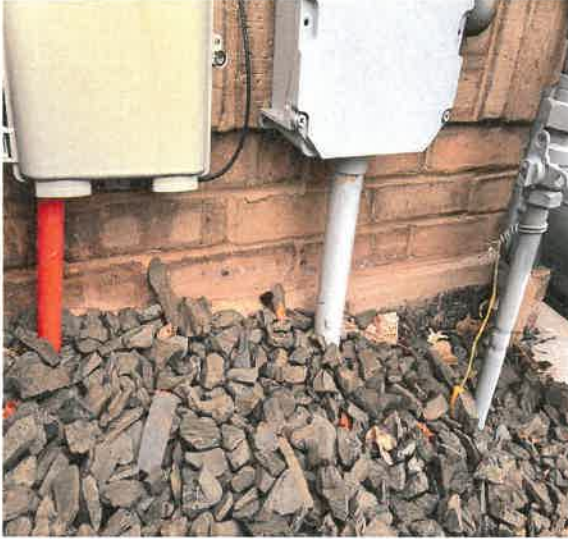
IMG_7947[1].JPG

Remarks:	<p><i>The brick exterior does not appear to have weep holes. Weep holes should have been installed when built.</i></p> <p><i>The exterior appears to be maintained and to be in satisfactory condition.</i></p> <p><i>One piece of missing metal fascia was noted on the front garage gable. This needs to be repaired. On repair schedule.</i></p>

The first course of brick are missing weep holes. Weep holes should have been added when applied. I did not note any moisture problems.

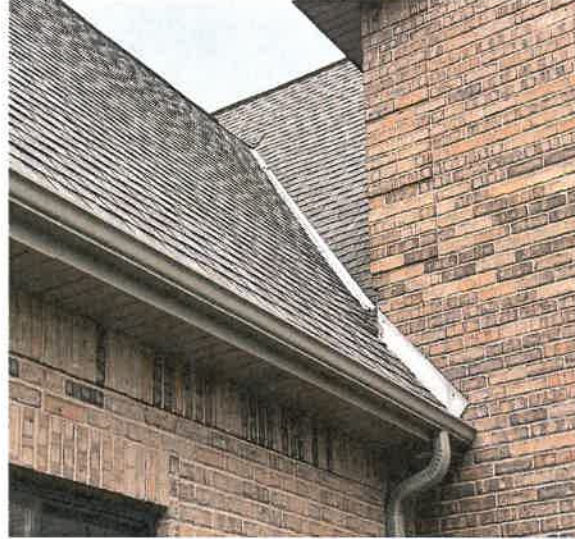
IMG_7962[1].JPG

The roof valley appears to be properly flashed.

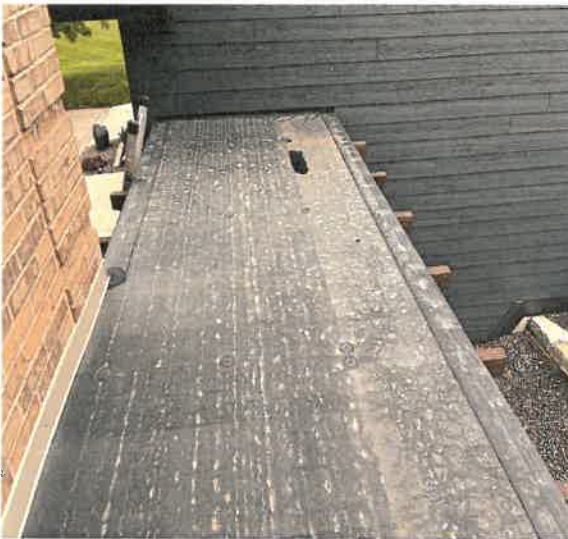
IMG_7966[1].JPG

The rubber roof at the house and detached garage appears to be in satisfactory condition.

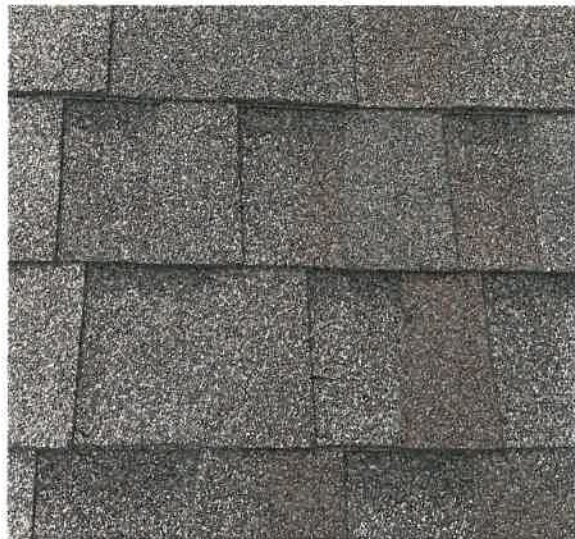
IMG_7967[1].JPG

Close up view of the roof shingles. These are better quality shingles which have a normal life of 20-25 years.

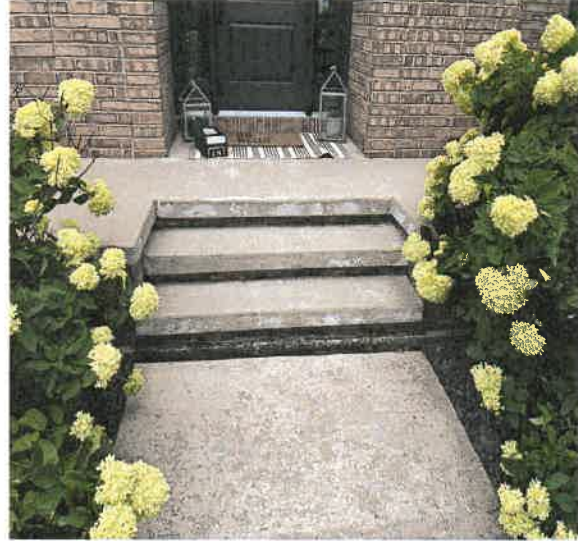
IMG_7963[1].JPG

The sidewalk at the front step has sunk a few inches. This has caused a high setp. This sunken concrete should be mudjacked or replaced.
