PROPERTY INSPECTION
REPORT

1913 N Outagamie St, Appleton, 54914 WI

DATE OF INSPECTION: 3/19/2026

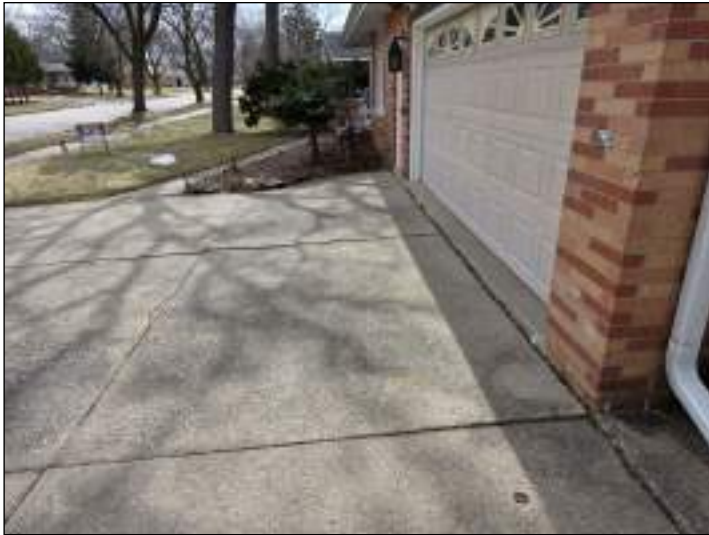
- **REPAIR:** The slabs in front of the garage door opening settled, and the concrete on the side of the garage was heavily cracked, creating potential trip hazards. For your safety, I recommend either repairing or replacing the affected areas.

The slabs in front of the garage door opening settled.

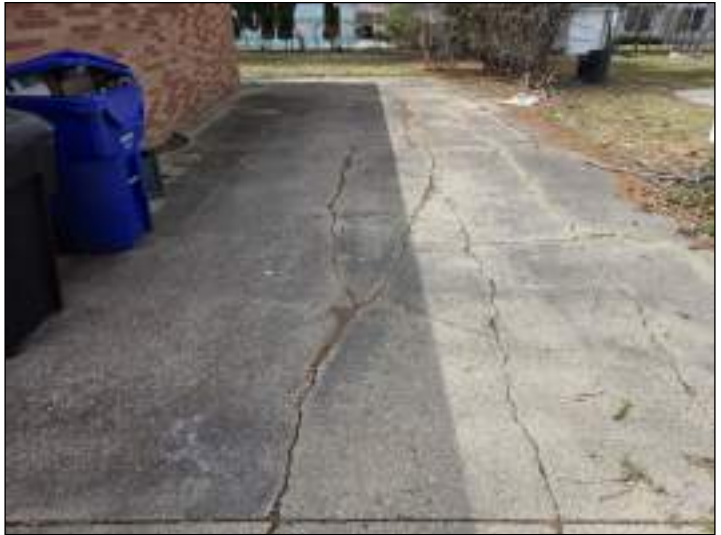
The slabs were heavily cracked in this area.

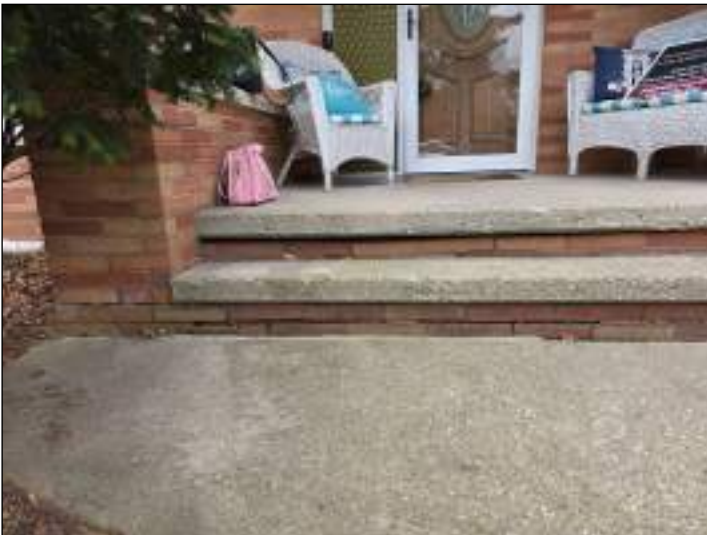
- **REPAIR:** The mortar was cracked and/or missing in some areas. These areas should be repaired to prevent water from entering, which could cause further damage.

The mortar was cracked or missing in some areas.

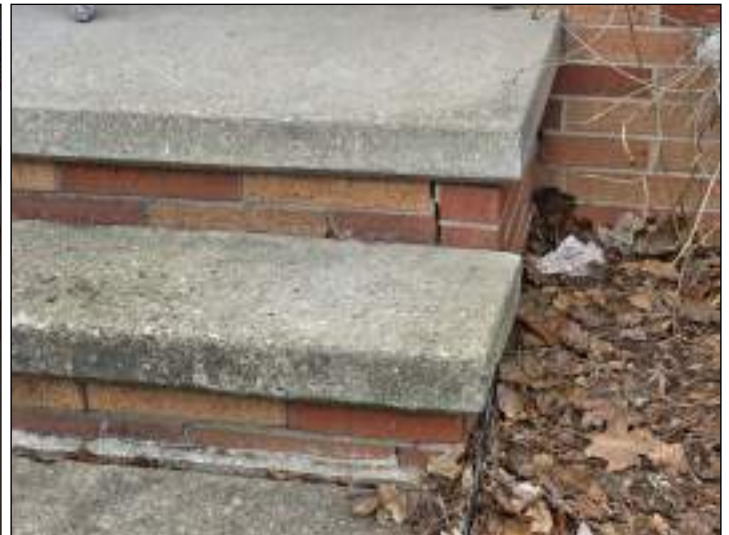
Close-up view.

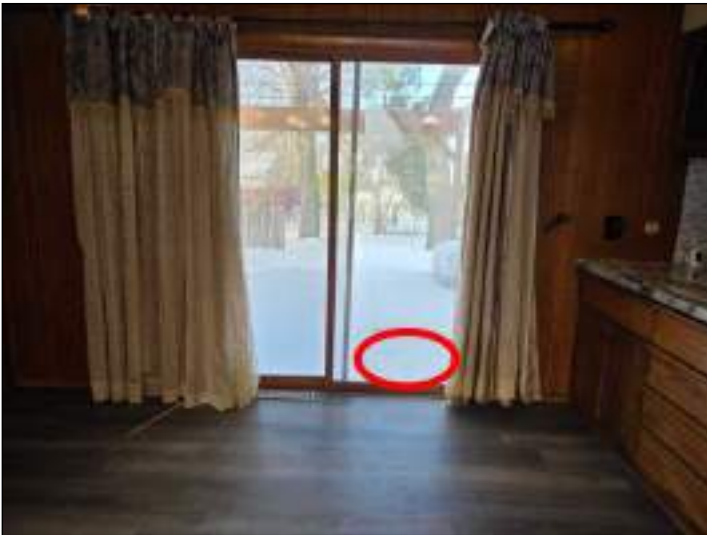
- **DEFECT:** The glass in one patio door was cracked, allowing moisture to build up between the two panes. I recommend having the door repaired by a qualified contractor.

The glass was cracked in this door.

NOTE: The sellers have a new door on order and plan to install it as soon as it arrives.

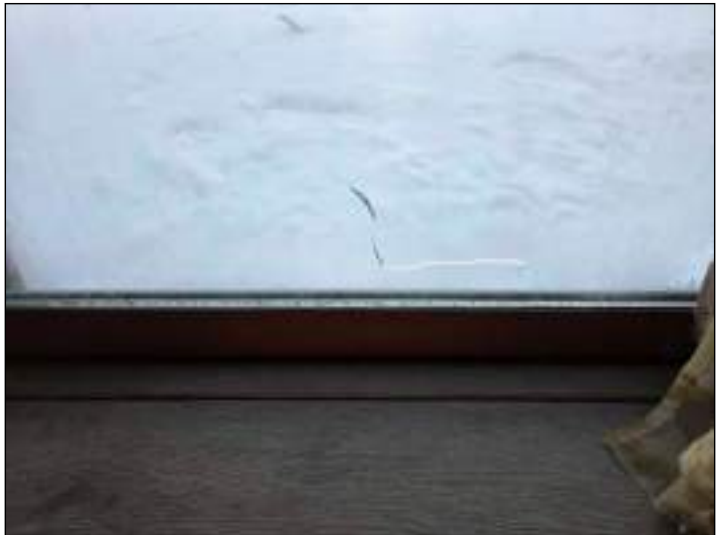
Close-up view.

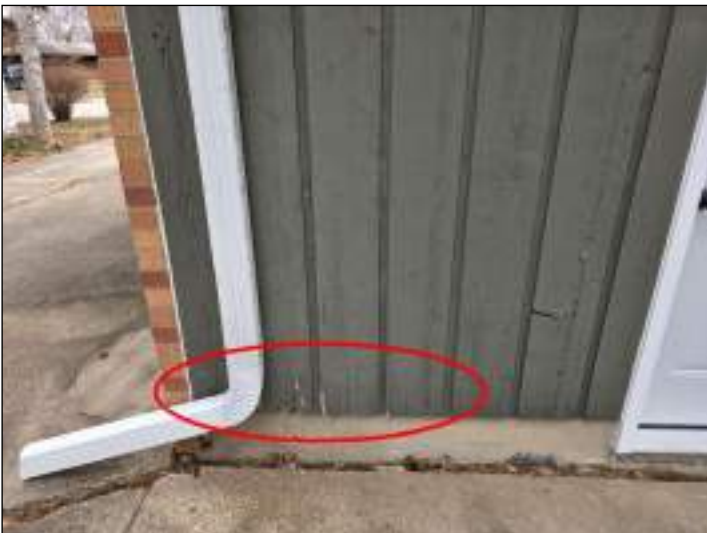
- REPAIR: The siding along the back side of the garage was starting to rot along the bottom. I recommend repairing or replacing this area as needed.
- MAINTENANCE: I recommend removing the vines on the east side of the house to protect the siding from damage.

The siding was starting to rot along the bottom of this wall.

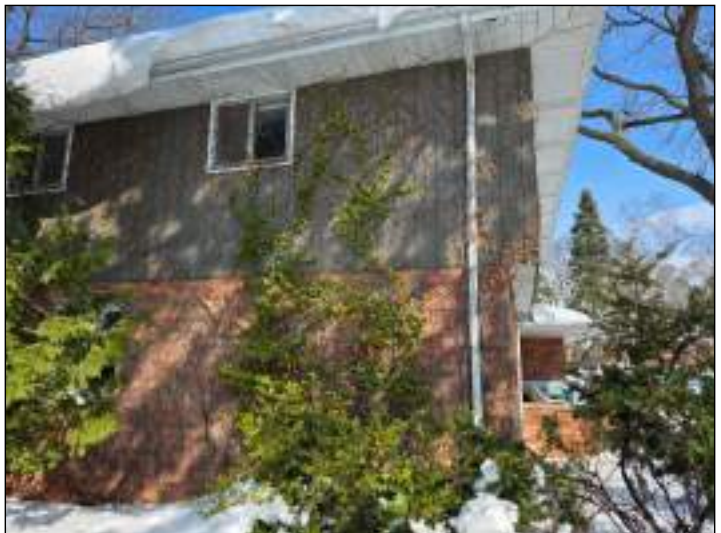
I recommend removing the vines.

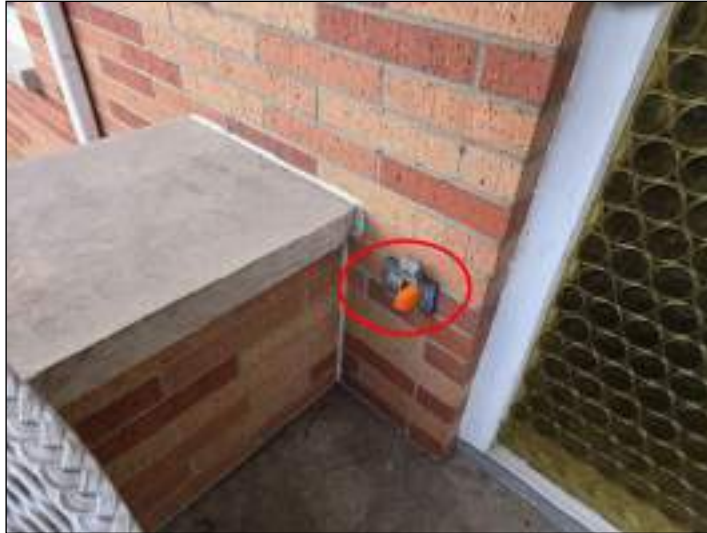
- **DEFECT:** the outlet on the front side of the house lacked GFCI protection, creating a potential safety/shock hazard. I recommend having this corrected by a licensed electrician.

GFCI protection was missing on this outlet.

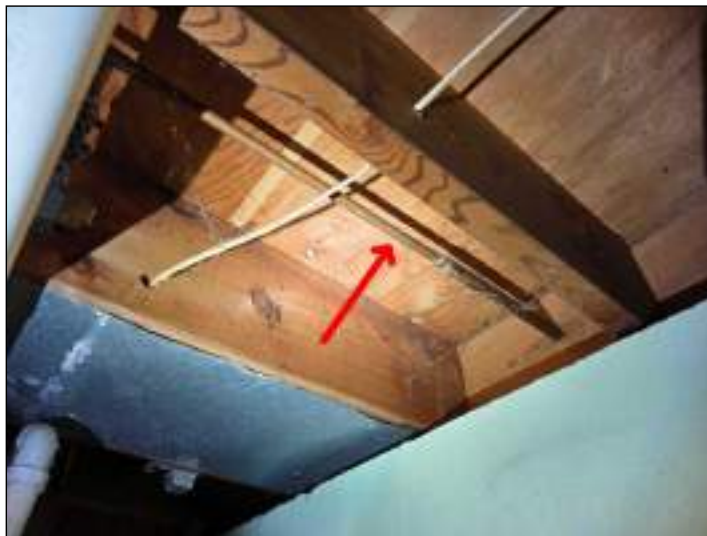
- The exterior faucets(s) functioned properly when tested.
- **REPAIR:** The rear hose bib lacked a shut-off valve. I recommend adding one, so it can be turned off during the winter.

I recommend adding a shut-off valve in the basement.

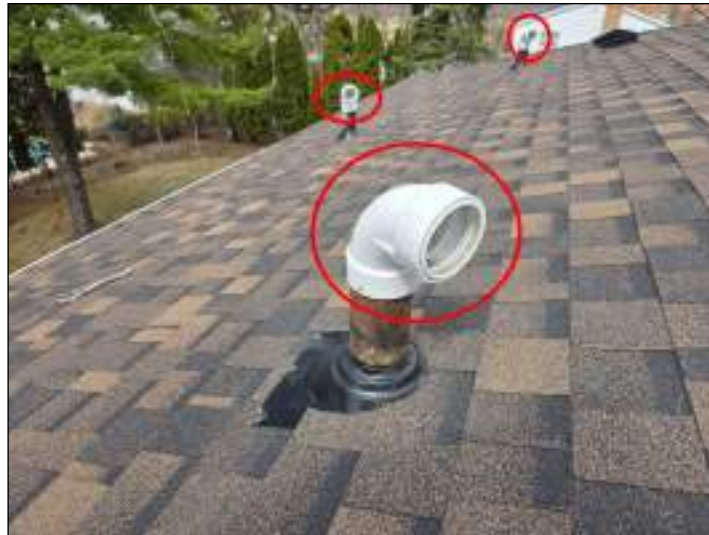
- The roof boots were in satisfactory condition.
- I recommend removing the **PVC** elbows from the vent pipes, as the screens on them could collect condensation and freeze them shut during winter.

I recommend removing these PVC elbows.

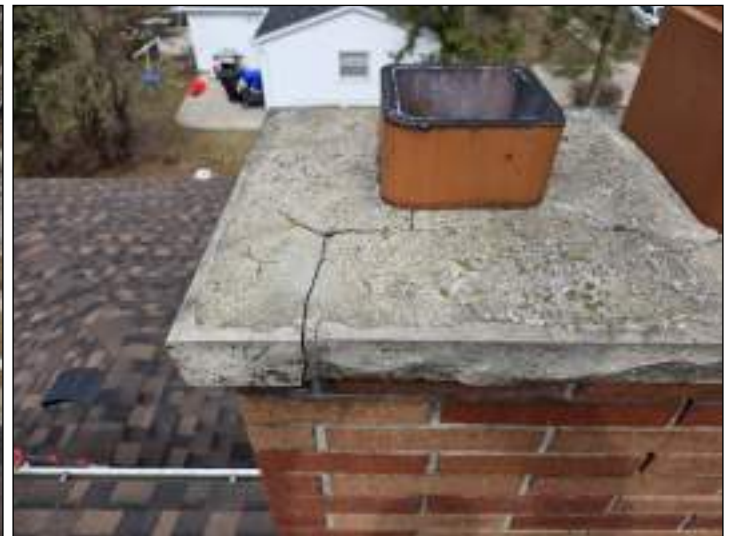
- REPAIR: The cement crown was cracked in a few areas. I recommend sealing them to prevent water from entering, which could cause further damage.
- MAINTENANCE: Chimney caps should be installed on the flue pipes to prevent water and wildlife from entering.

The crown was cracked in a few areas.

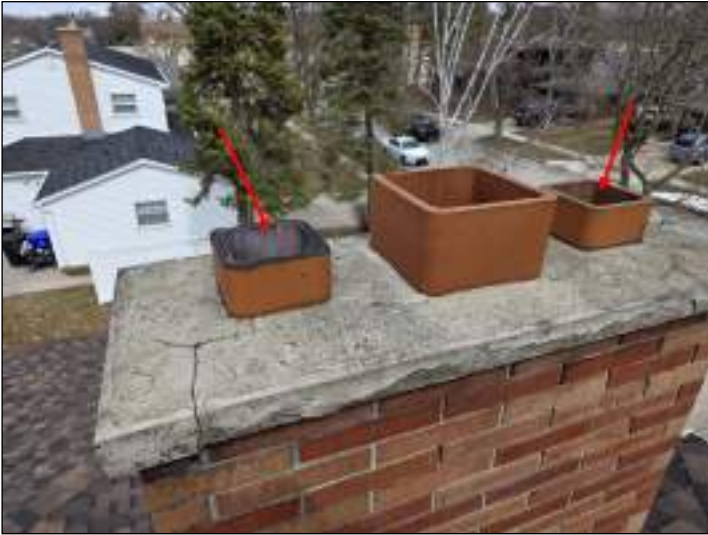
I recommend capping off these two unused flue pipes.

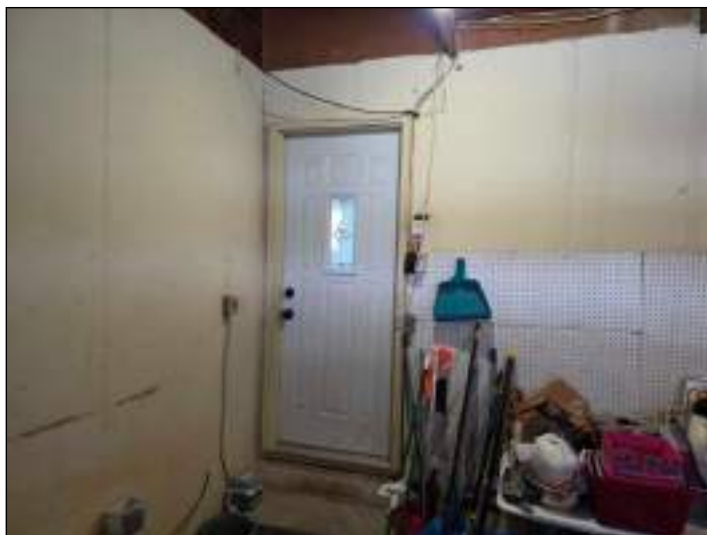
- IMPROVE: The wall separating the garage from the home living space did not meet the current fire separation requirements. Although fire separation may not have been required when the home was initially constructed, I recommend updating the existing condition for your safety. This can be done by adding a layer of 5/8" type X drywall onto the wall with the seams taped or sealed. The door between the garage and the home should also have a 20-minute fire rating.

I recommend adding a fire-rated door and covering the walls with drywall.

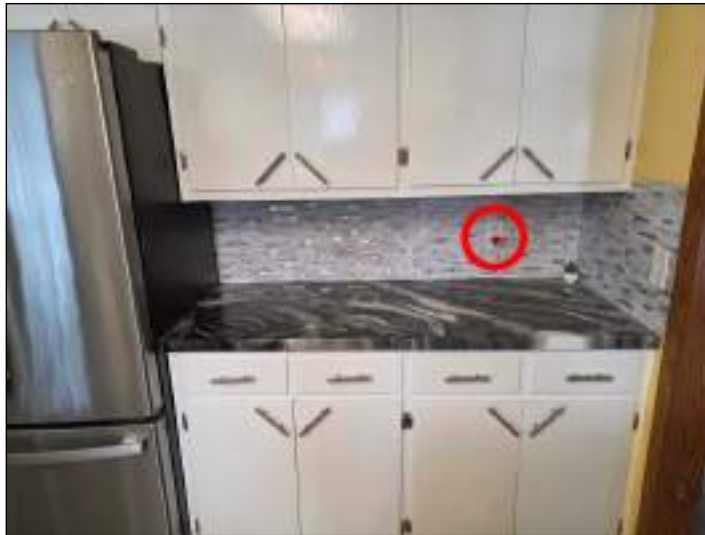
- IMPROVE: I recommend adding GFCI protection to all countertop outlets to comply with today's building standards for safety.

I recommend adding GFCI protection to this outlet.

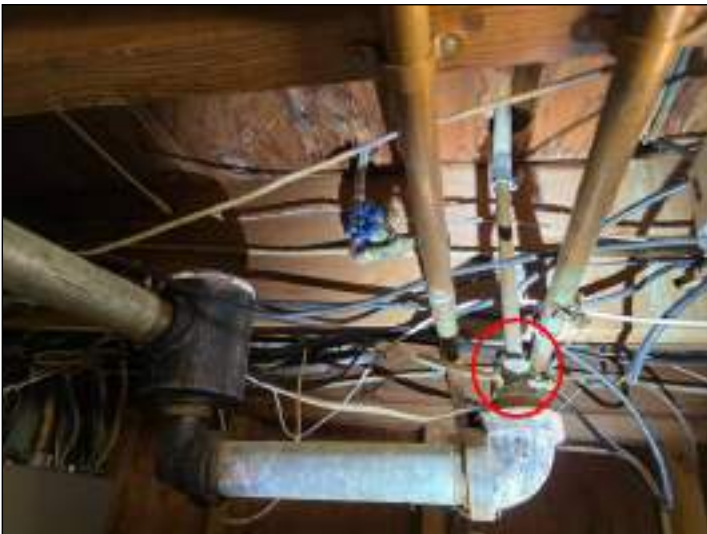
- **DEFECT:** The dishwasher was missing an **air gap** or anti-siphon device. The air gap or anti-siphon device prevents the wastewater from being siphoned back into the dishwasher, which could contaminate its contents. I recommend having this repaired for your safety.

The dishwasher was missing an air gap on the drain line.

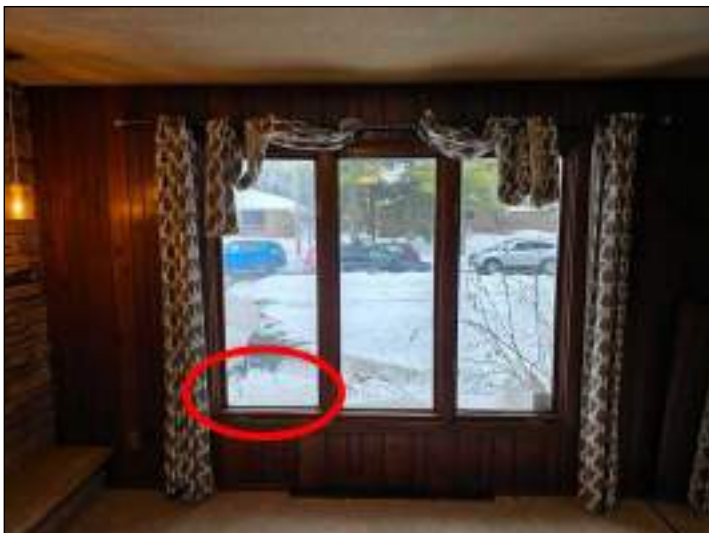
- REPAIR: Several windows needed repair.
- One of the family room windows rubbed on the frame, making it difficult to close.
- Both dining room windows rubbed on the frame, making them difficult to close.
- The glass was loose in the first-floor bedroom windows.
- One of the kitchen windows had a stripped crank mechanism.
- The lock lever was broken on one of the living room and family room windows.
- The northeast bedroom window was loose from the frame, and the storm window was damaged.
- The glazing putty was cracked or missing on several windows.

This family room window rubbed on the frame making it difficult to close.

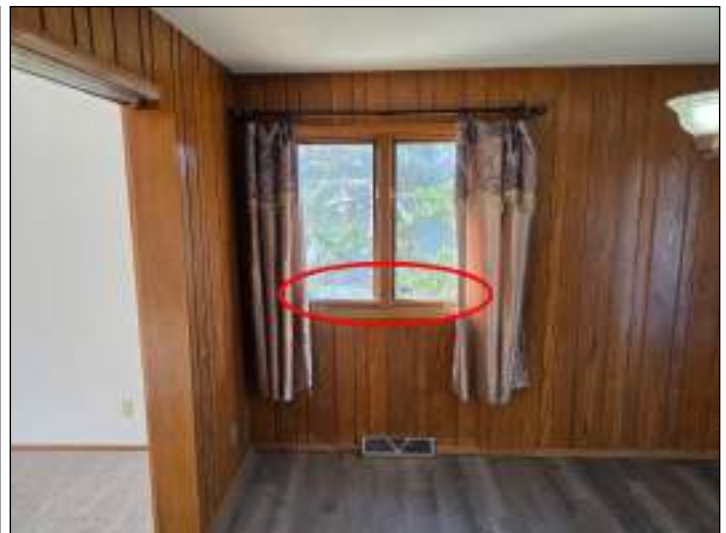
Both of these dining room windows rubbed on the frame, making them difficult to close.

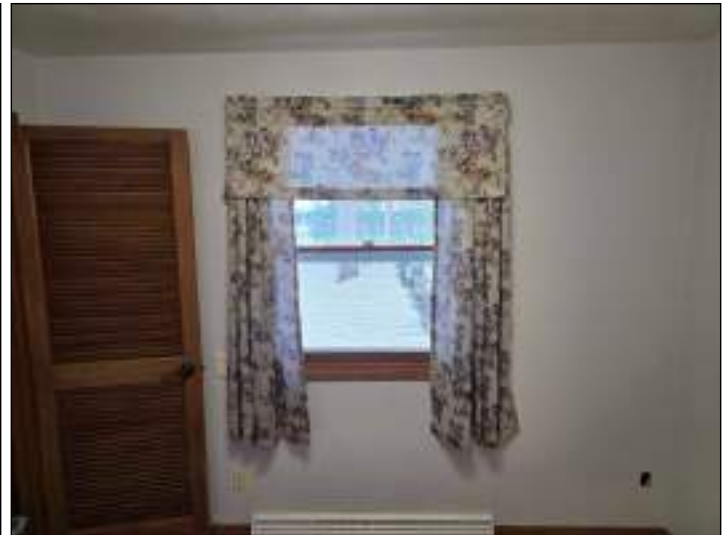
The glass was loose in this first-floor bedroom window.

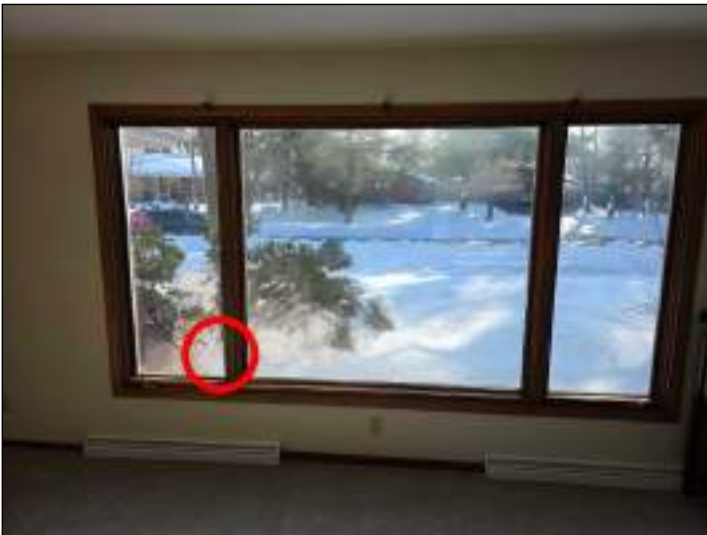
The lock lever was damaged on this living room window.

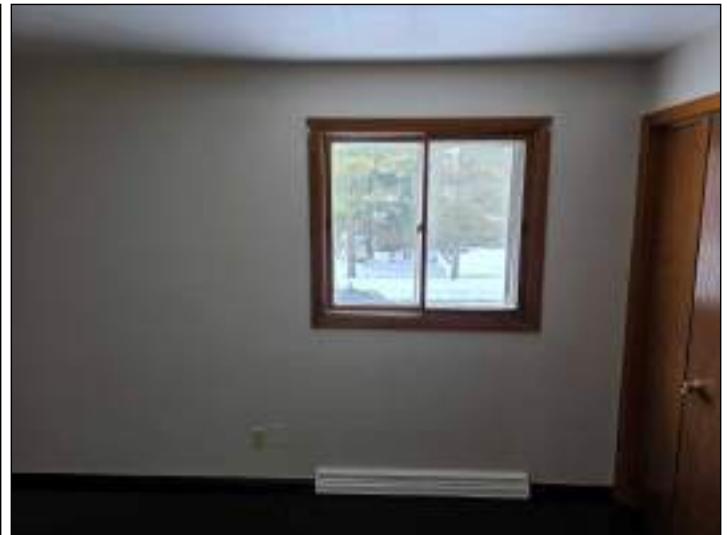
The northeast bedroom window had a damaged storm window, and the slider window was loose from the frame.

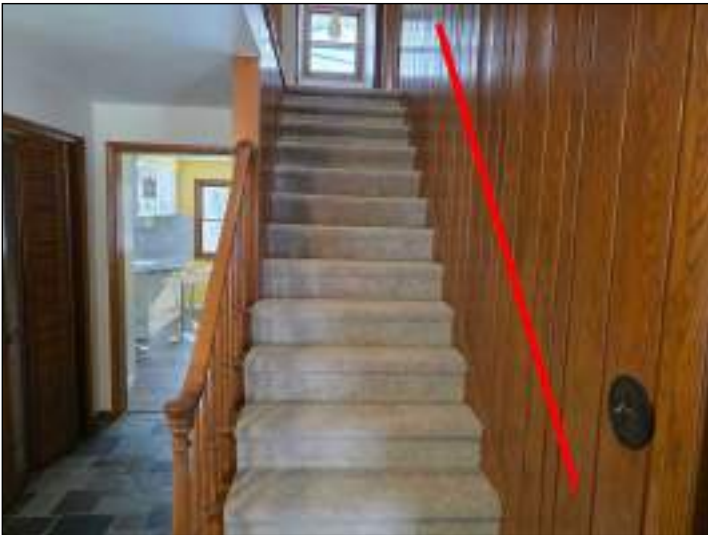
- **DEFECT:** The stairway leading to the second floor was missing a handrail. I recommend having this corrected for your safety.

I recommend adding a continuous handrail on this stairway.

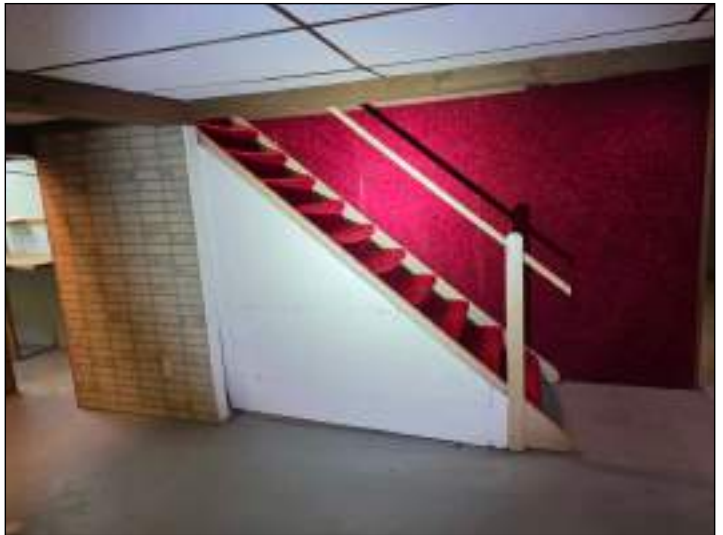
• **IMPROVE:** I recommend adding guardrails on the basement stairway to meet today's building standards for safety. The guardrails should extend at least 36" high, prevent the through-passage of a sphere with a diameter of 4 3/8 inches between the balusters, and support 200# of force when applied in any direction.

I recommend adding a guardrail on this stairway.

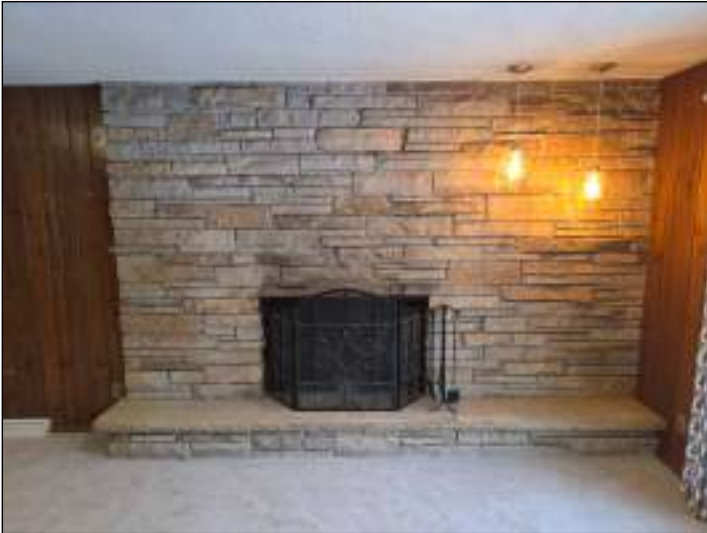
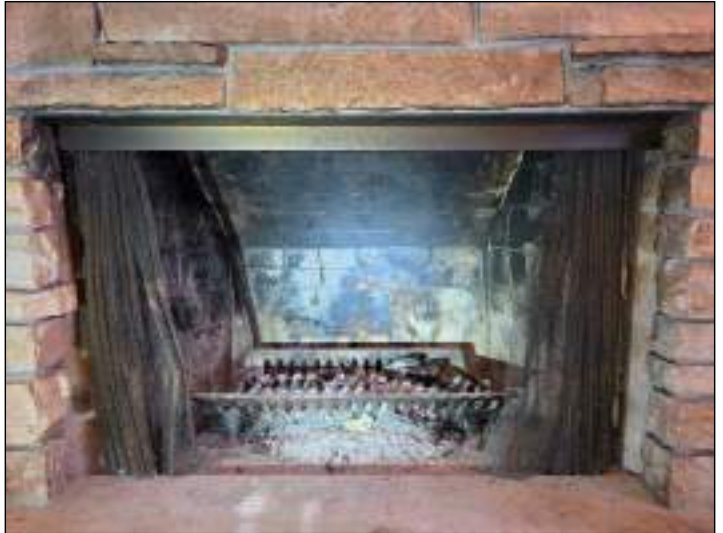
- REPAIR: Some of the bricks in the firebox were cracked. I recommend having them repaired by a mason contractor.

Some of the bricks in the firebox were cracked.

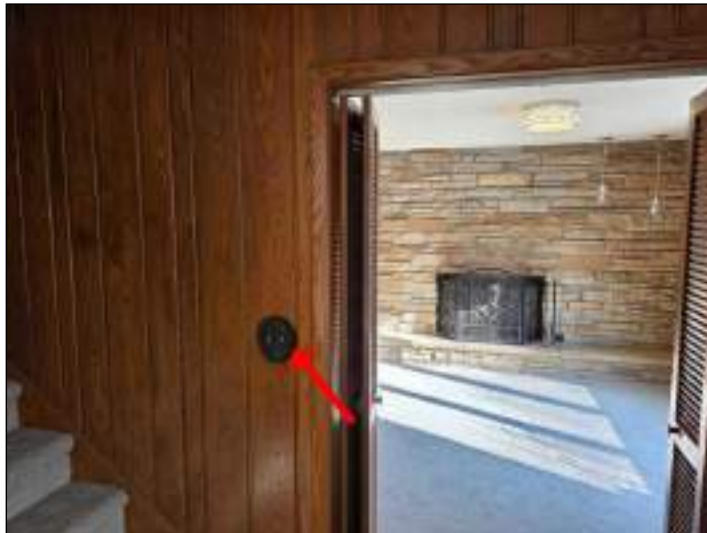
- The 3-way switch for the family room lights was not functioning correctly and required both switches to be in the "ON" position for the light fixture to work.
- Some of the outlets throughout the house were worn, causing a poor connection with my electrical tester.

This three-way switch was miss-wired.

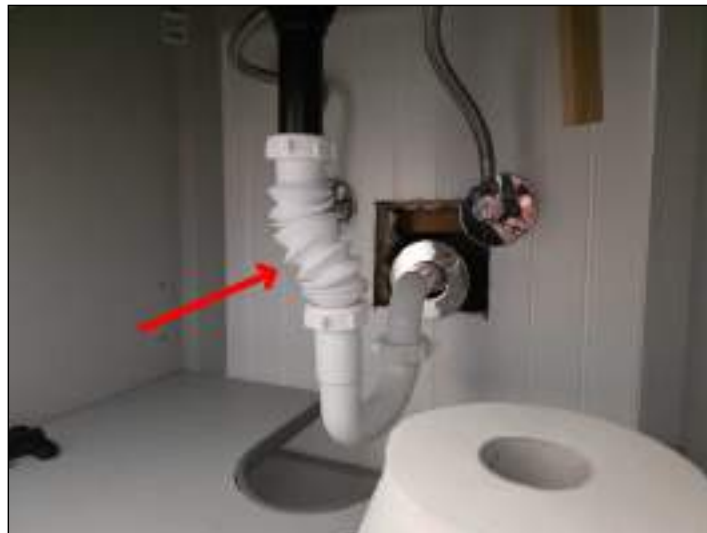
• REPAIR: The drain piping for the sink was made of corrugated or flexible plastic pipes, which is unsuitable for this application because the grooves can trap bacteria and debris, causing frequent clogging. I recommend replacing this material with a standard smooth-walled pipe to ensure proper drainage.

Corrugated / flexible piping was installed.

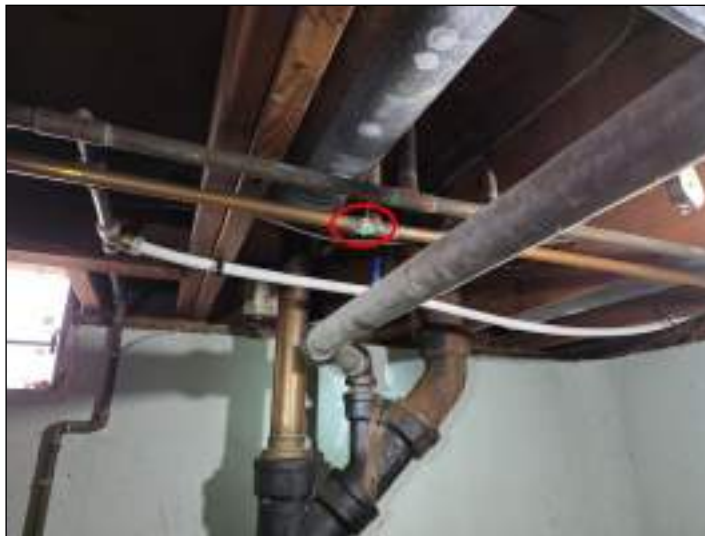
- **DEFECT:** One of the supply lines was leaking. (See photo for location) I recommend having it repaired by a licensed plumber.

The supply line was leaking at this connection.

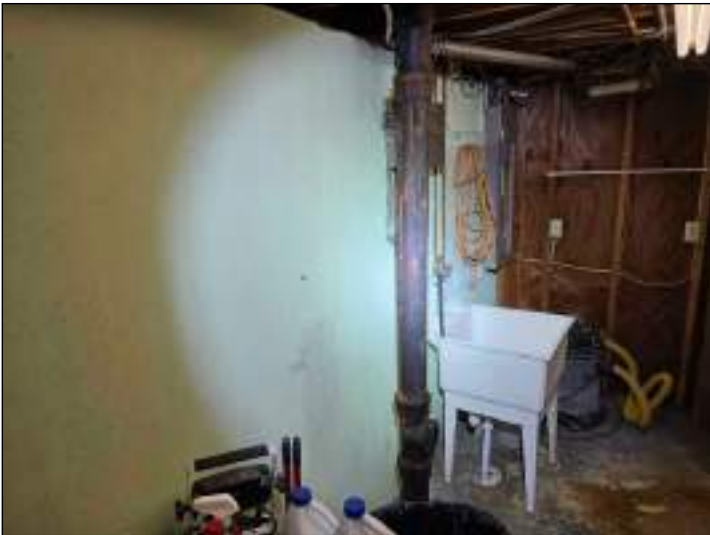
- **DEFECT:** Rust blisters were observed on the cast iron drain pipes. The rust blisters are caused by small pinhole leaks that have sealed themselves shut with corrosion. I recommend having the drain pipes evaluated and repaired by a licensed plumber.

Rust blisters were observed on the cast iron pipes.

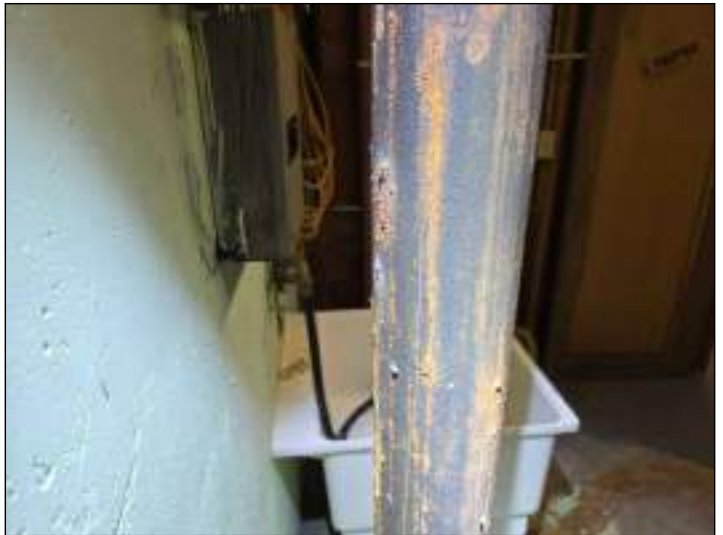
Close-up view.

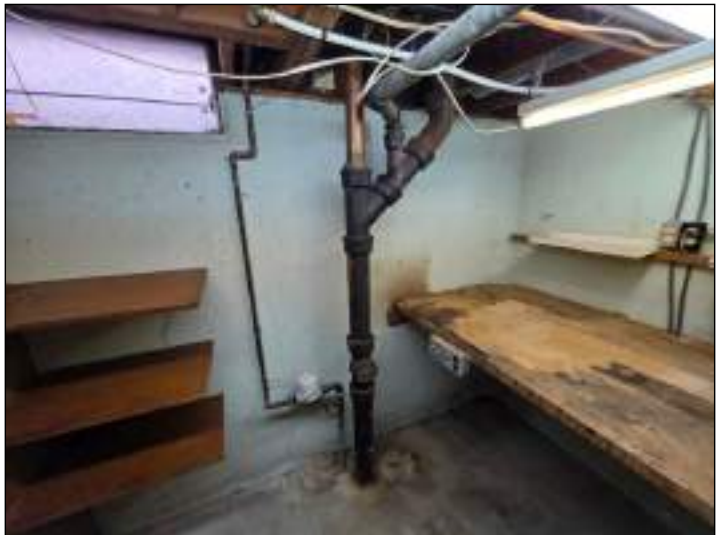
Rust blisters were observed on the cast iron pipes.

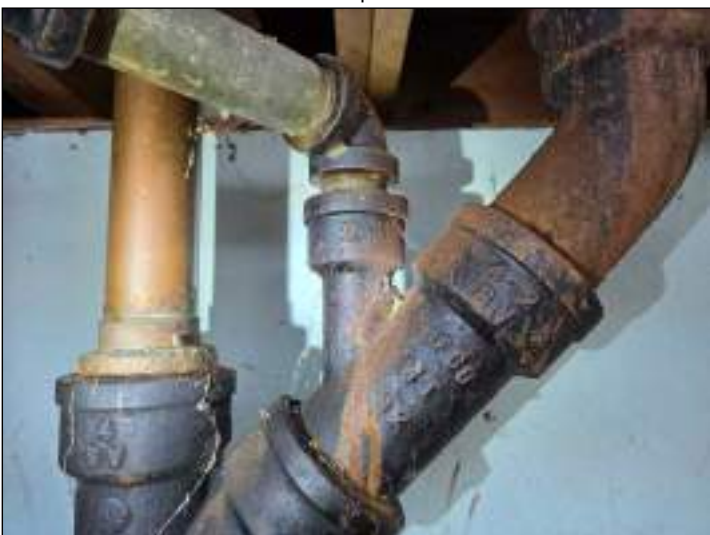
Close-up view.

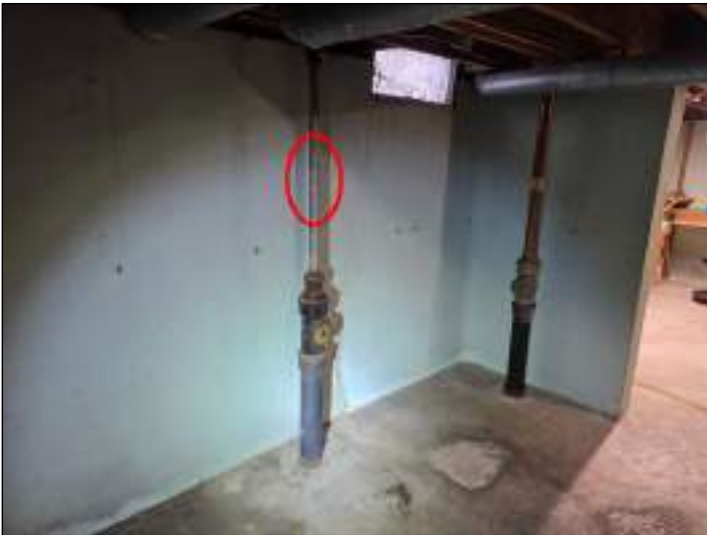
Rust blisters were observed on the cast iron pipes.

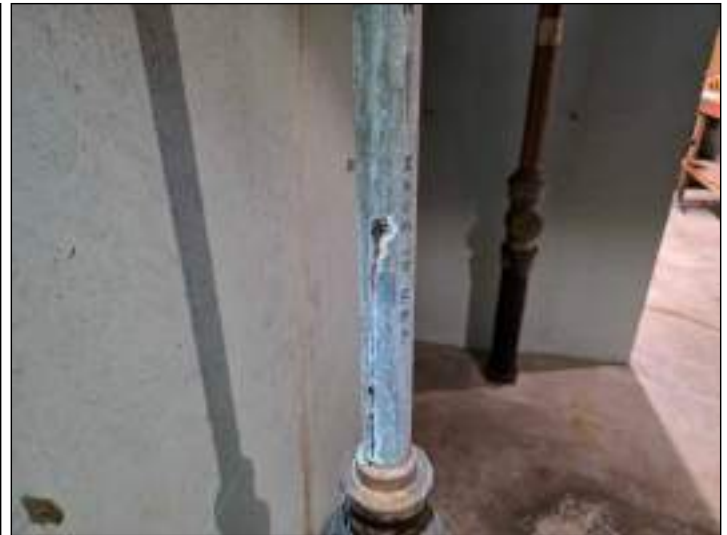
Close-up view.

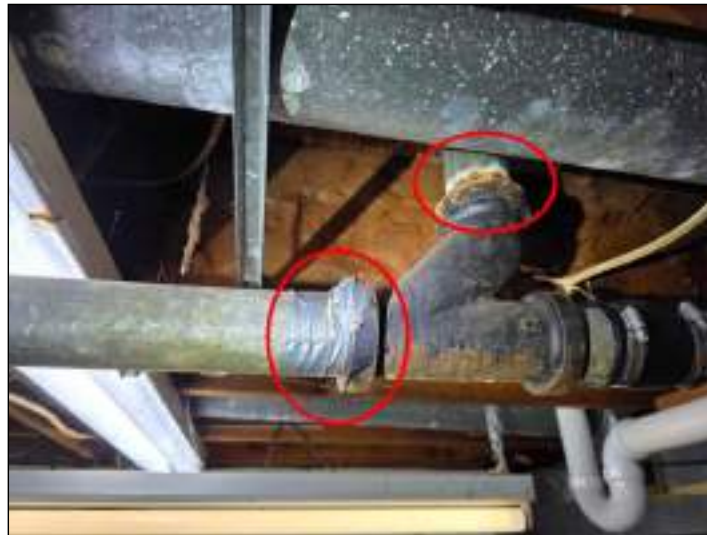
The drain pipes were rusting in several areas.

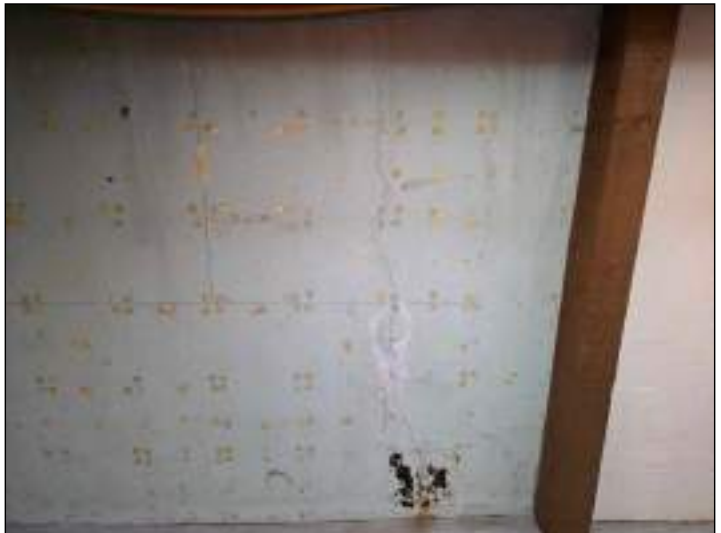
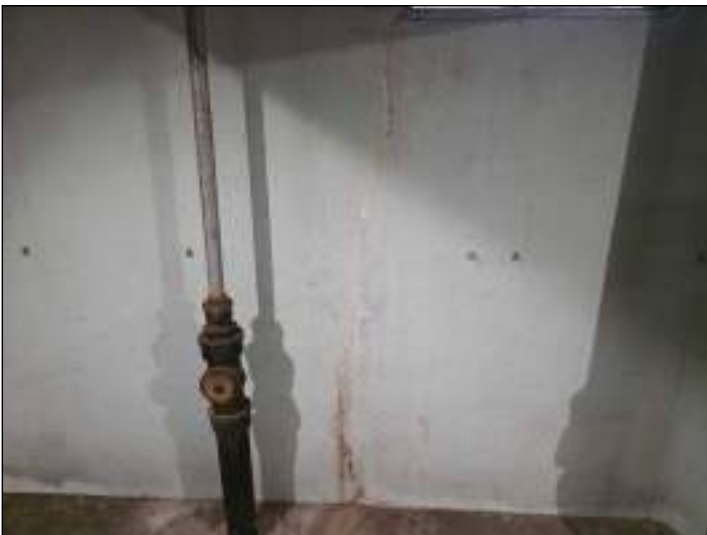
Some small cracks were observed in the foundation.

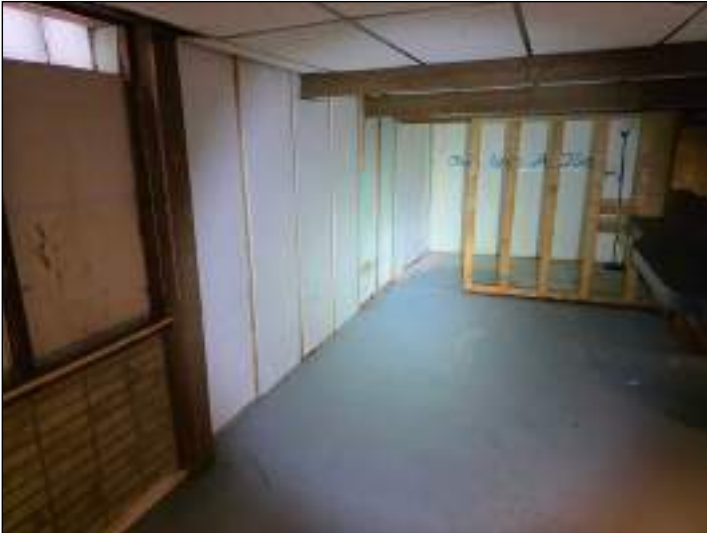
Some moisture stains were observed along the foundation walls. However, the basement was dry during the inspection. I recommended asking the seller about the foundation's history to help determine whether any problems exist or have been corrected.

Some old moisture stains were observed along the foundation walls.

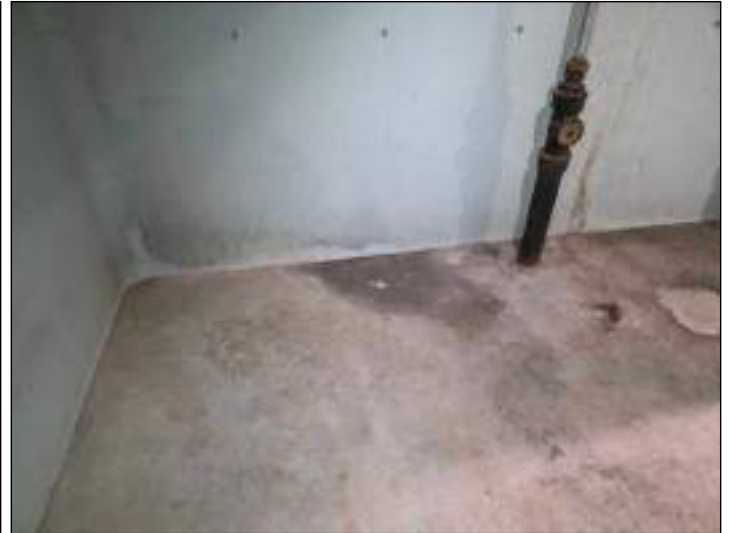
Some old moisture stains were observed along the foundation walls.
