## Improvement Location Report

That on August 2, 2006, I made an inspection of the premises situated at, 46 Los Arroyos Rd. in Vista Linda Subdivision, Taos County New Mexico.

Briefly described as Lot 55-C also as a certain Tract of Land lying and being situate within Lot 55 of the Vista Linda Subdivision, and being a portion of lot 7 & 8 of the Ranchos Orchard and land Company Subdivision.

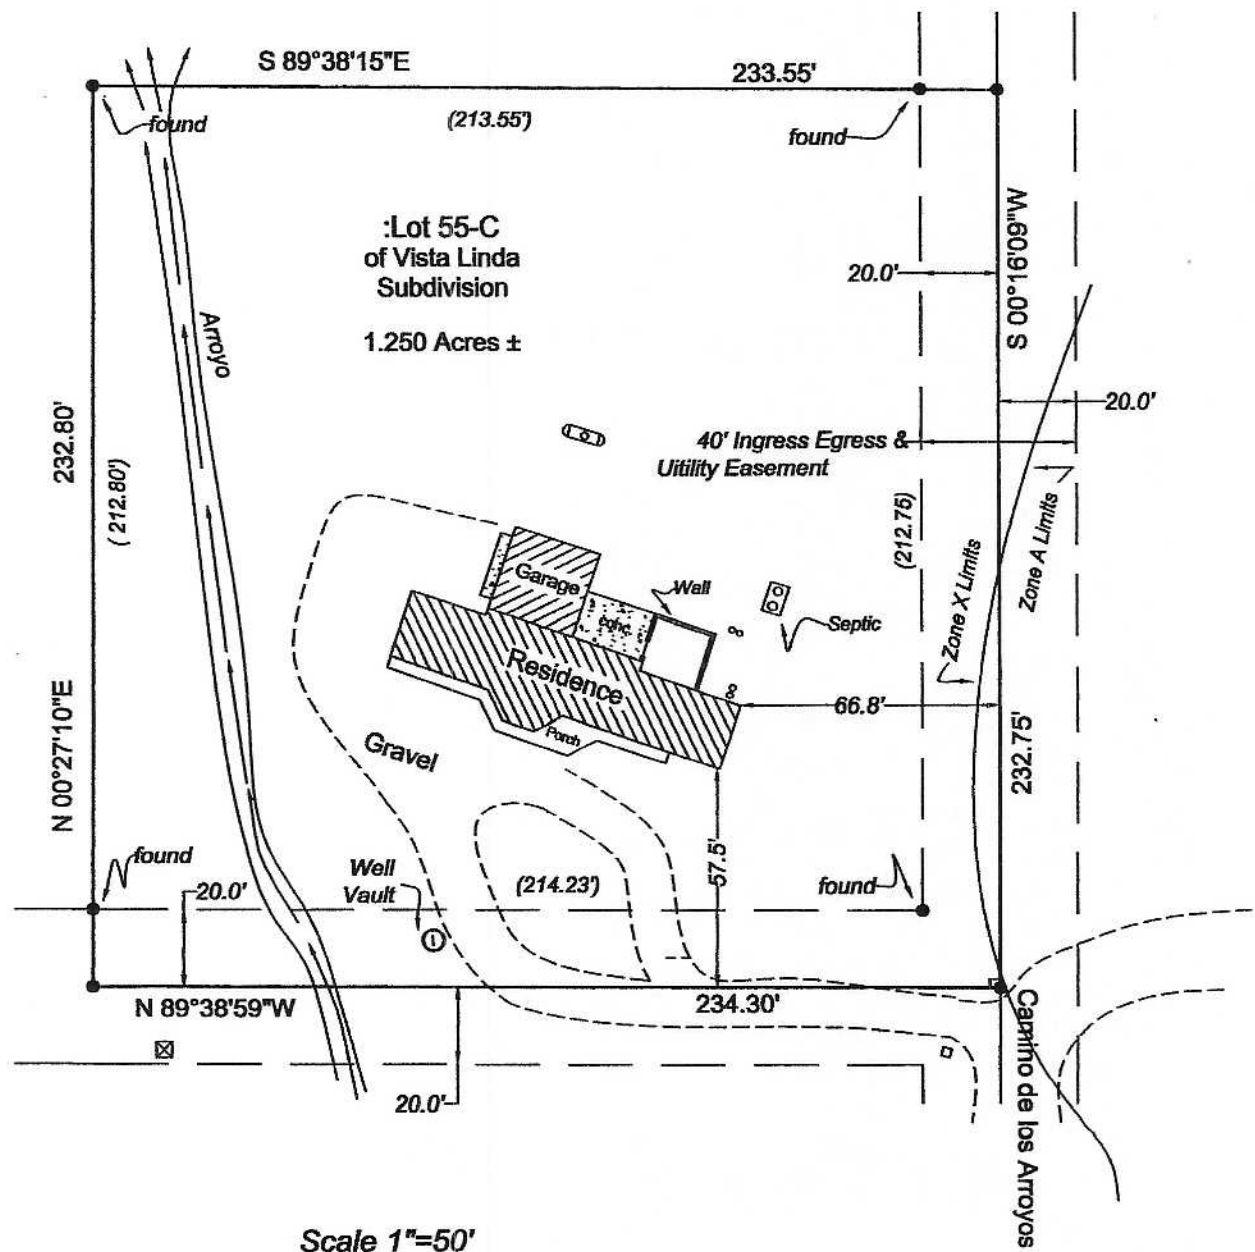
# Sketch

**NOTE:** *Flood Zone limits scaled from flood insurance rate map. A very small portion of this tract appears to be within the flood zone according to flood maps.*  
See Attached Sketch

**See Sketch**

**As illustrated on attached sketch**
