# REPORT

## SB 326: EXTERIOR ELEVATED ELEMENTS

Inspection Date: April 2<sup>nd</sup>, 2024.

**10417 Louisiana Ave  
Los Angeles, CA 90025**

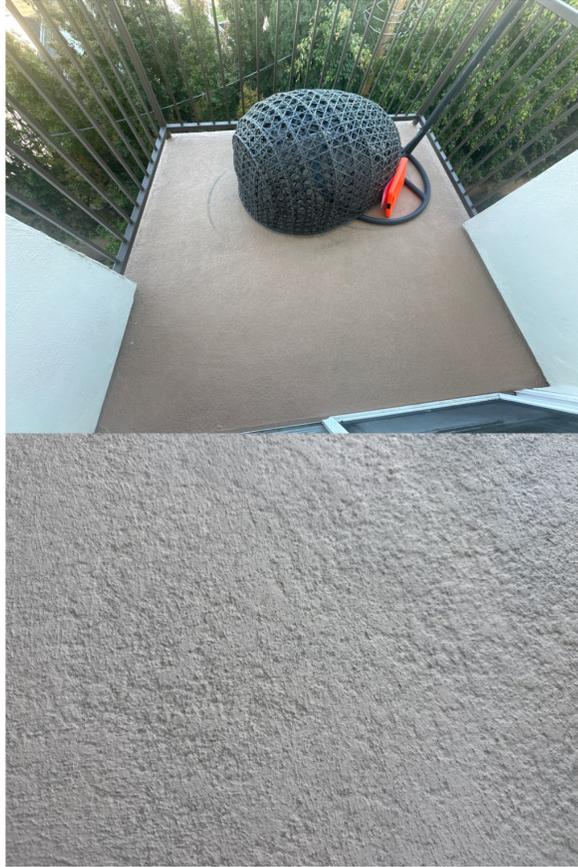
Title: PH 1

Waterproofing is in good condition. No recommendations at this time.

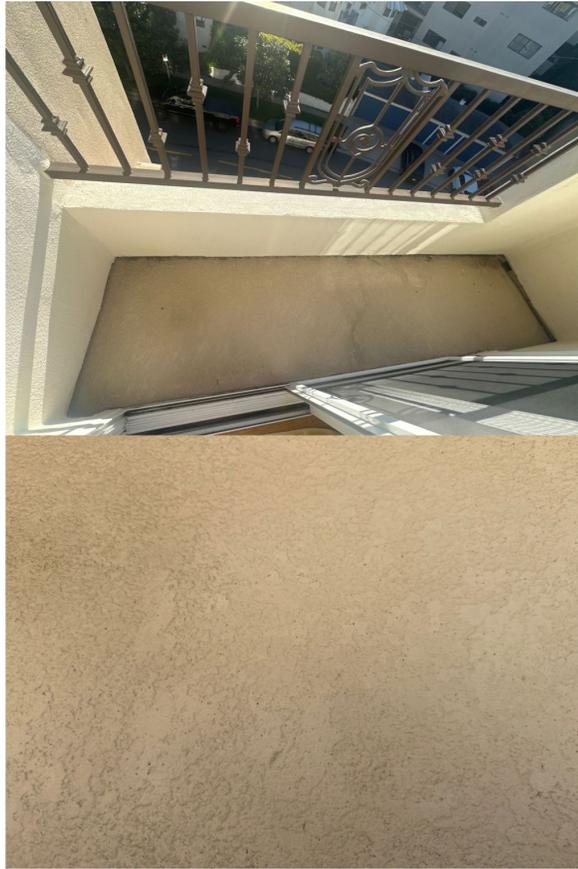
Title: PH 2 Balcony 1

Waterproofing is in good condition. No recommendations at this time.

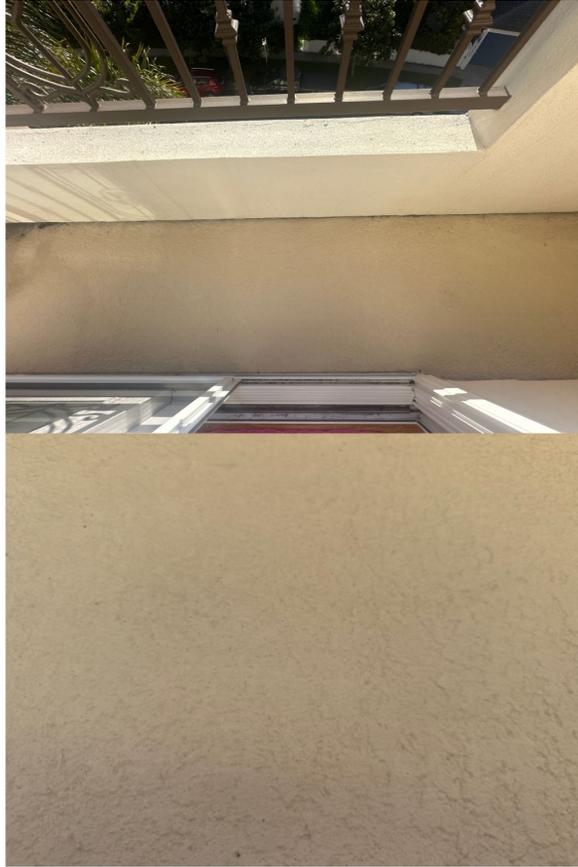
Title: PH 2 Balcony 2

Waterproofing is in good condition. No recommendations at this time.

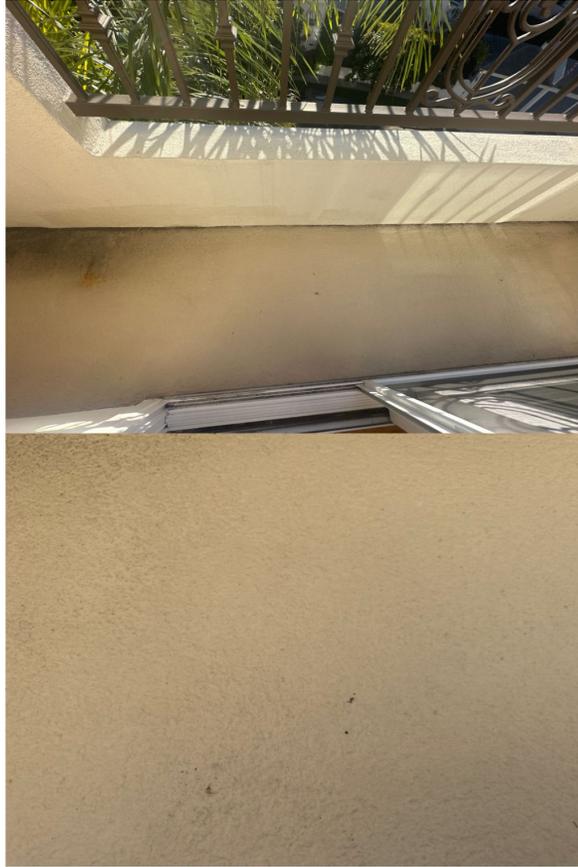
Title: PH 2 Balcony 3

Waterproofing is in good condition. No recommendations at this time.

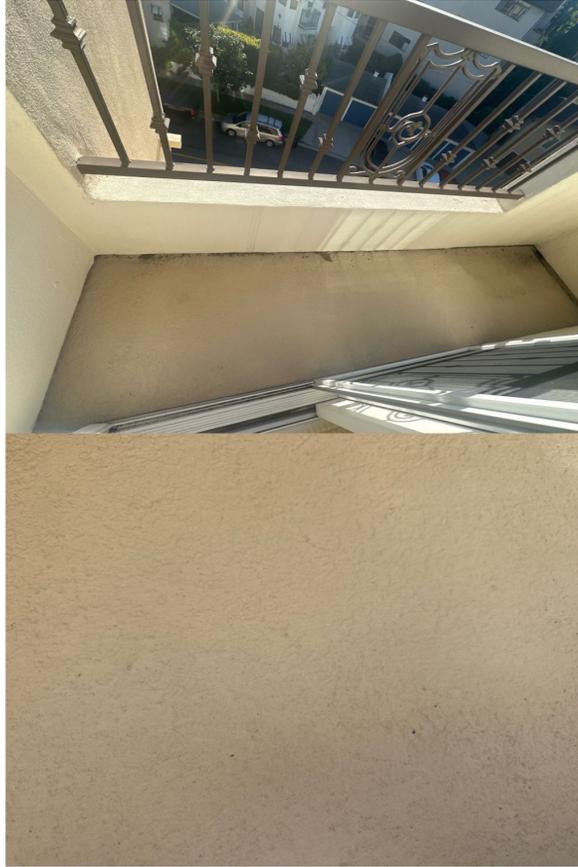
Title: PH 2 Balcony 4

Waterproofing is in good condition. No recommendations at this time.

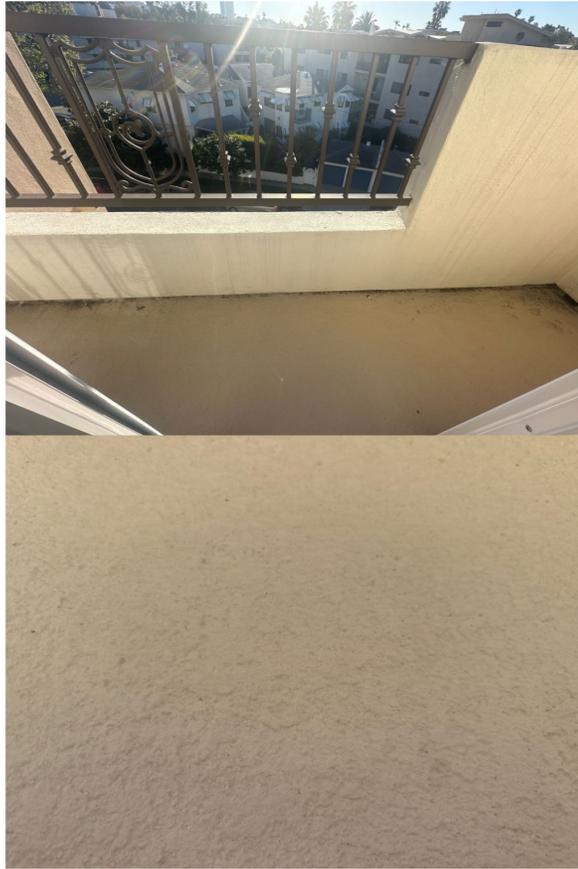
Title: PH 2 Balcony 5

Waterproofing is in good condition. No recommendations at this time.

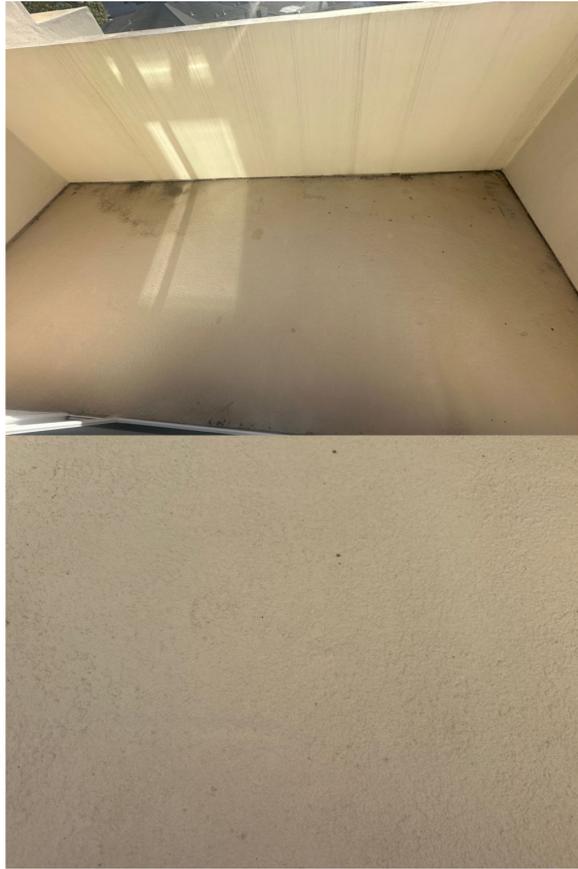
Title: PH 2 Balcony 6

Waterproofing is in good condition. No recommendations at this time.

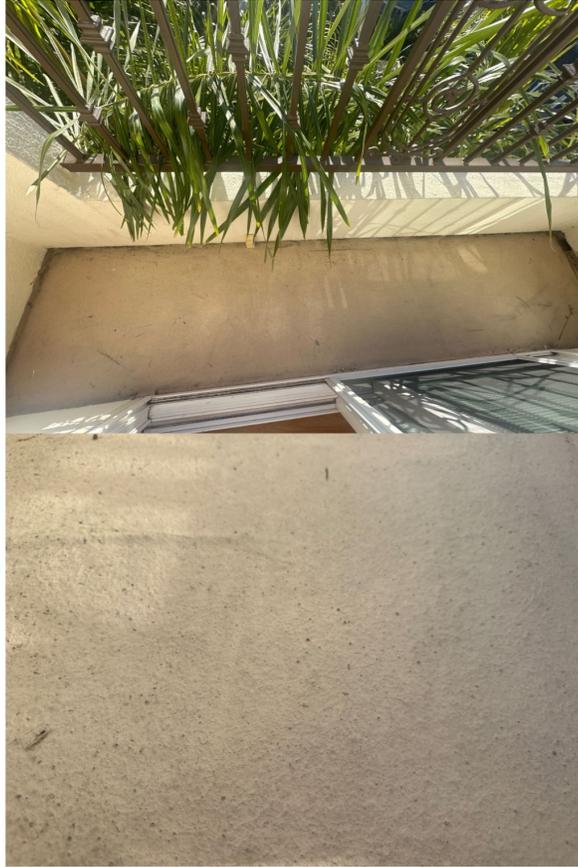
Title: PH 3 Balcony 1

Waterproofing is in good condition. No recommendations at this time.

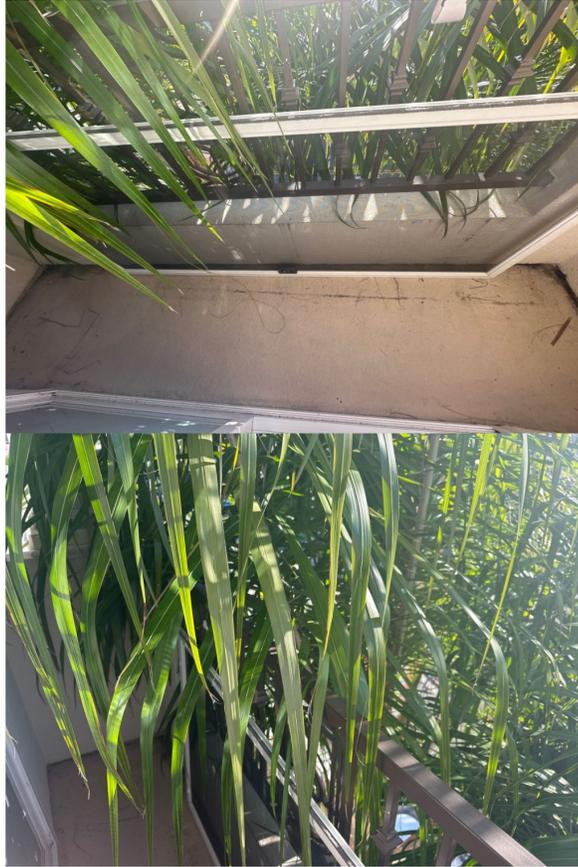
Title: PH 3 Balcony 2

UNITS #	DEFICIENCY	DAYS TO ADDRESS
PH 3 Balcony 2	Recommend trimming back palm trees so they don't affect the structure of the balcony.	N/A
<i>All remaining units are in good condition with no visual deficiencies.</i>		N/A

Waterproofing is in good condition. Recommend trimming back palm trees in front.

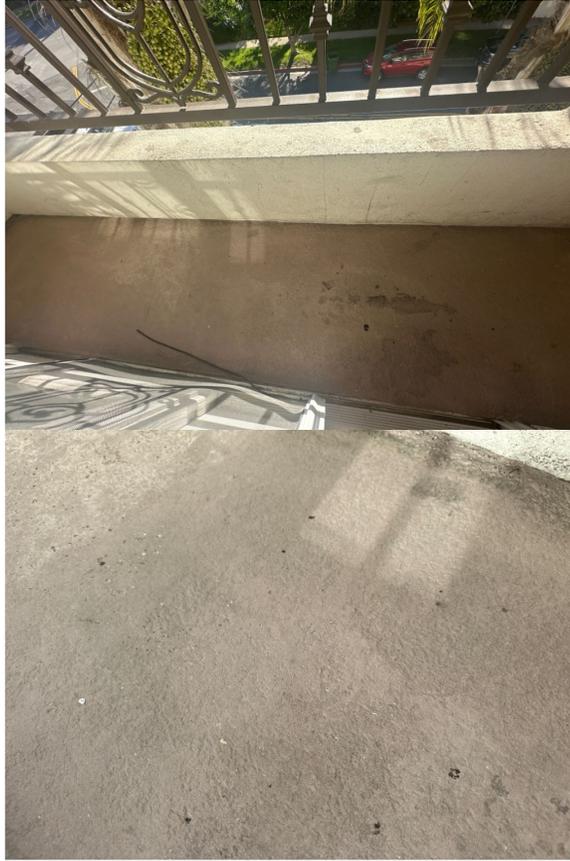
Title: Unit 303 Balcony 1

Waterproofing is in good condition. No recommendations at this time.

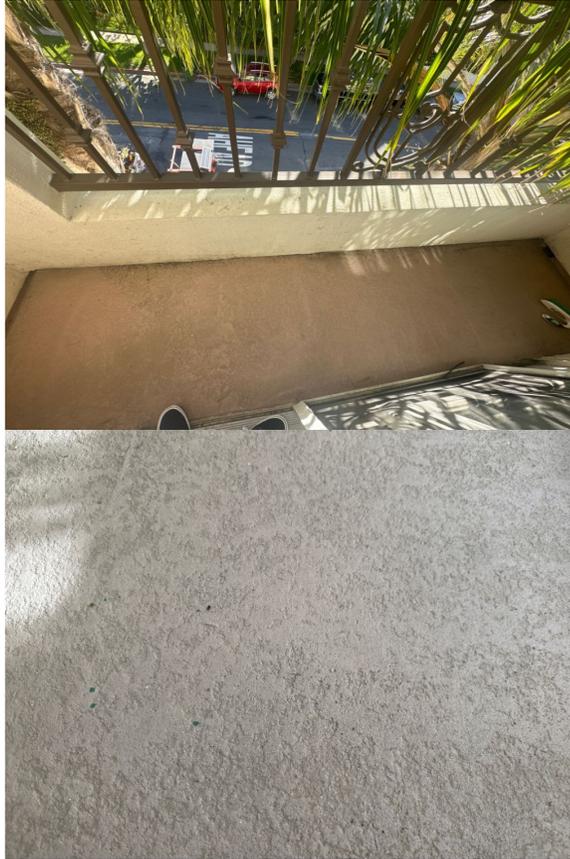
Title: Unit 303 Balcony 2

Waterproofing is in good condition. No recommendations at this time.

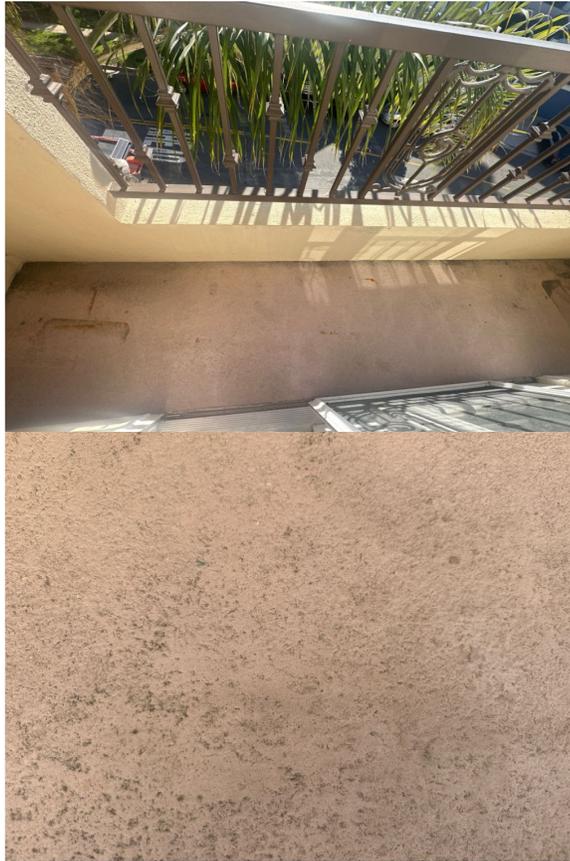
Title: Unit 302 Balcony 1

Waterproofing is in good condition. No recommendations at this time.

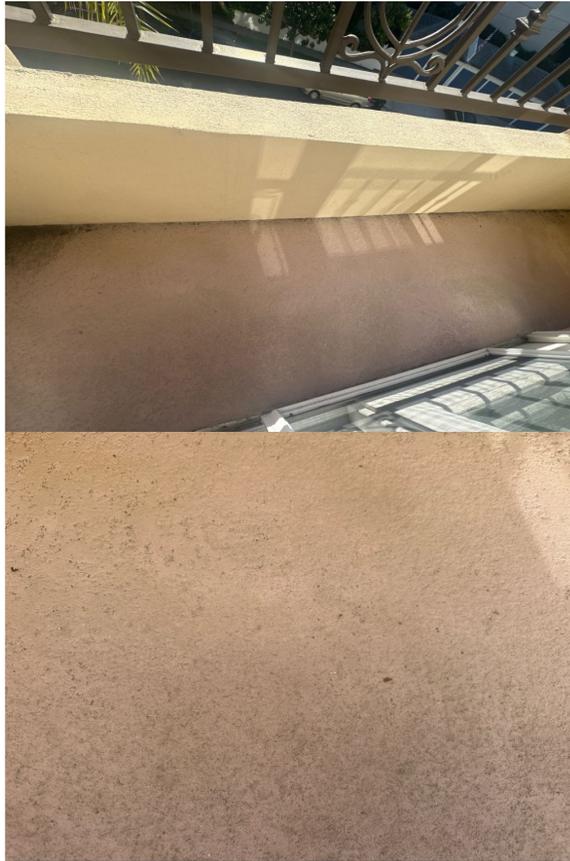
Title: Unit 302 Balcony 2

Waterproofing is in good condition. No recommendations at this time.

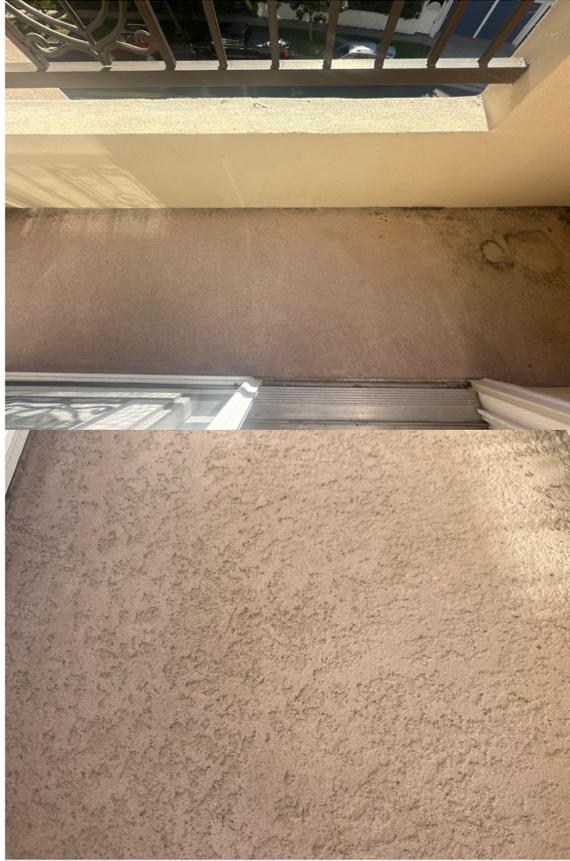
Title: Unit 302 Balcony 3

Waterproofing is in good condition. No recommendations at this time.

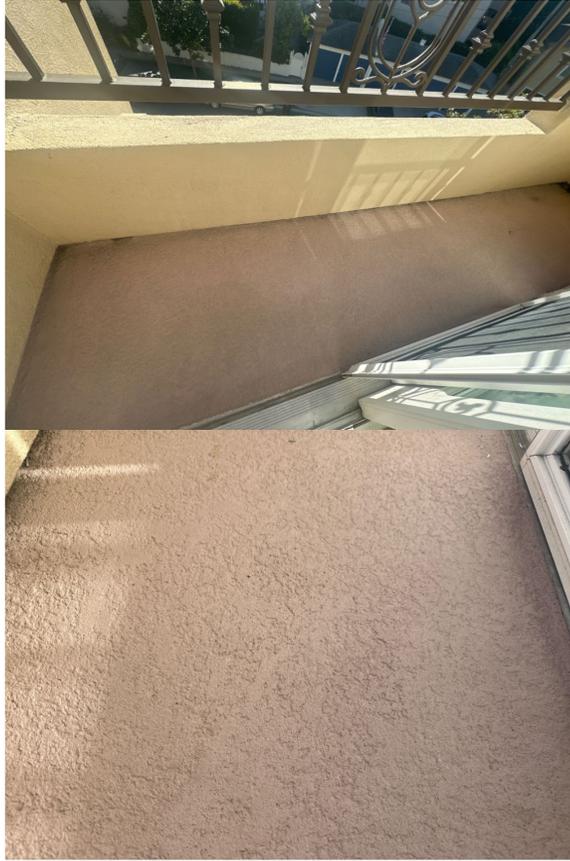
Title: Unit 302 Balcony 4

Waterproofing is in good condition. No recommendations at this time.

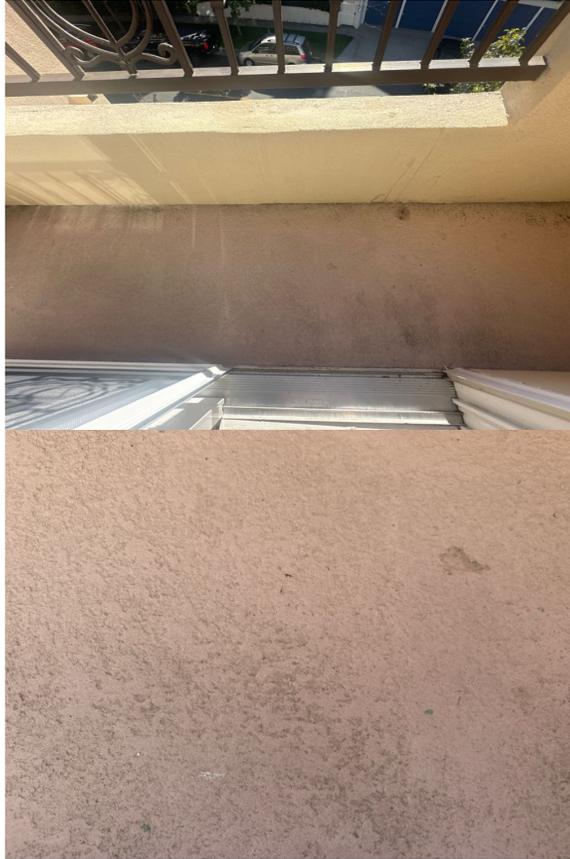
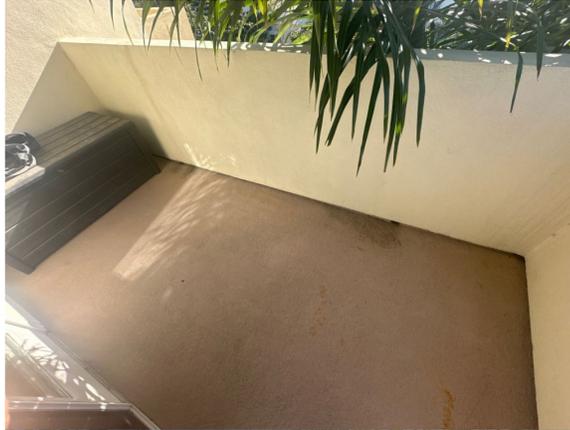
Title: Unit 302 Balcony 5

Waterproofing is in good condition. No recommendations at this time.

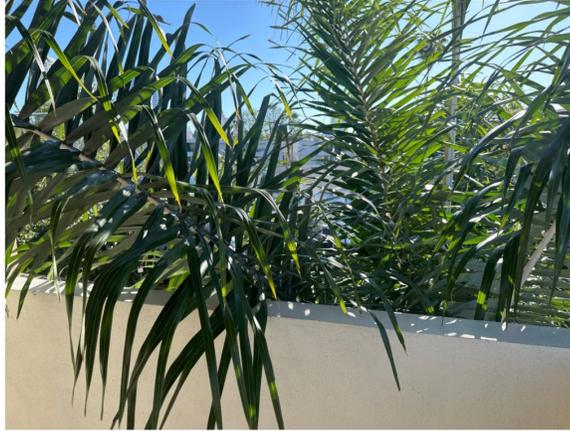
Title: Unit 302 Balcony 6

Waterproofing is in good condition. Recommend trimming palm tree back away from balcony.

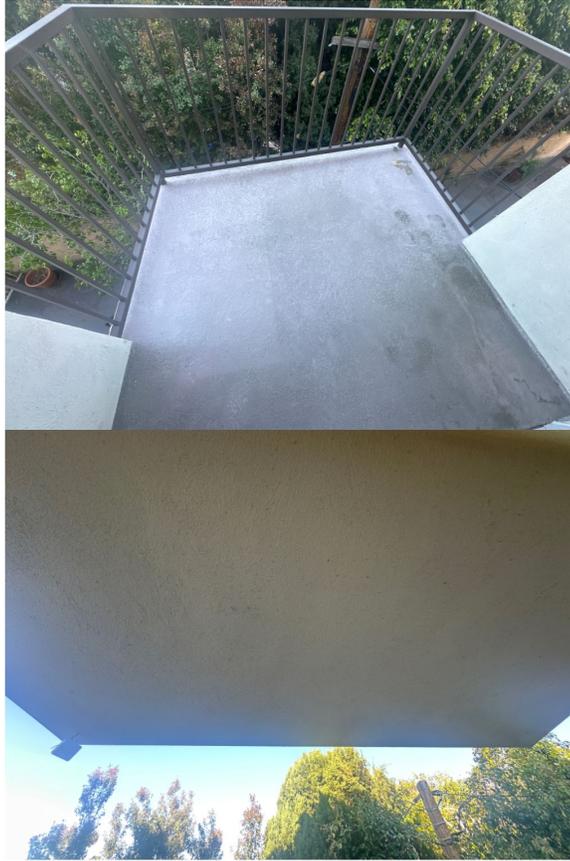
Title: Unit 301

Waterproofing is in good condition. No recommendations at this time. Ceiling above shows no cracks or discoloration.

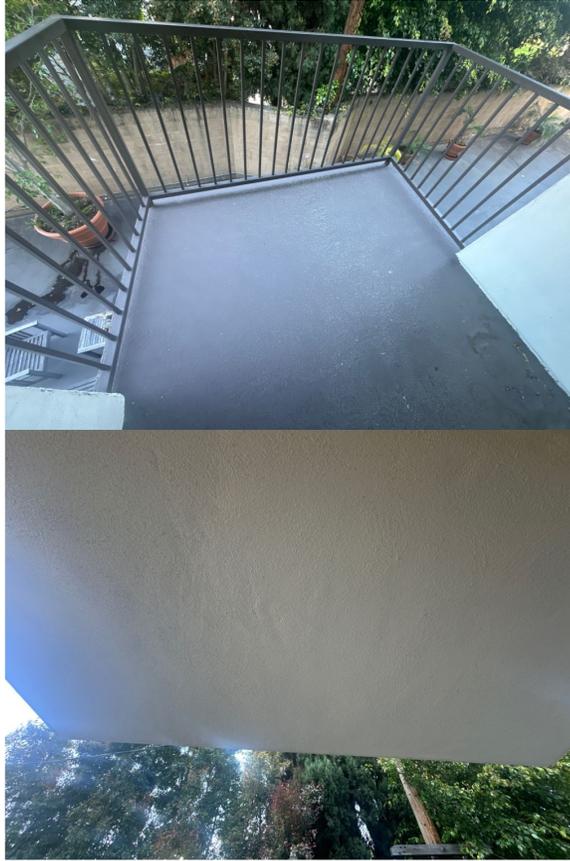
Title: Unit 201

Waterproofing is in good condition. No recommendations at this time.

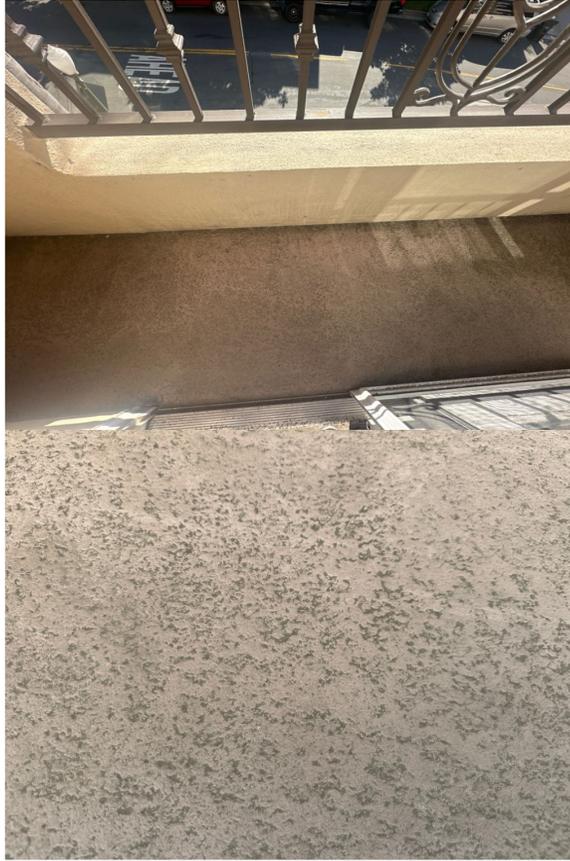
Title: Unit 202 Balcony 1

Waterproofing is in good condition. No recommendations at this time.

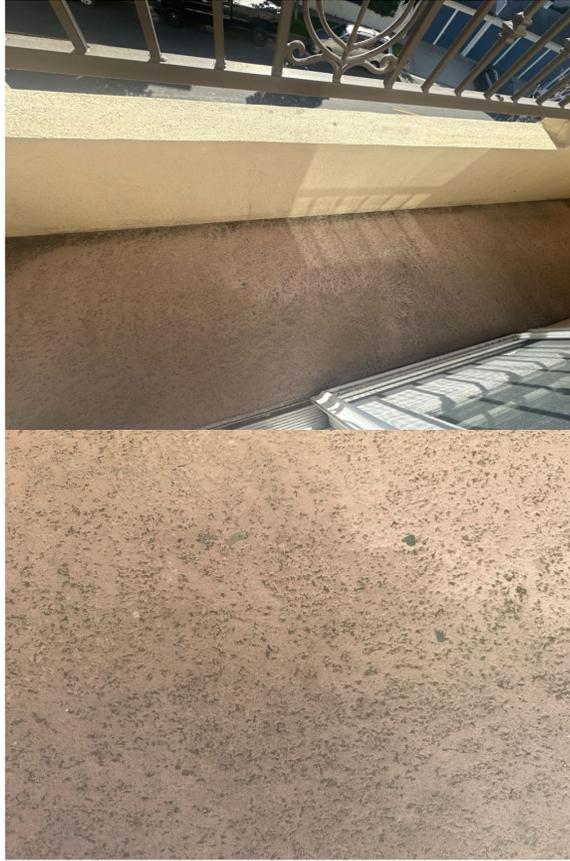
Title: Unit 202 Balcony 2

Waterproofing is in good condition. No recommendations at this time.

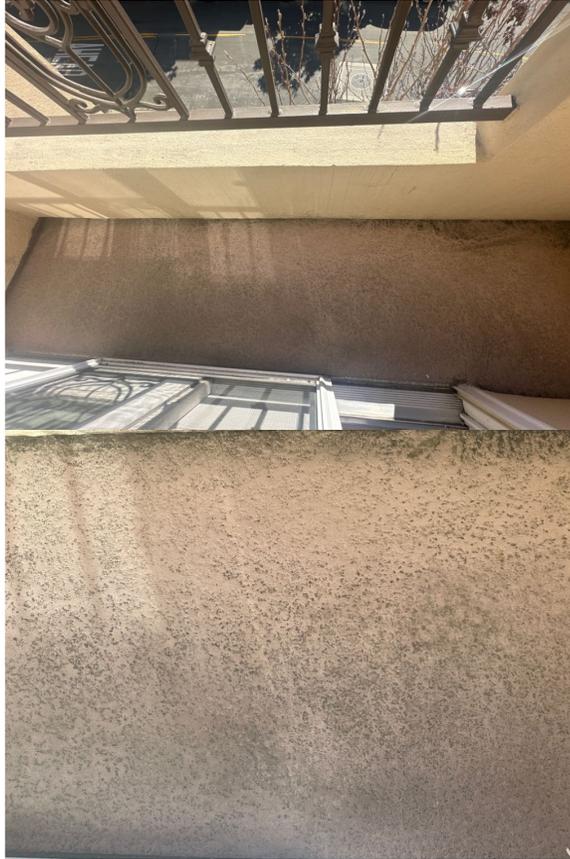
Title: Unit 202 Balcony 3

Waterproofing is in good condition. No recommendations at this time.

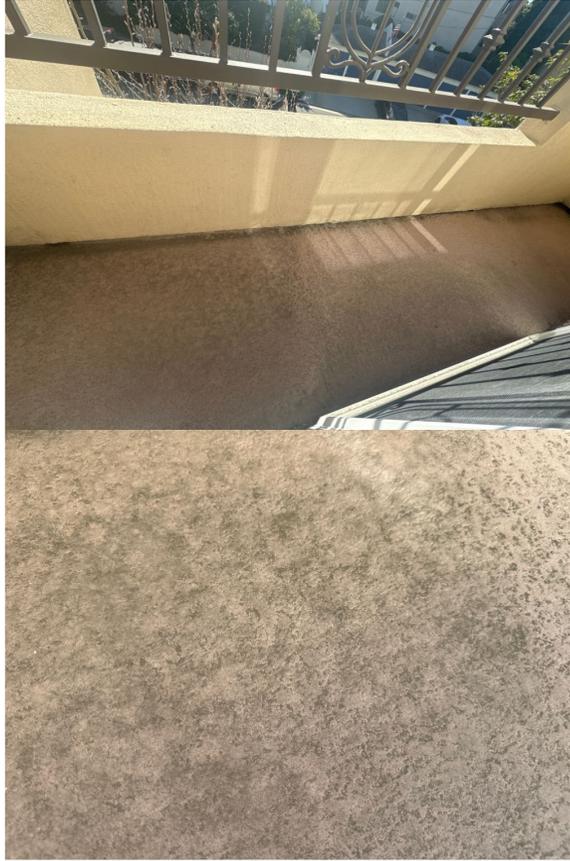
Title: Unit 202 Balcony 4

Waterproofing is in good condition. No recommendations at this time.

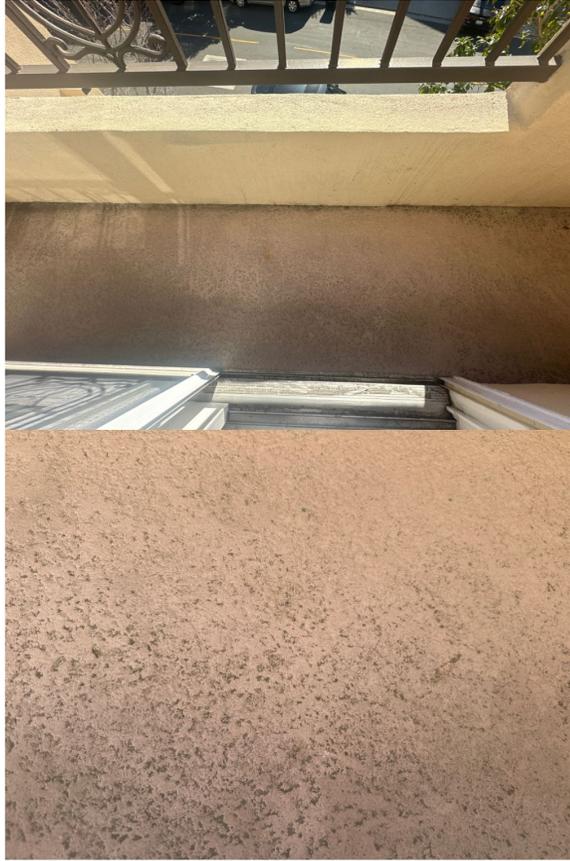
Title: Unit 202 Balcony 5

Waterproofing is in good condition. No recommendations at this time.

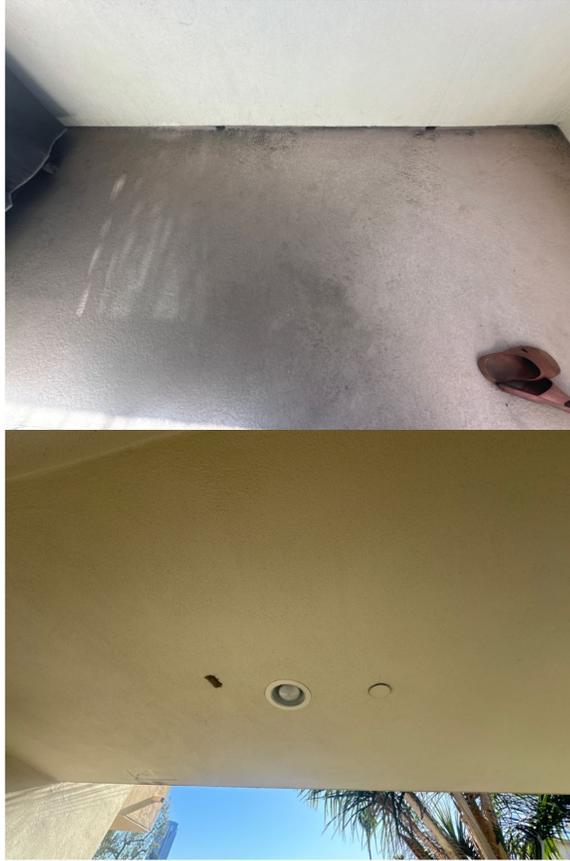
Title: Unit 202 Balcony 6

Waterproofing is in good condition. No recommendations at this time.

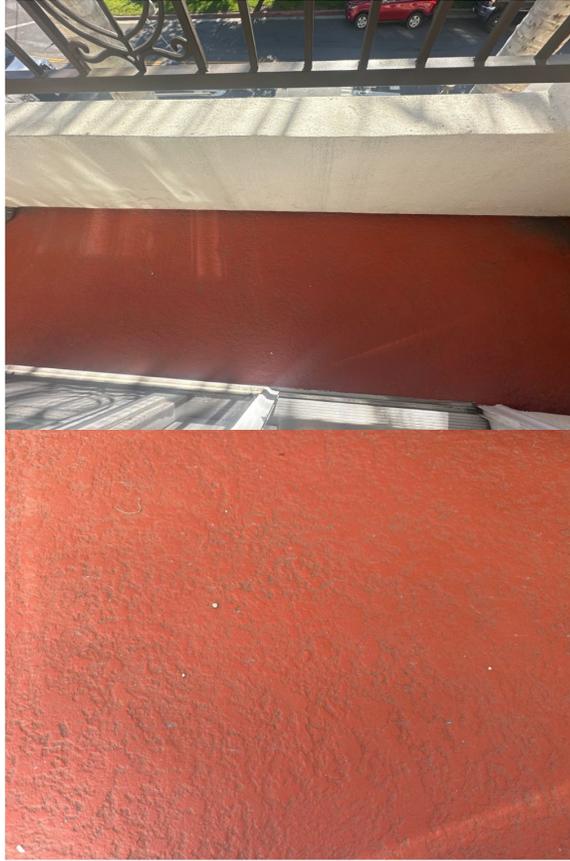
Title: Unit 201 Balcony 1

Waterproofing is in good condition. No recommendations at this time.

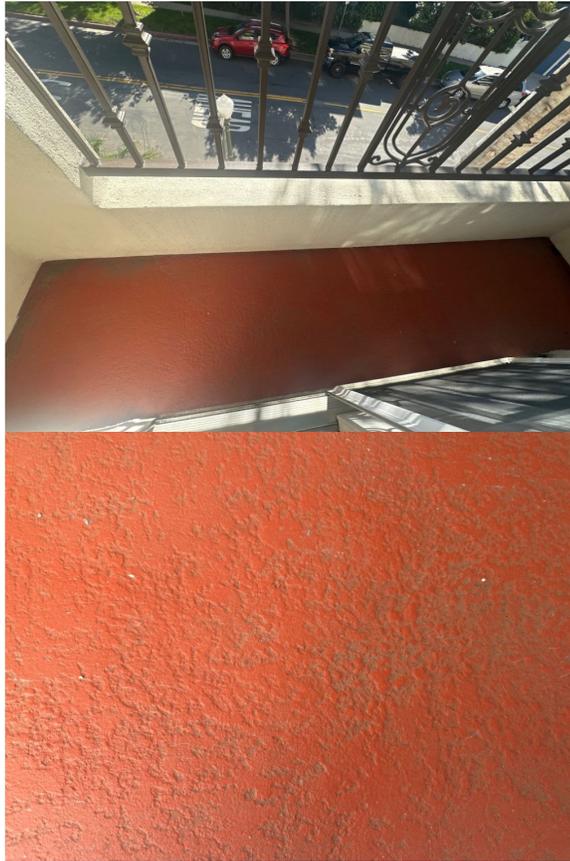
Title: Unit 201 Balcony 2

Waterproofing is in good condition. No recommendations at this time.
