Residential Building Inspection Report

324 Faber St, Pittsburgh, PA 15214

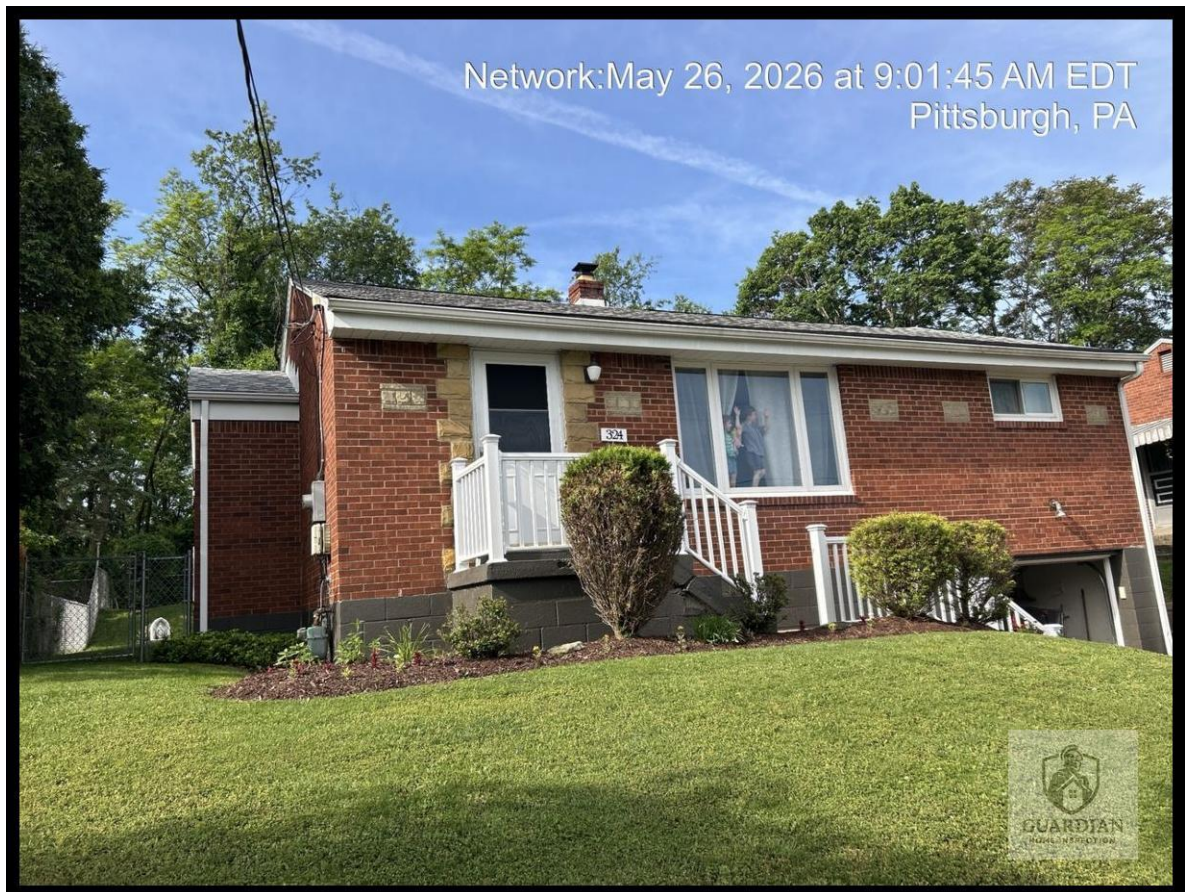
CONVENTIONS USED IN THIS REPORT – ***PLEASE REVIEW***

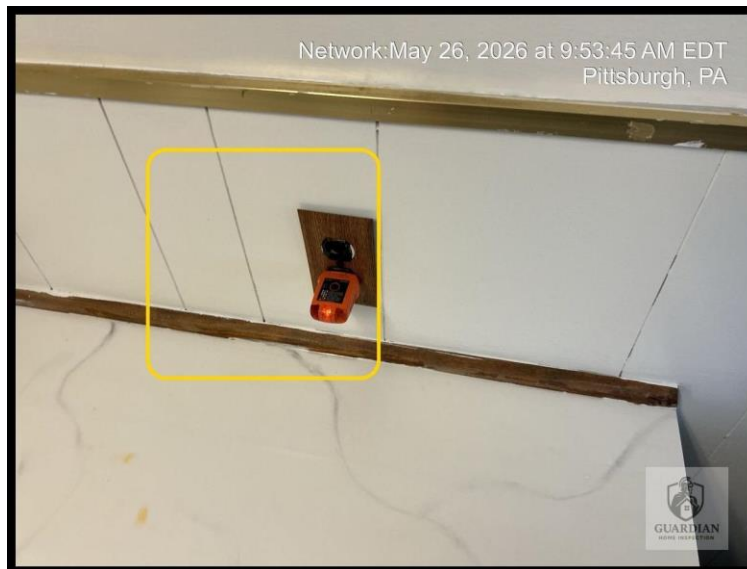
Figure 1: The kitchen bar receptacle was observed to be ungrounded (as indicated by the outlet tester in the photo).

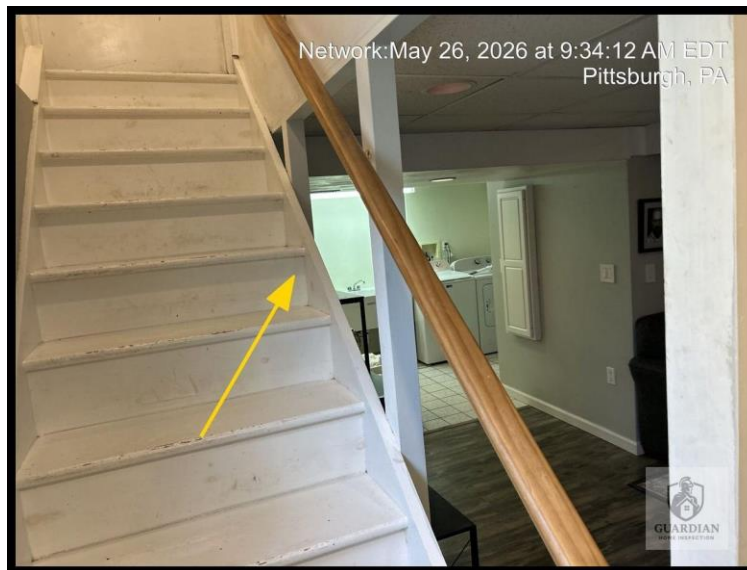
Figure 2: The basement stairway was observed to lack an adequate handrail/rail protection, as shown in the provided photo.

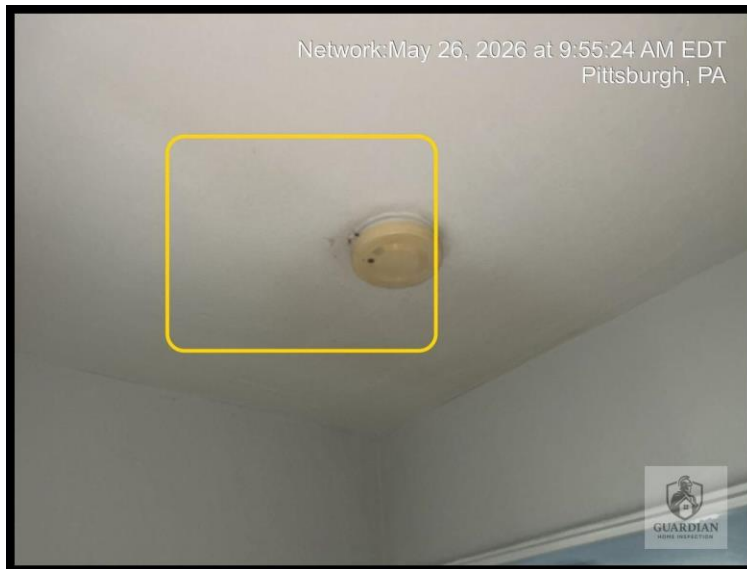
Figure 3: Carbon monoxide protection was not observed in the living space in the hallway at the time of inspection.

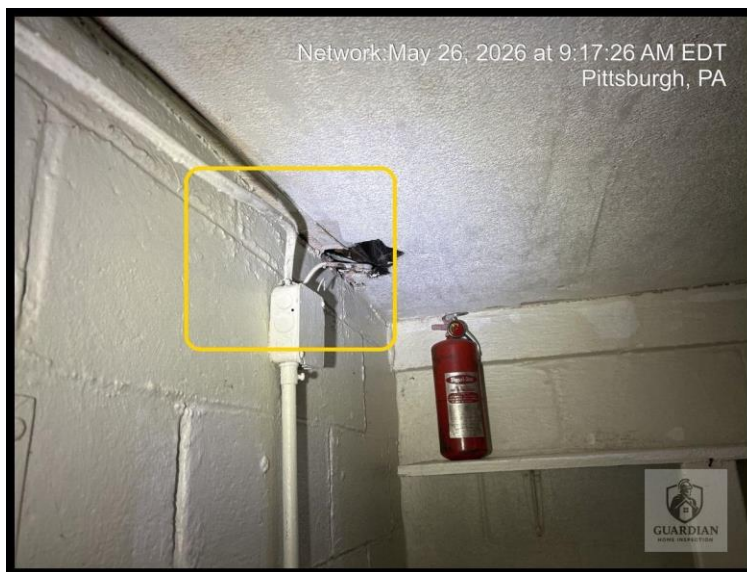
Figure 4: A visible gap/opening was observed along the garage ceiling, which can compromise the required fire-resistance separation between the garage and adjacent areas.

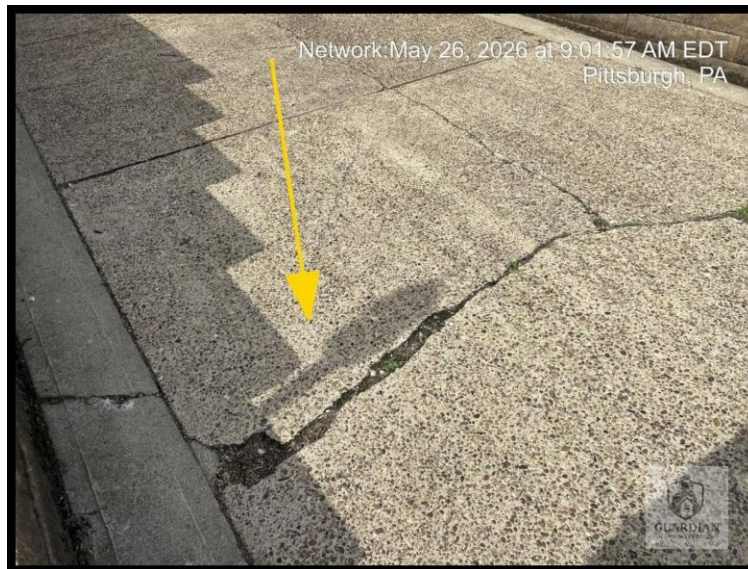
Figure 5: Minor cracking was observed in the concrete driveway.

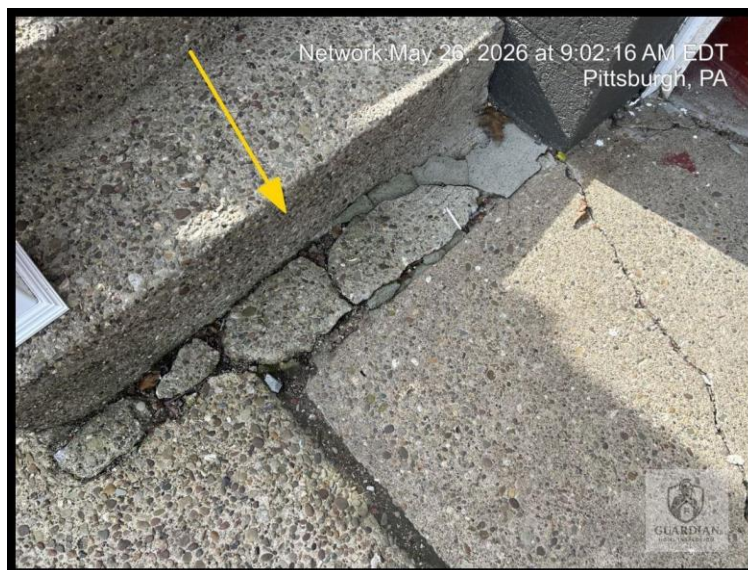
Figure 6: Minor surface deterioration/spalling was observed at the bottom of the front exterior stairway along the front exterior wall.

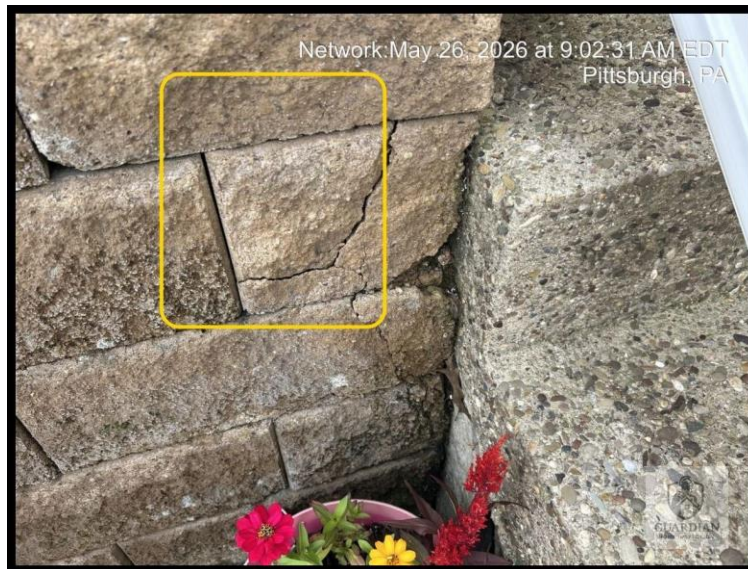
Figure 7: The left-facing retaining wall along the driveway showed cracked brick/masonry units, as visible in the wall face.

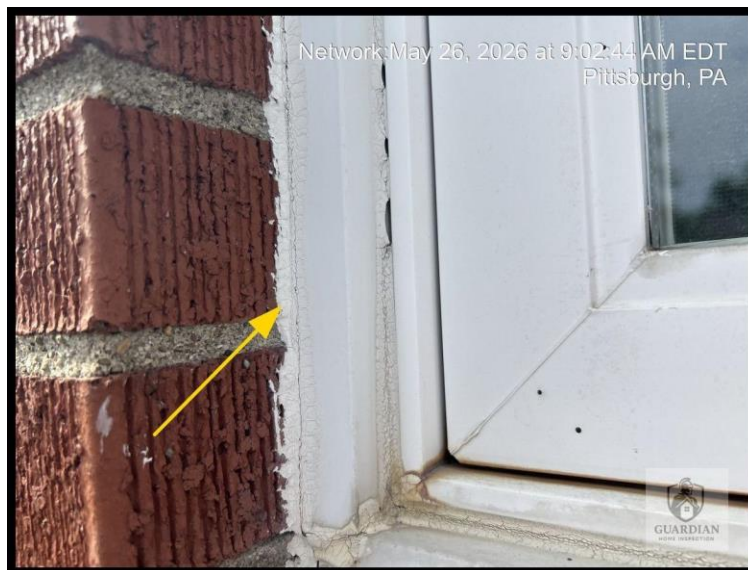
Figure 8: Exterior window and door frame joints were observed with deteriorated/missing sealant at the trim-to-masonry/frame interfaces.

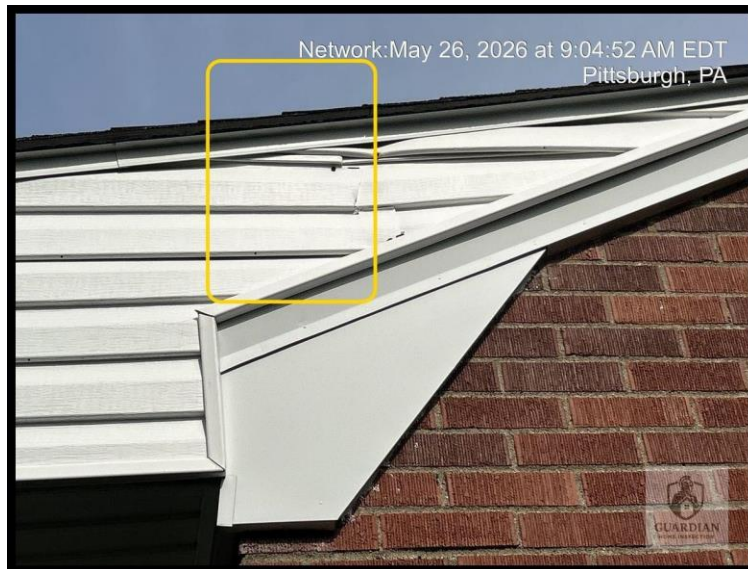
Figure 9: Damaged exterior siding was observed along the left-facing exterior wall.

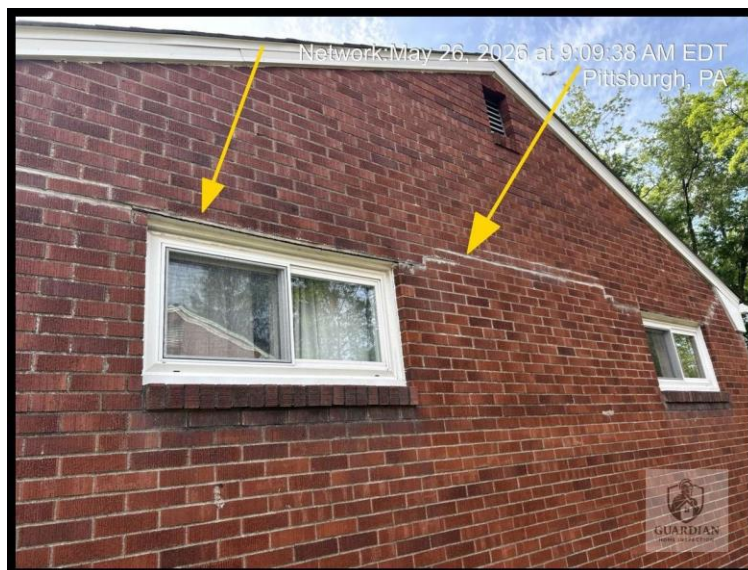
Figure 10: Steel lintels along the right-facing exterior brick wall were observed to be sagging, with associated step cracking and mortar cracking in the surrounding brickwork.

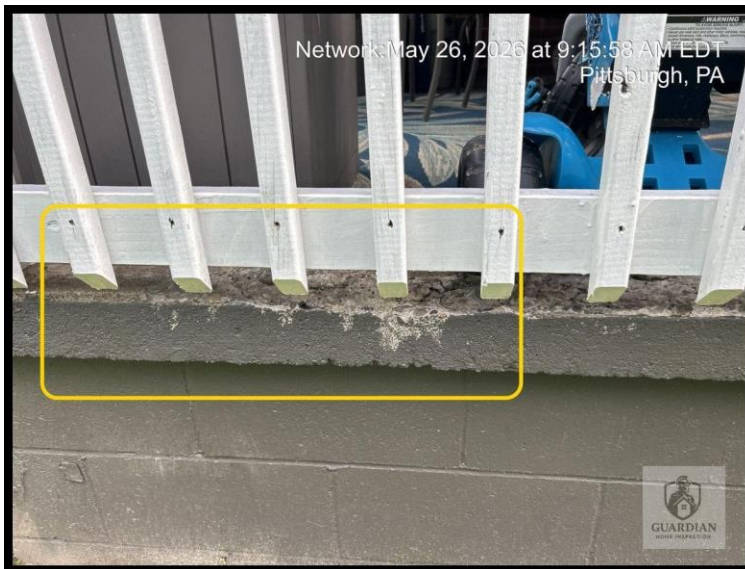
Figure 11: Minor surface spalling/falling was observed along the rear concrete porch edge.

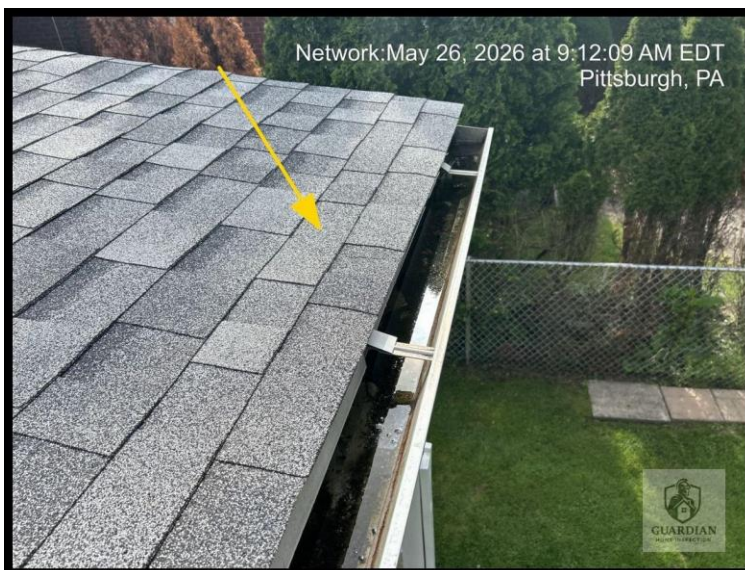
Figure 12: The rear-facing gutter run at the roofline lacked adequate slope, evidenced by standing water observed in the gutter.

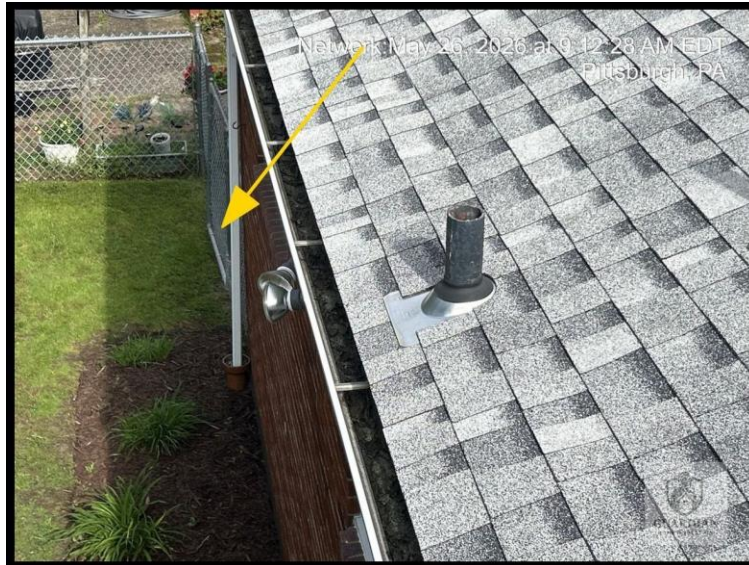
Figure 13: Debris was observed accumulated in the gutters at the roofline.

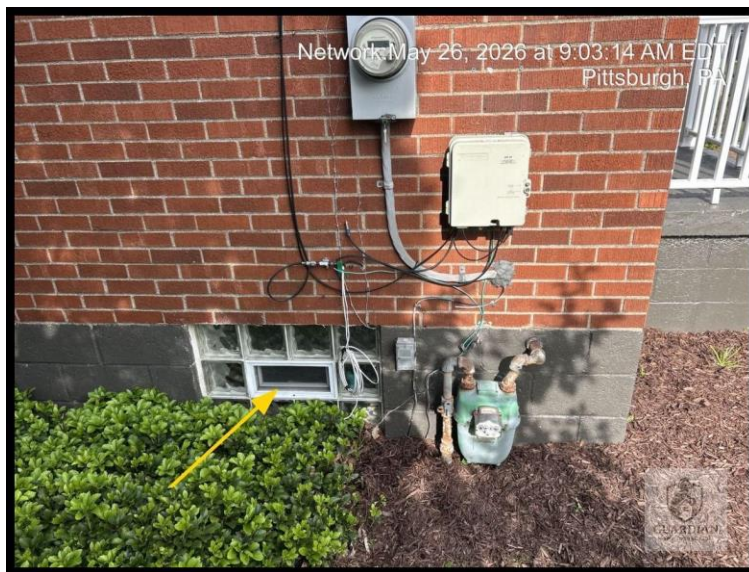
Figure 14: The left-facing exterior electrical outlet was observed to be loose from the wall.

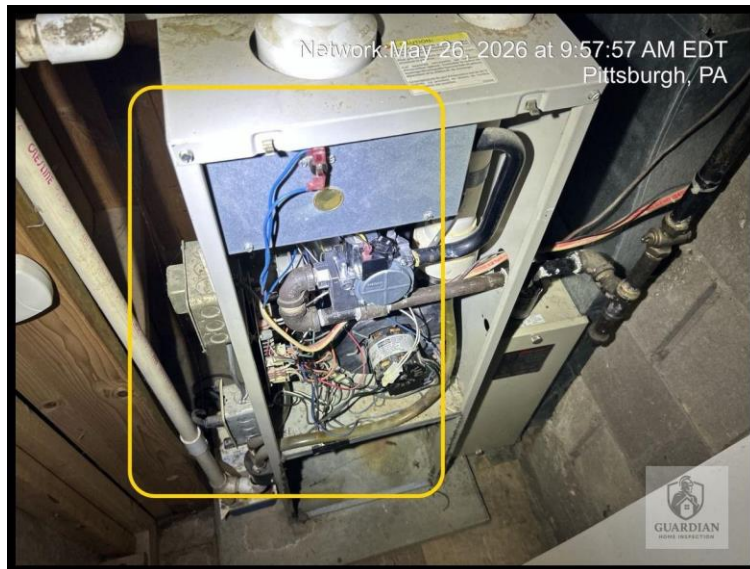
Figure 15: The furnace in the basement appeared to need servicing at the time of inspection.

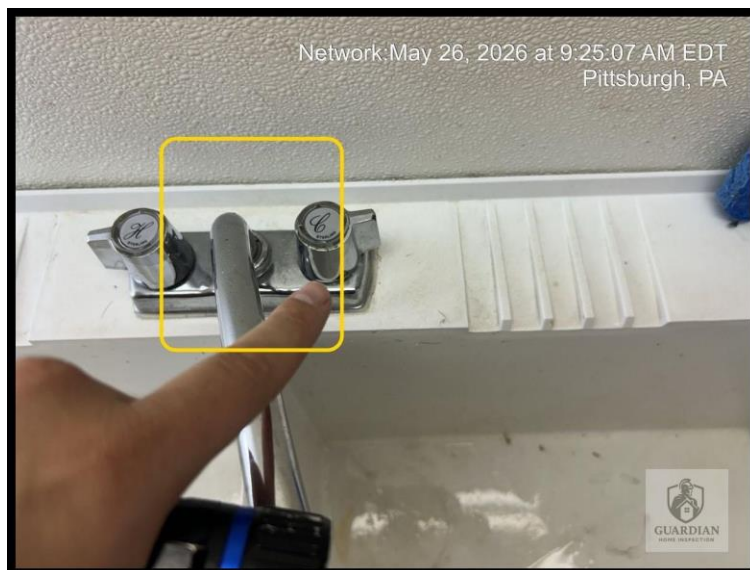
Figure 16: The cold water faucet handle at the basement laundry sink was observed to spin without properly operating the valve.

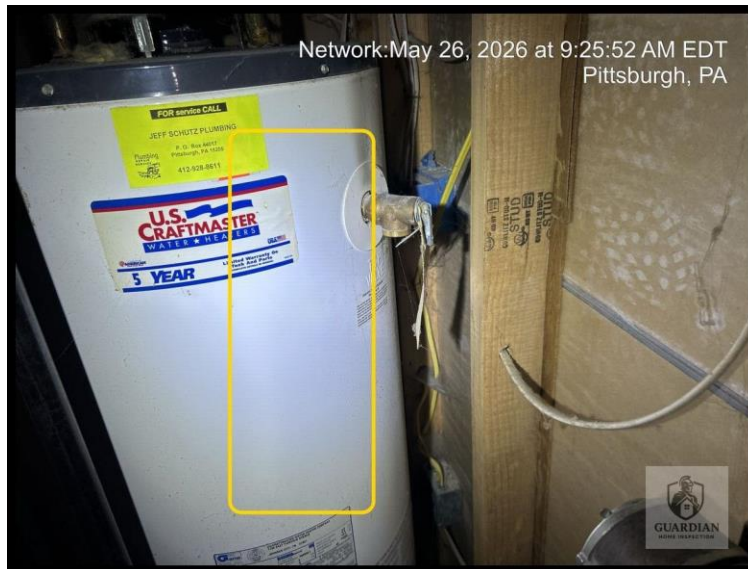
Figure 17: The water heater in the basement was observed to be missing the temperature/pressure relief (TPR) valve discharge tube.

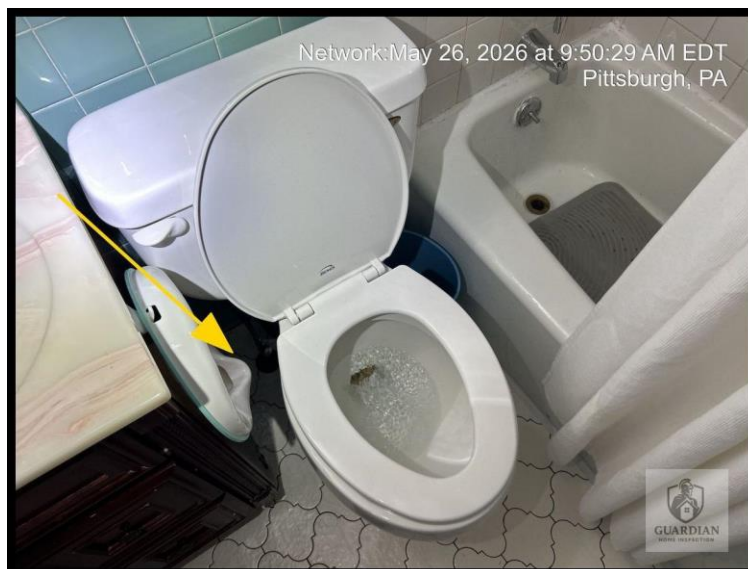
Figure 18: The hallway bathroom toilet was observed to be loose at the floor.

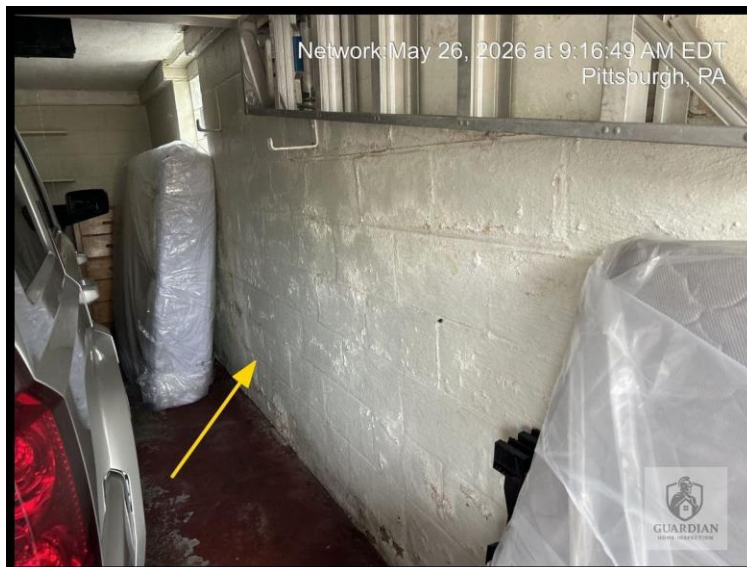
Figure 19: Evidence of moisture intrusion was observed along the right-facing interior garage wall, with visible staining/efflorescence consistent with water migration through the masonry.

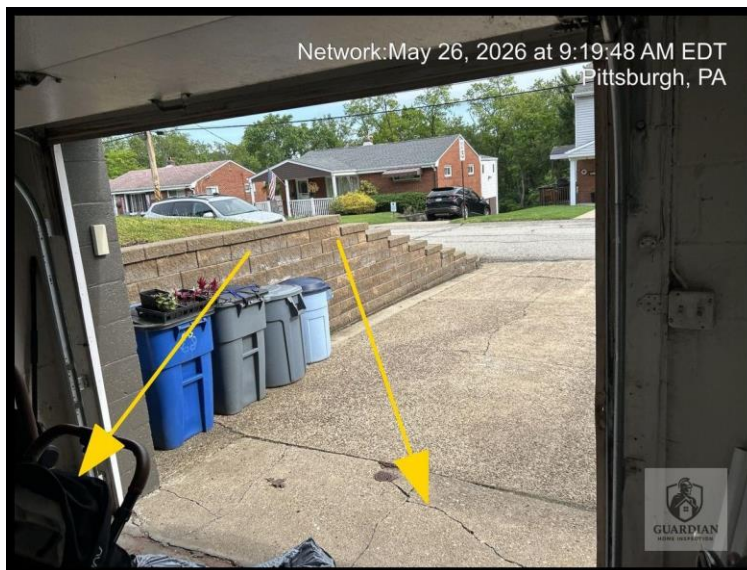
Figure 20: The garage door opener would only close when the wall control button was held down, which commonly indicates a fault or misalignment with the photoelectric safety sensors.

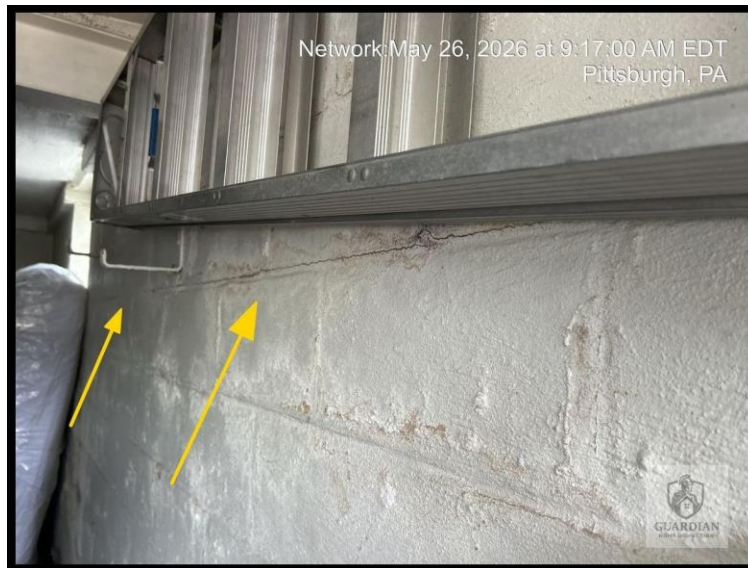
Figure 21: Evidence of hairline, step, and horizontal cracking was noted along the right-facing wall in the garage.

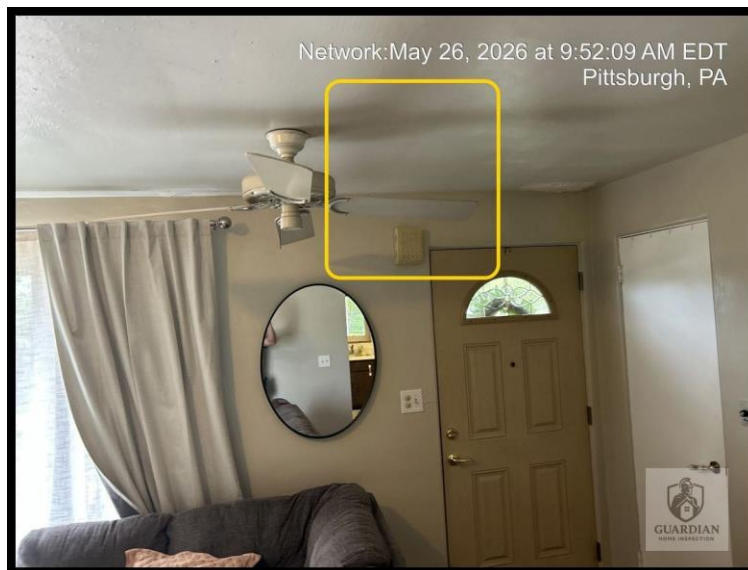
Figure 22: Evidence of patching was noted along the ceiling above the front entryway door in the living room.

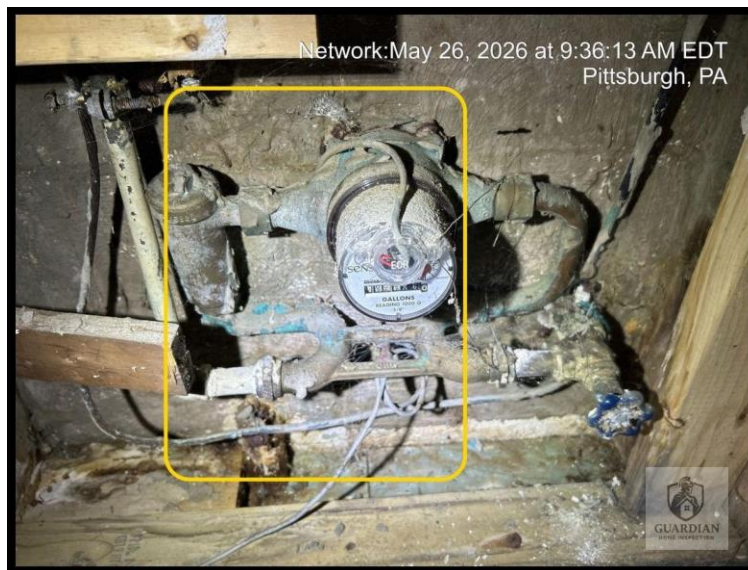
Figure 23: Corrosion was observed on the fittings and waterlines along the front-facing basement wall.

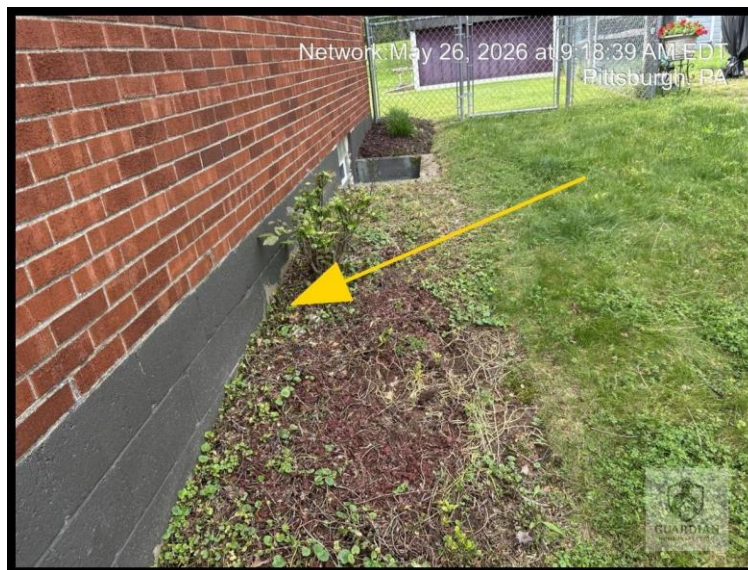
Figure 24: The grading along the right-facing side of the home appears to slope toward the foundation (negative grade).

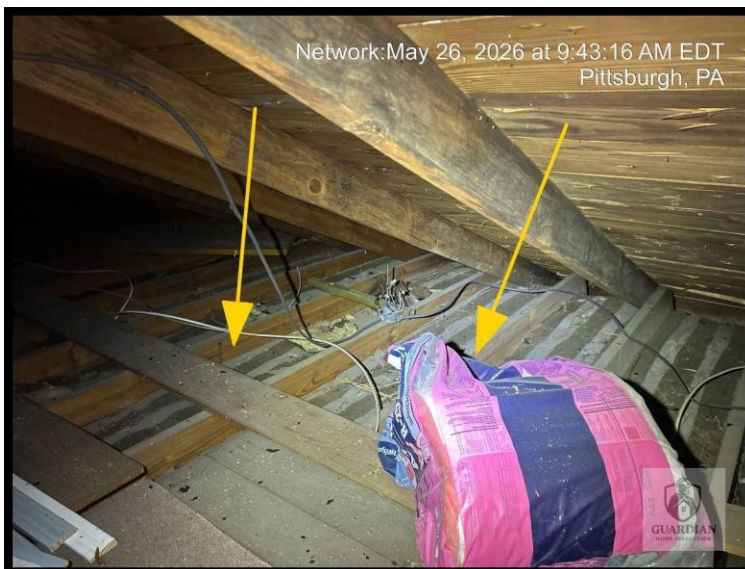
Figure 25: The attic insulation levels were observed to be poor/inadequate in the attic area.

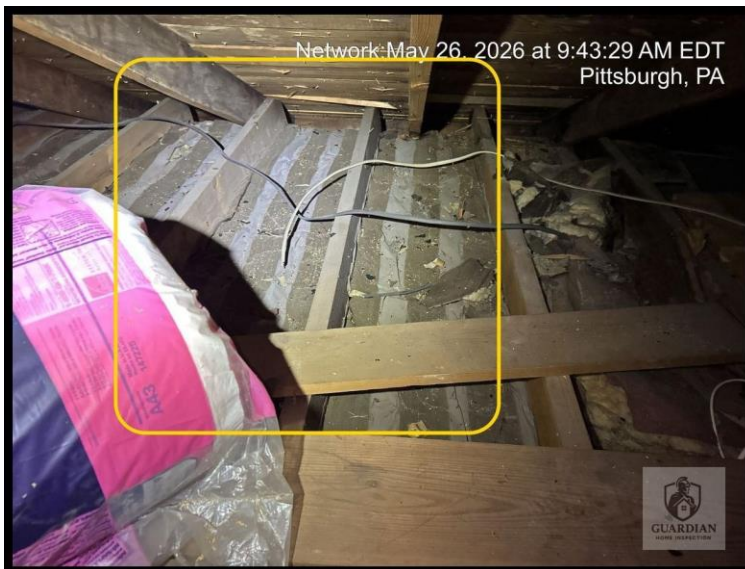
Figure 26: In the attic, kraft-faced fiberglass insulation appears to be installed with the kraft paper facing the wrong direction (not facing downward toward the conditioned space).

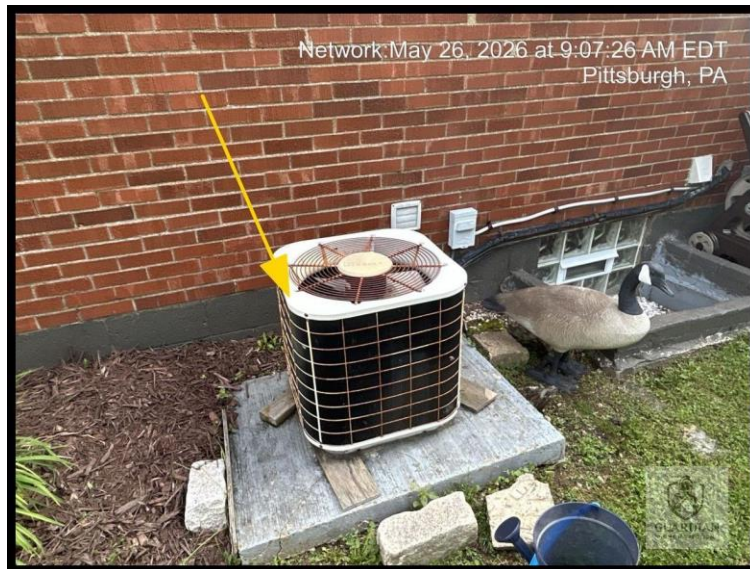
Figure 27: The exterior air conditioning condensing unit appears to be older and, based on its apparent age/condition, is approaching the end of its typical useful life.

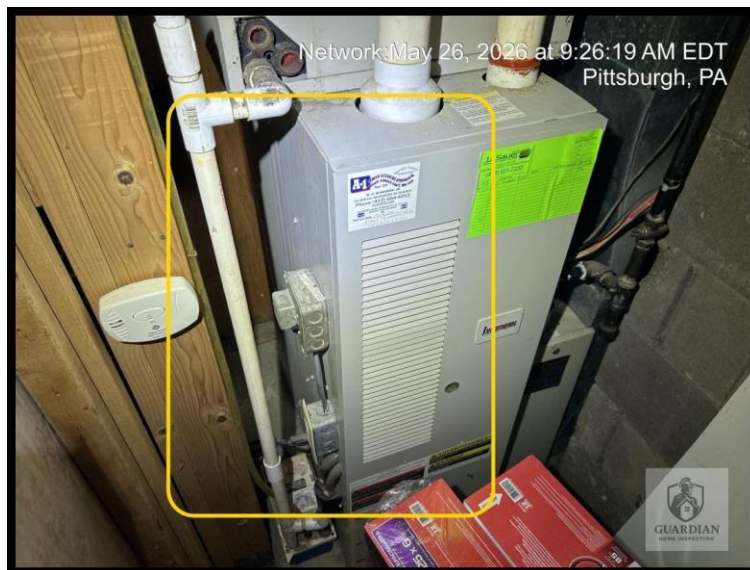
Figure 28: The basement furnace was reported to be approaching the end of its useful service life compared to similar units.
