# Residential Building Inspection Report

513 Audrey Ct, Zelienople, PA 16063

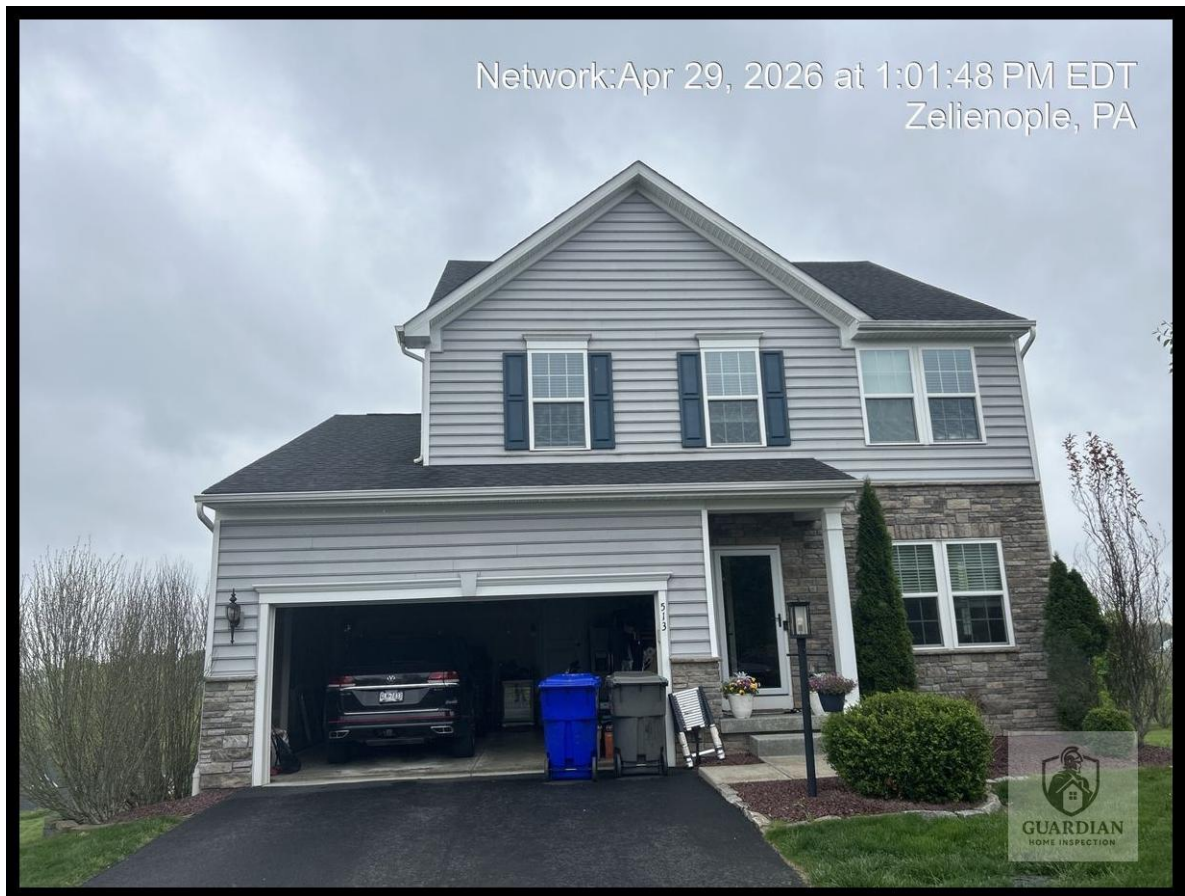
## CONVENTIONS USED IN THIS REPORT – \*\*\*PLEASE REVIEW\*\*\*

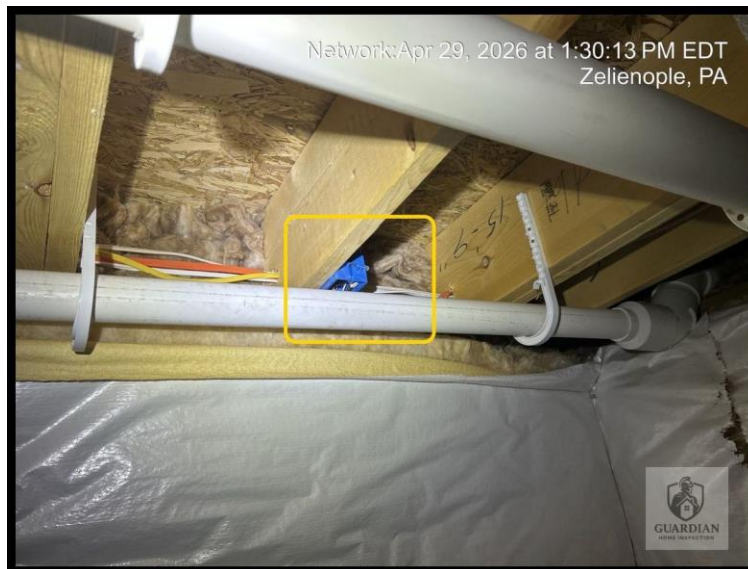
**Figure 1: An open electrical junction box was observed along the basement ceiling.**

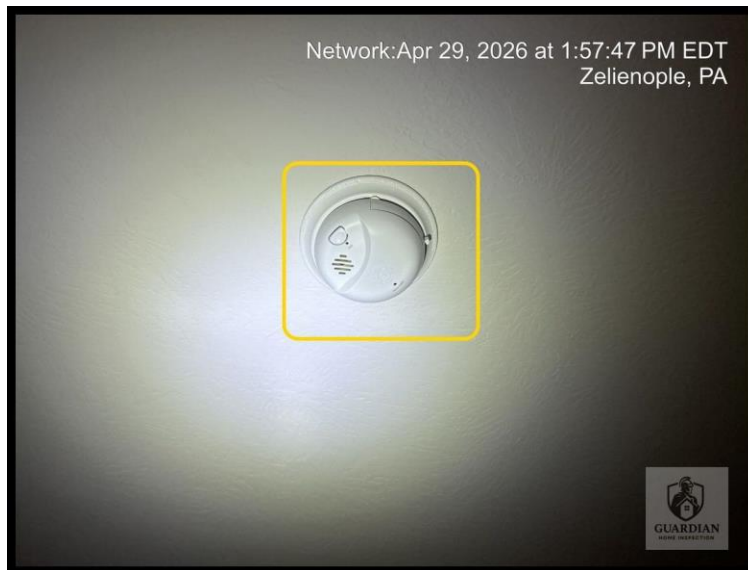
**Figure 2: The second-floor hallway lacked adequate carbon monoxide protection at the time of inspection.**

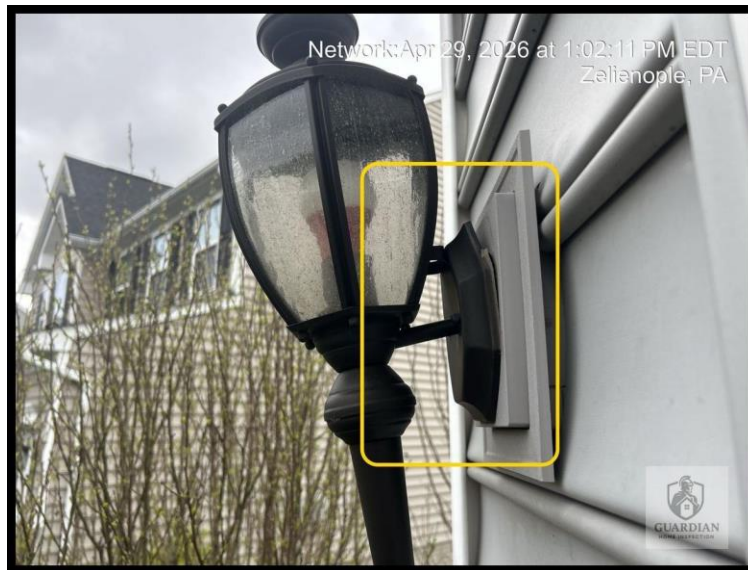
**Figure 3: The front-facing exterior light fixture housing was observed to be loose from the wall.**

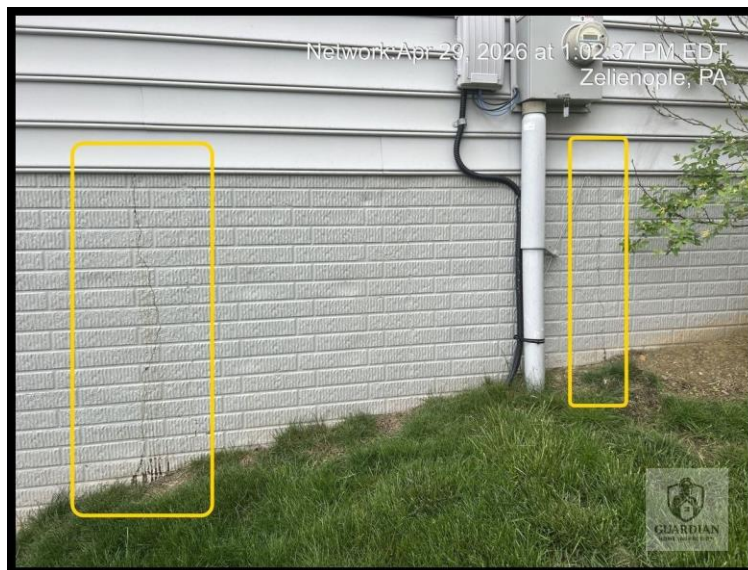
**Figure 4: Thermal cracking was observed in the brick veneer along the left-facing exterior wall.**

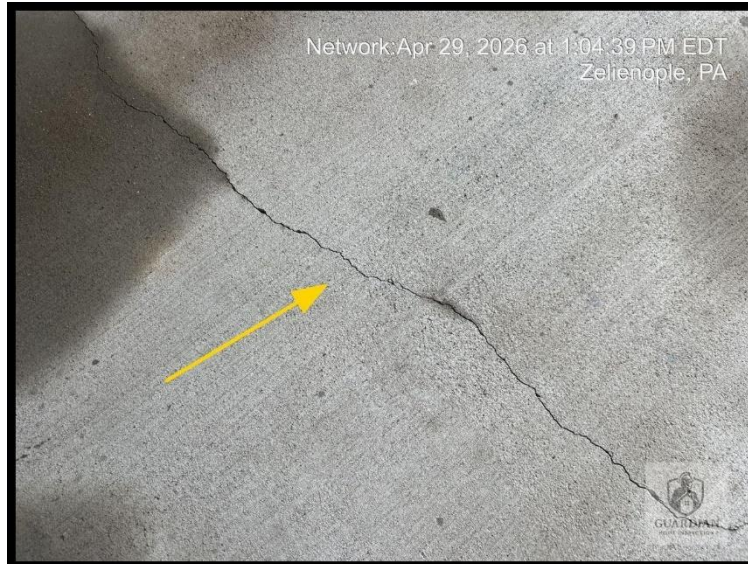
**Figure 5: Minor cracking was noted along the rear patio concrete slab.**

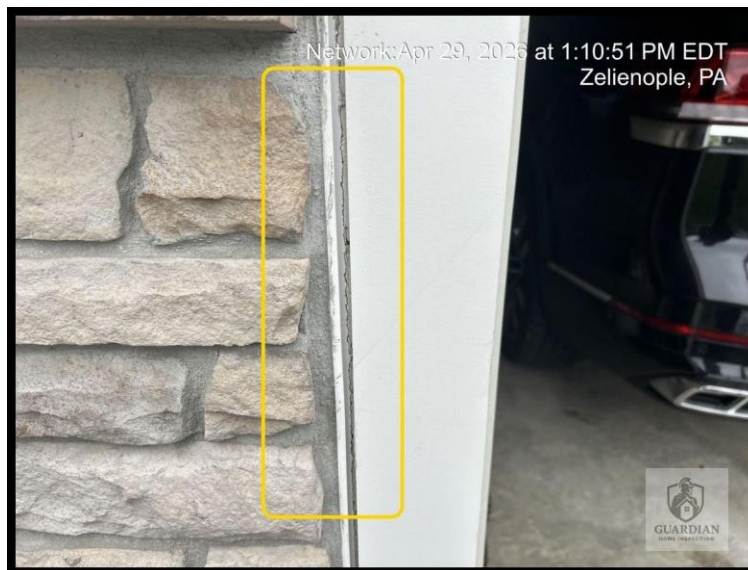
**Figure 6: Exterior window and door frames/trim were observed with areas needing resealing and caulking (notably at trim-to-masonry/trim joints).**

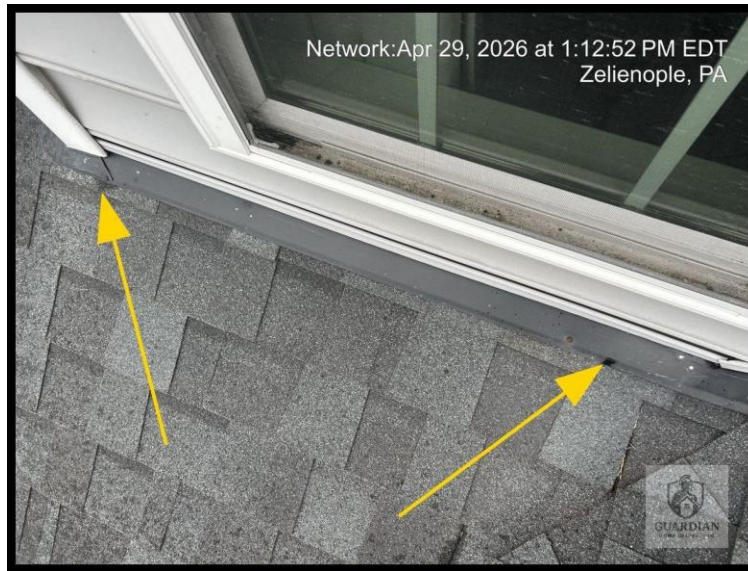
**Figure 7: Roof-to-wall flashing and diverter flashing at the roof area were observed with exposed nail heads that require sealing, as visible at the flashing edges.**

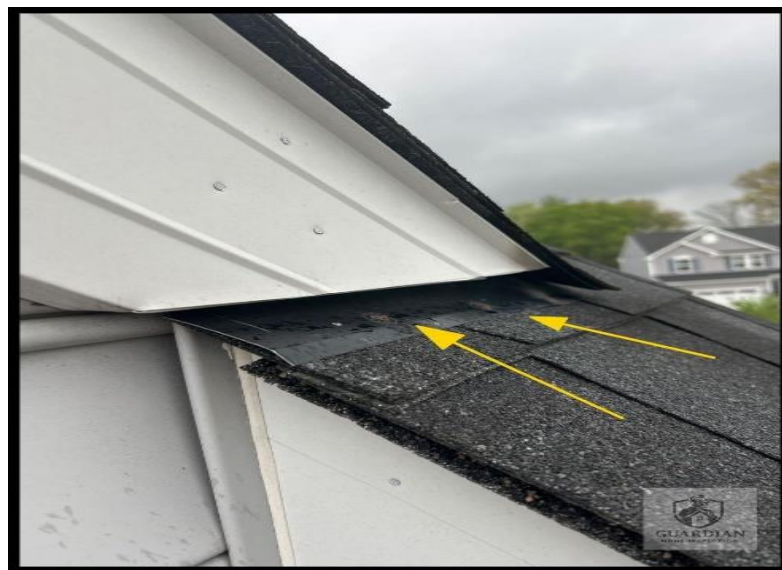
**Figure 8: Roof-to-wall flashing and diverter flashing at the roof area were observed with exposed nail heads that require sealing, as visible at the flashing edges.**

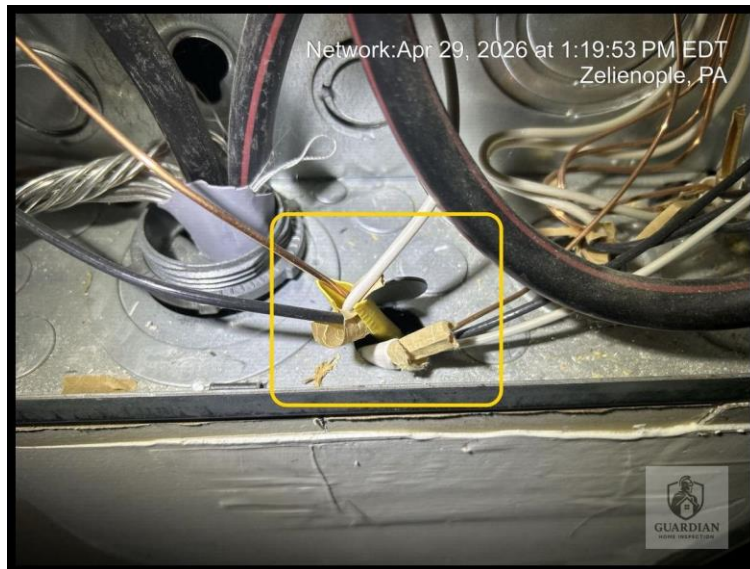
**Figure 9: In the garage, electrical conductors were observed passing through the main electrical panel cabinet without an approved protective cable clamp/bushing at the cabinet knockout.**

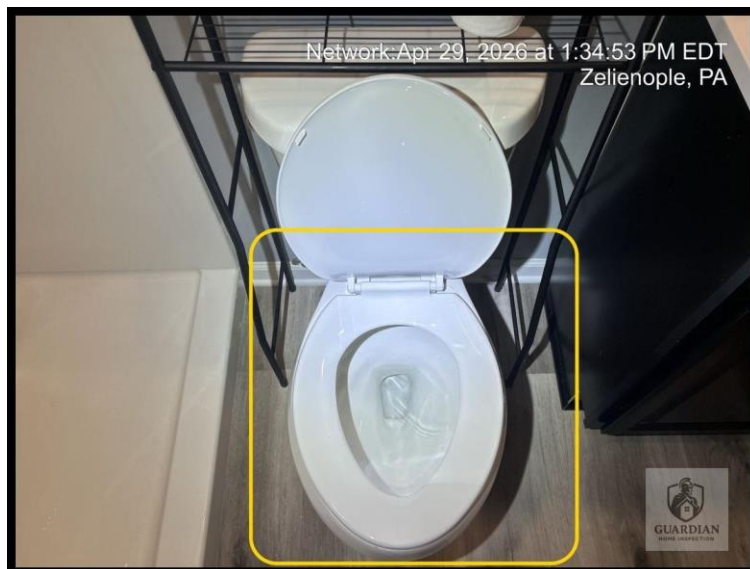
**Figure 10: The toilet in the basement bathroom was observed to be loose at the floor connection.**

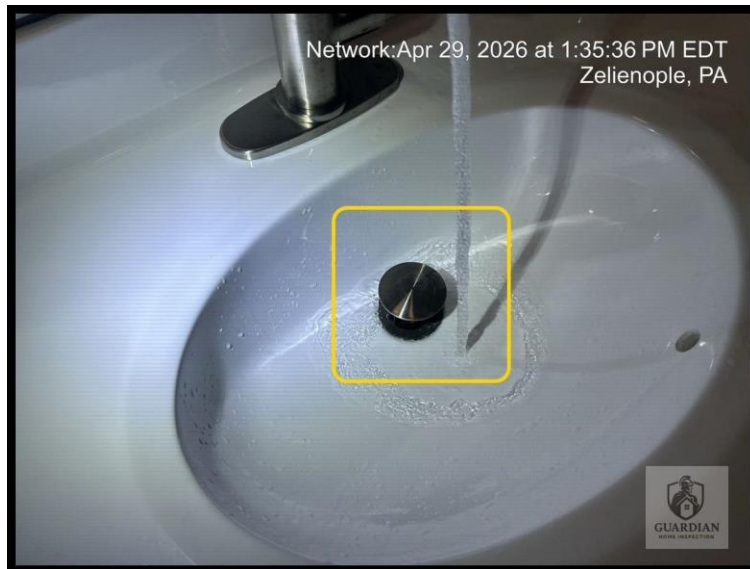
**Figure 11: The plug stopper assembly at the basement bathroom sink would not release once pressed in, as confirmed by the provided photo.**

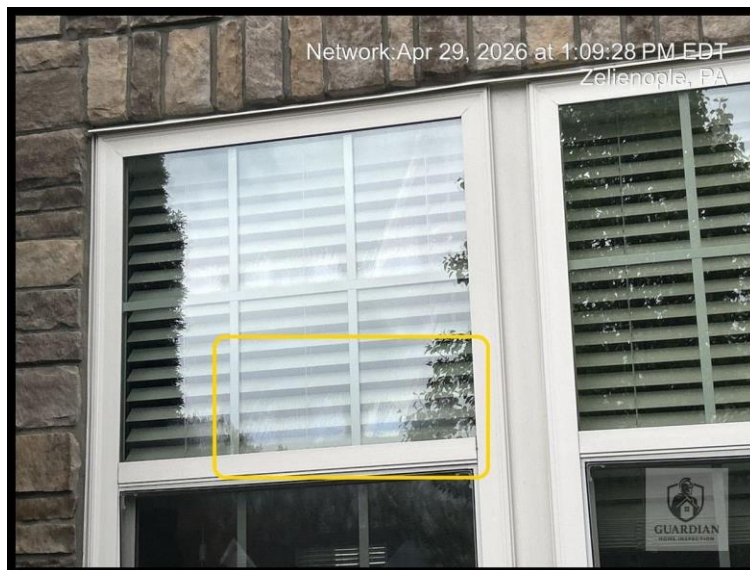
**Figure 12: The front-facing first-floor window in the Family Room was observed to be fogged, consistent with moisture between the panes of an insulated glass unit.**

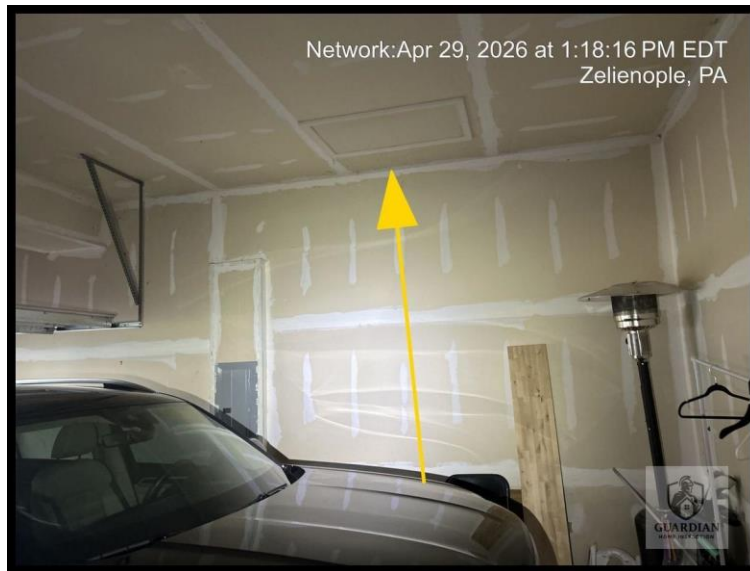
**Figure 13: The attic space above the garage was not accessible at the time of the inspection (no accessible entry point was available).**

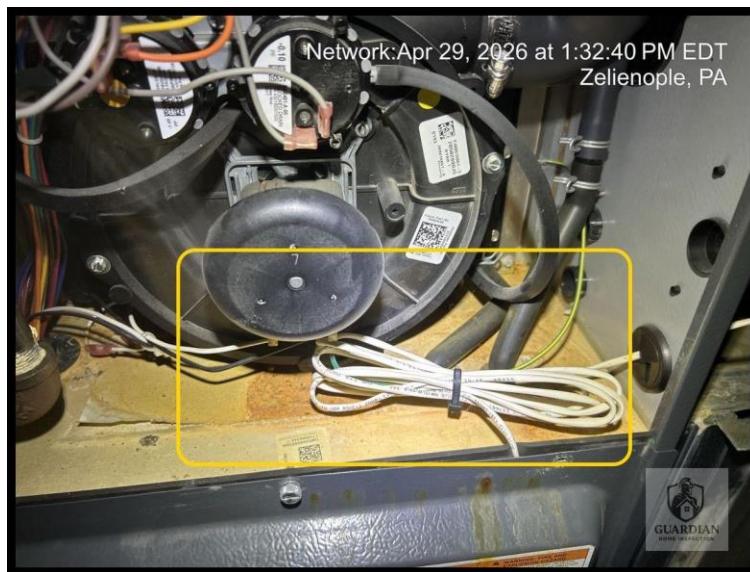
**Figure 14: A limited amount of rust was observed within the furnace burner cabinet in the basement, indicating a past condensate leak.**

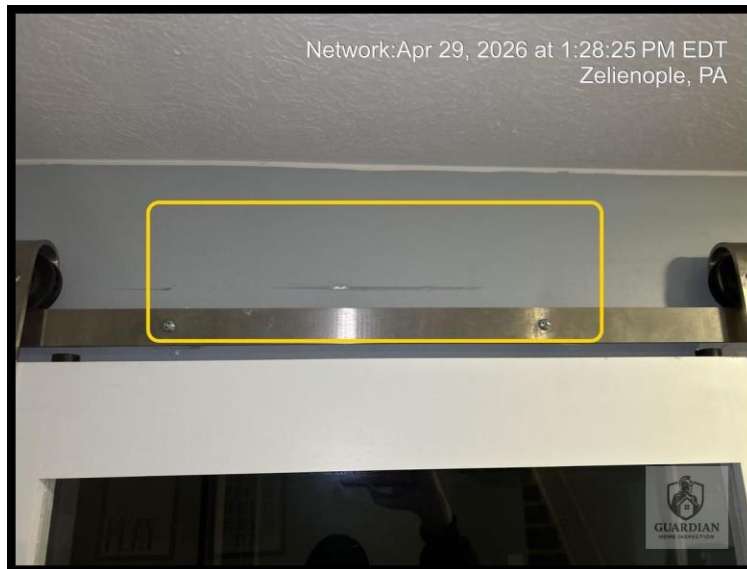
**Figure 15: Minor damage was noted along the basement wall adjacent to the barn door.**

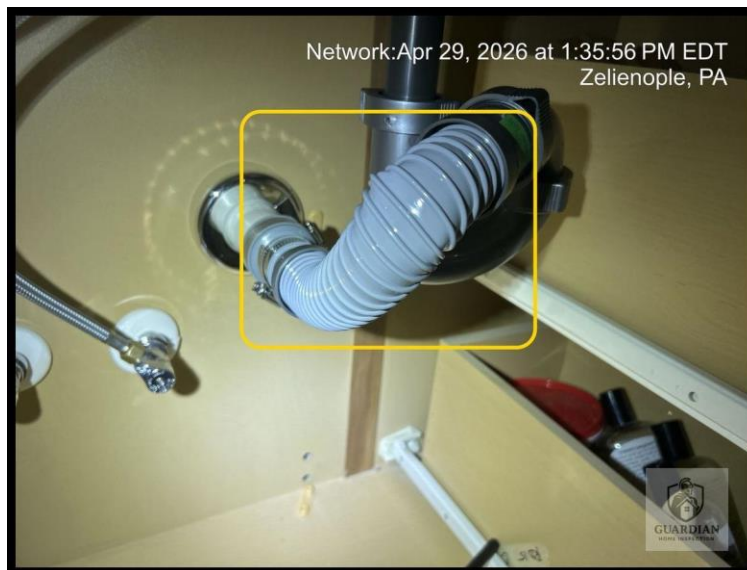
**Figure 16: The rigid drain pipe under the bathroom sink was observed to be an inappropriate/less suitable configuration for a sink drain connection.**

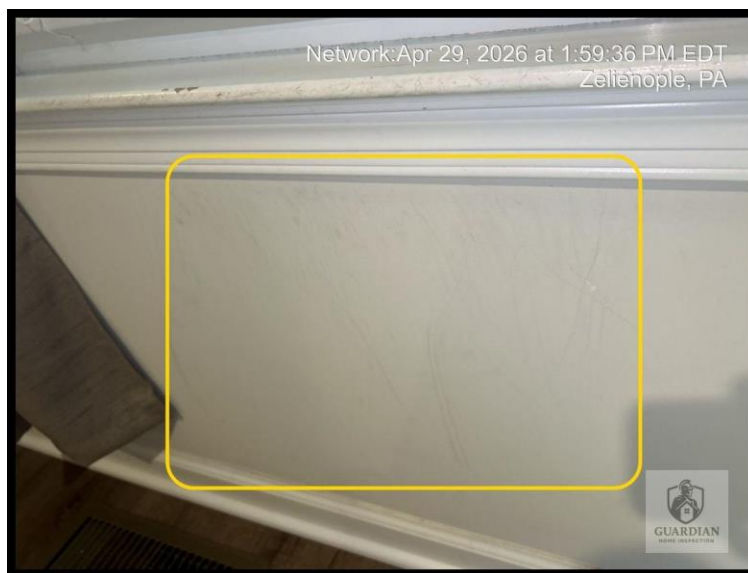
**Figure 17: Minor damage/scuffing was observed on the drywall finish along the second-floor front-facing windows in the loft area (hallway).**
