Residential Building Inspection Report

5317 Keystone St, Pittsburgh, PA 15201

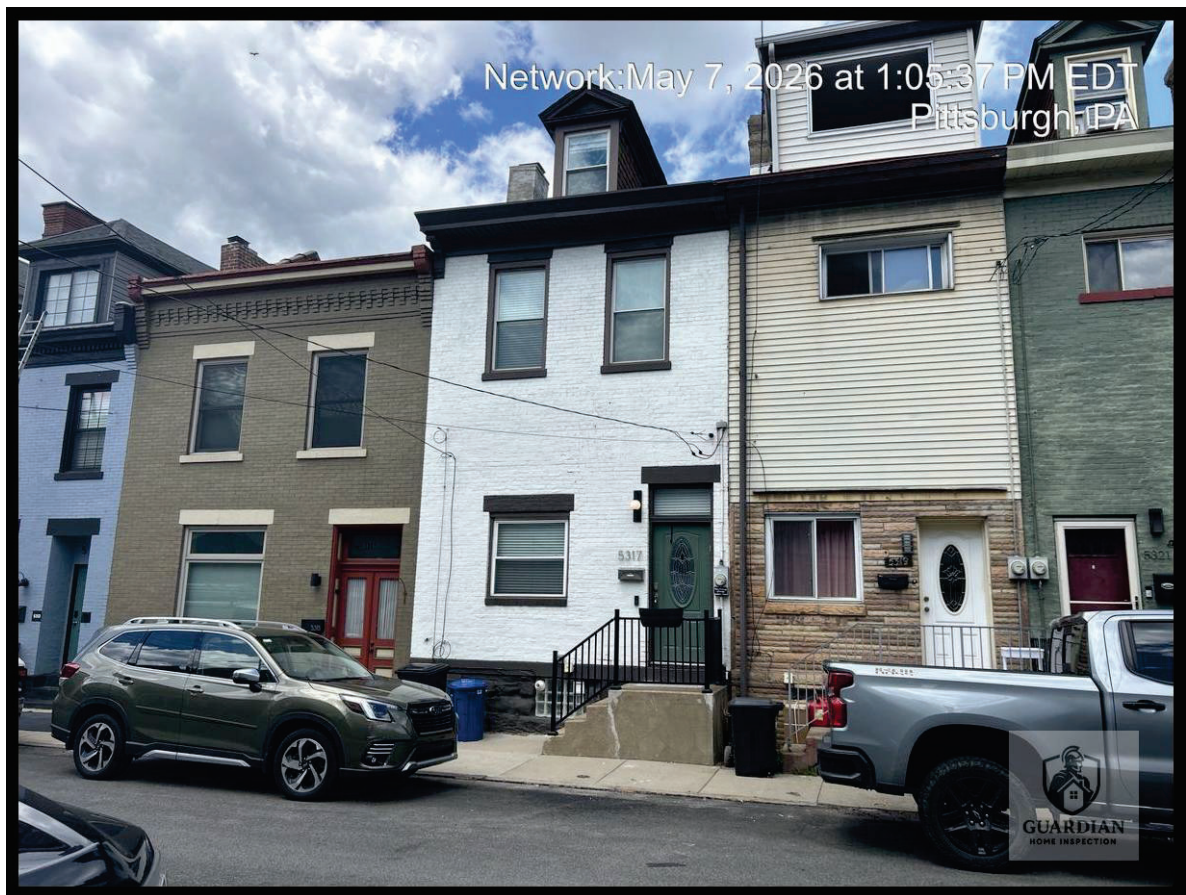
CONVENTIONS USED IN THIS REPORT – ***PLEASE REVIEW***

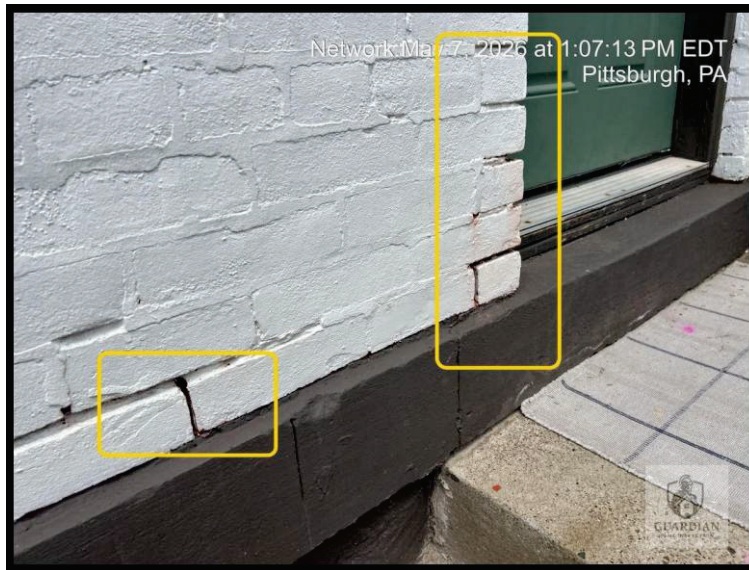
Figure 1: Minor mortar deterioration was noted along the front-facing exterior brick wall.

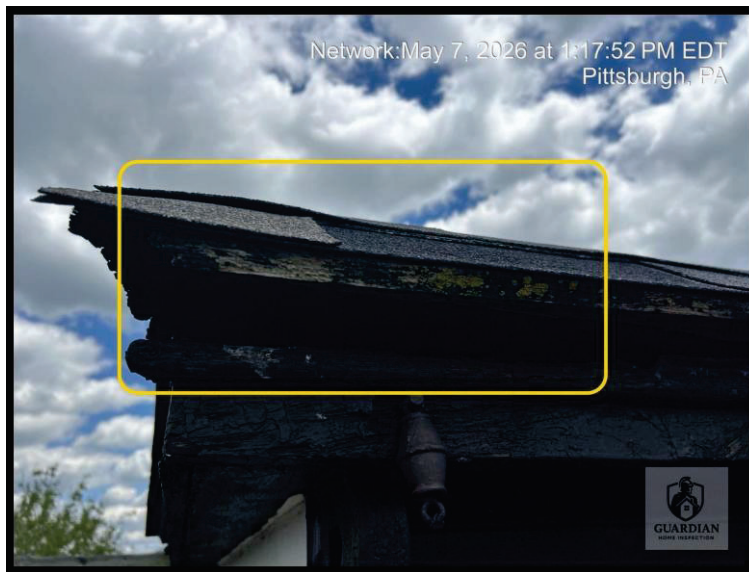
Figure 2: The rear-facing dormer exhibited evidence of wood rot along the eave, with deteriorated/decayed wood visible at the trim/soffit area.

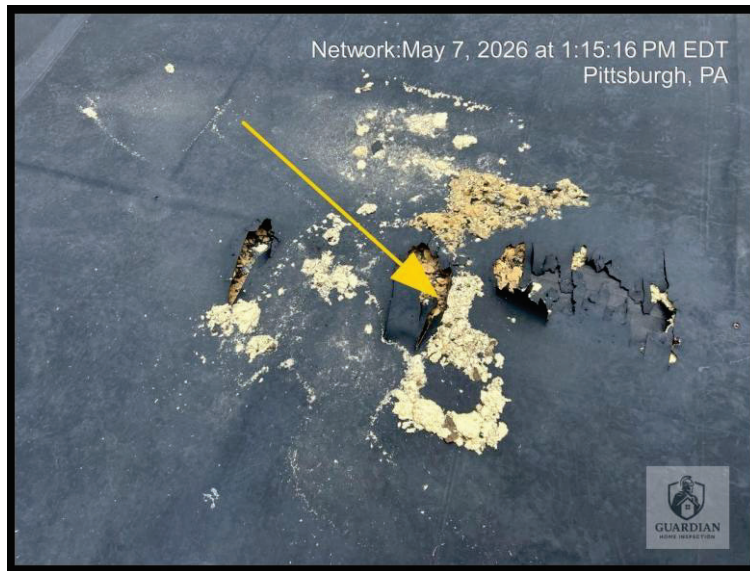
Figure 3: The rubber membrane roofing at the roof was observed to be heavily damaged, with visible holes/tears and deteriorated areas in the membrane.

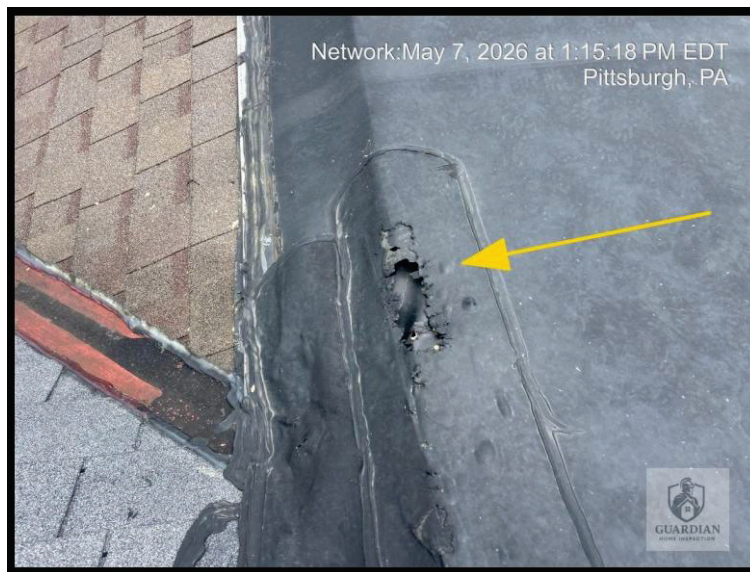
Figure 4: The rubber membrane roofing at the roof was observed to be heavily damaged, with visible holes/tears and deteriorated areas in the membrane.

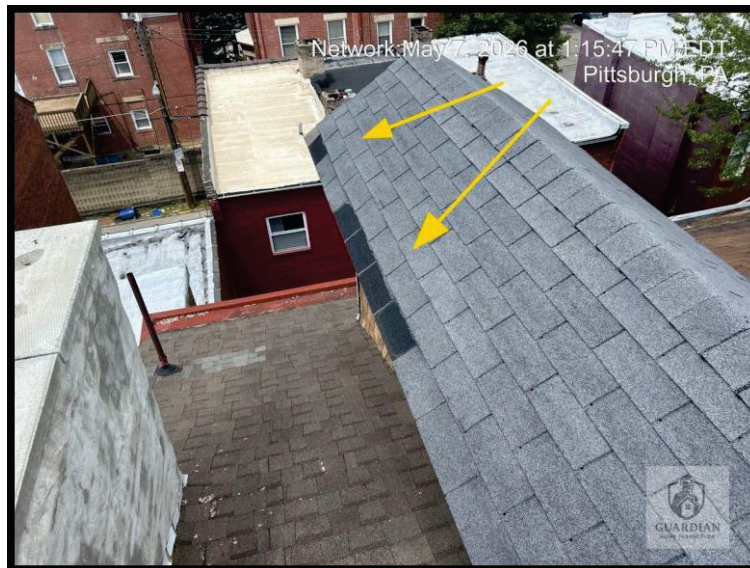
Figure 5: Several asphalt shingles were observed missing on the rear-facing dormer roof.

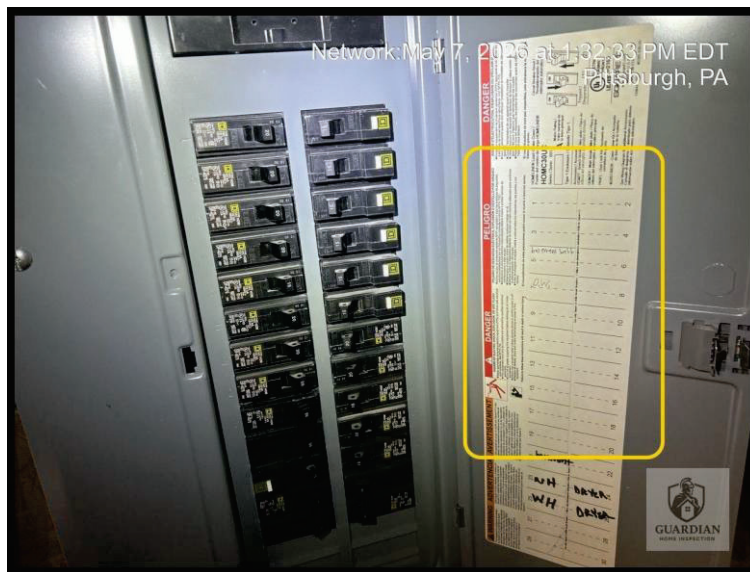
Figure 6: Several circuit breakers in the basement electrical panel were observed to be unlabeled on the panel directory.

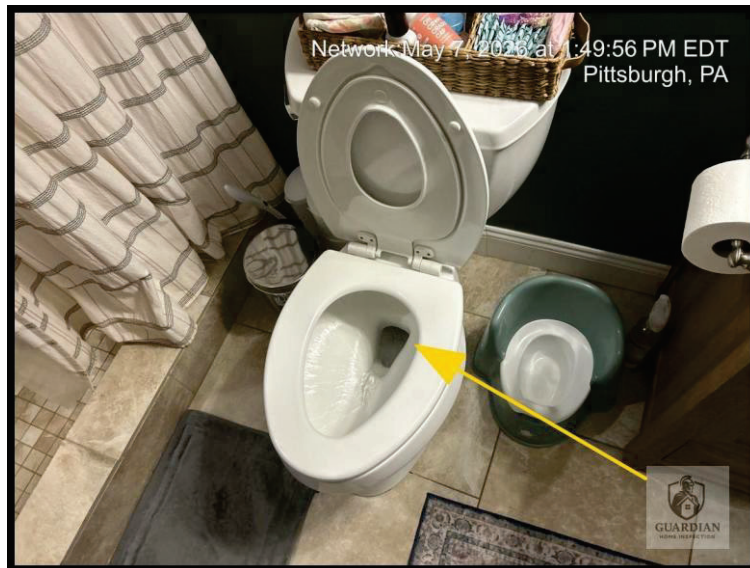
Figure 7: The second floor bathroom toilet was observed to be loose at the floor connection.

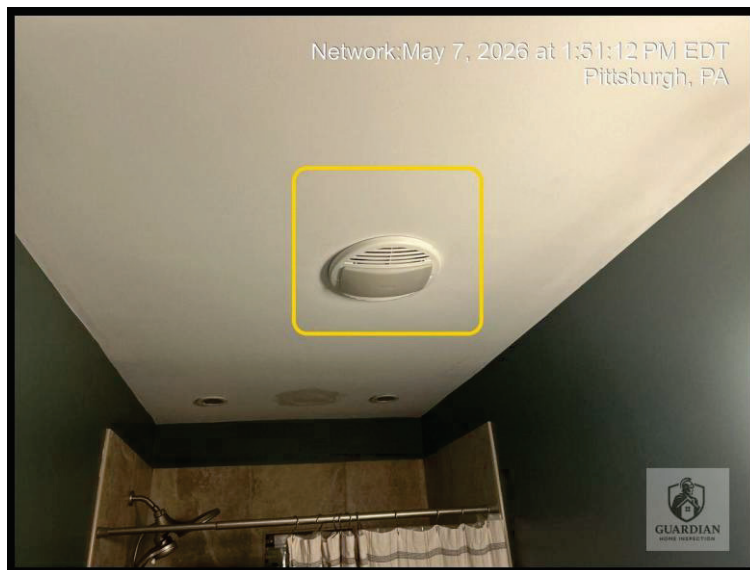
Figure 8: The light bulb in the second-floor bathroom exhaust fan/light fixture was reported as inoperable.

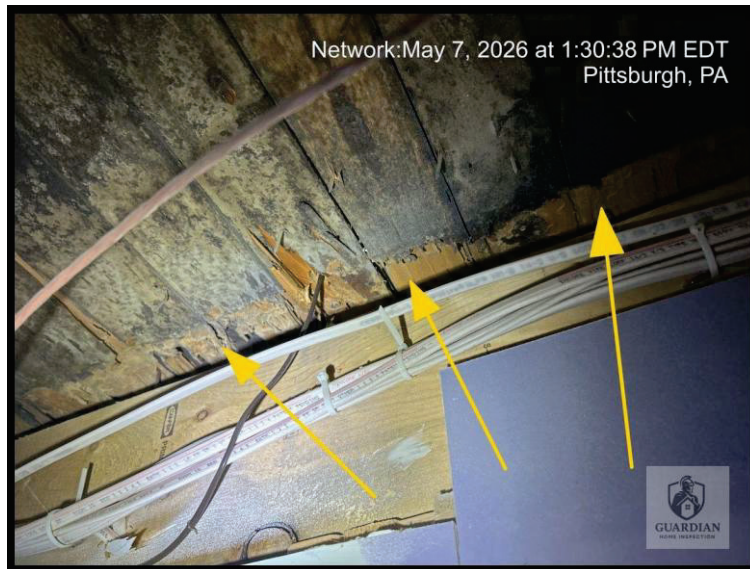
Figure 9: Termite-related damage was observed along the subfloor above the center basement wall; the visible activity appeared inactive at the time of inspection.

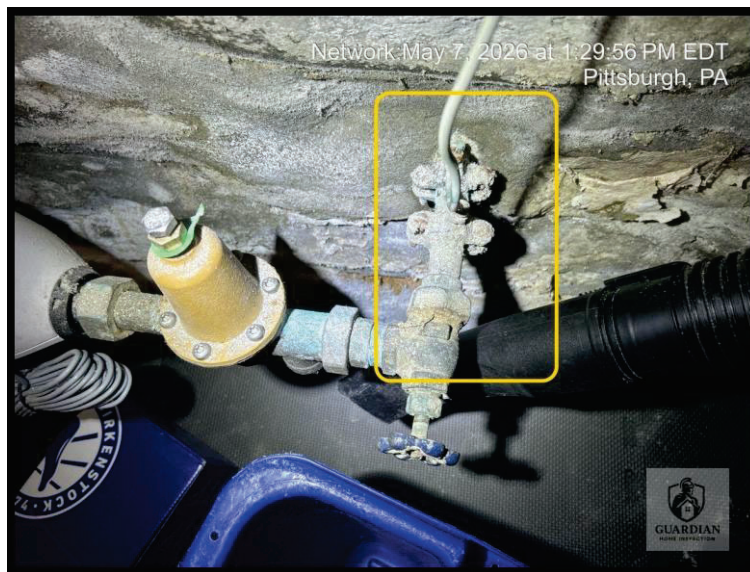
Figure 10: Corrosion was observed on the water line where it enters the home along the front-facing foundation wall in the basement.

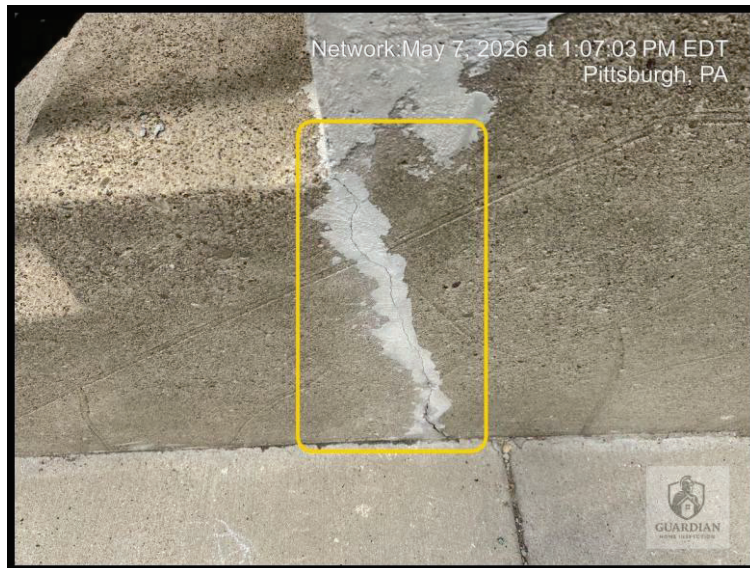
Figure 11: The front-facing porch/stoop exhibited evidence of minor cracking.

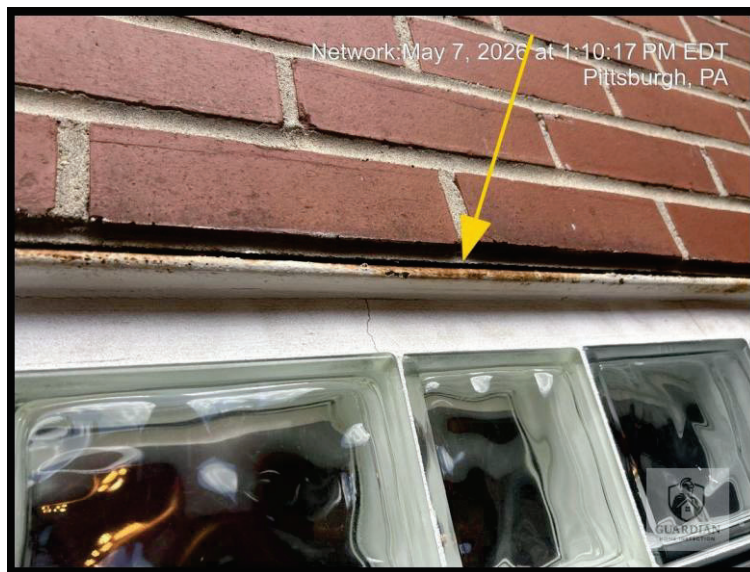
Figure 12: Steel lintels at the exterior masonry opening were observed with exposed metal and surface rust staining.

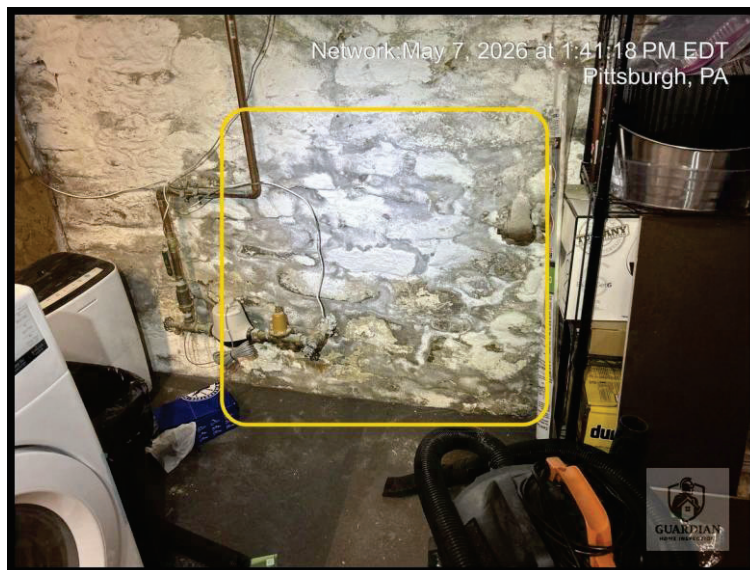
Figure 13: Minor moisture intrusion was observed along the front-facing basement foundation wall.

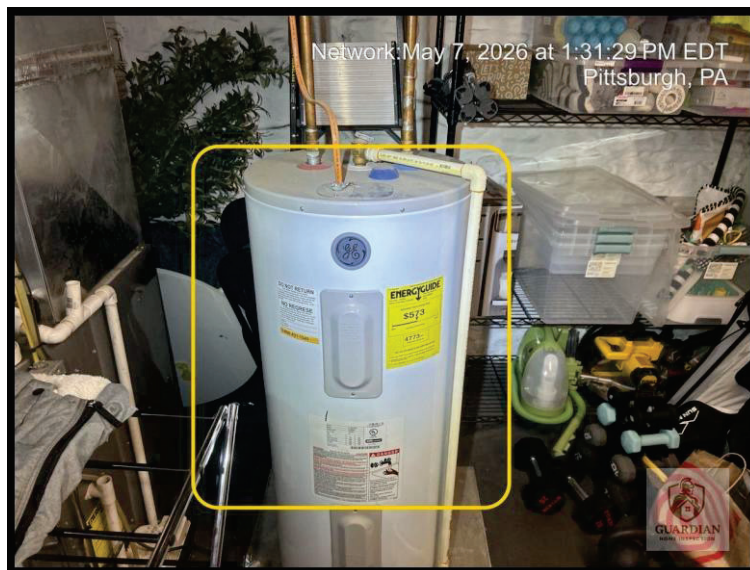
Figure 14: The basement water heater was observed to be approaching the end of its typical useful life for similar units.
