AN ARCHAEOLOGICAL ASSESSMENT OF DINTON HALL, DINTON, BUCKINGHAMSHIRE

Bob Zeepvat BA MIFA and Nicola King BA MPhil

October 2000

ASC/M/DHD00/2

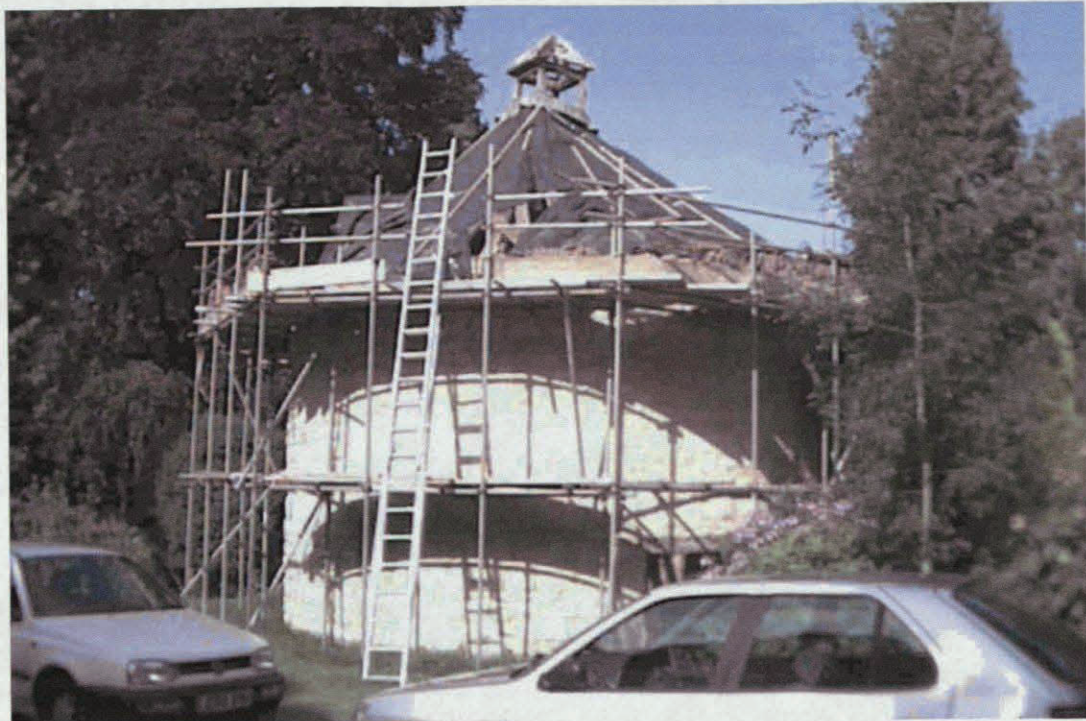
Plate 5: The dovecote, from south.

Restoration work on this structure has not yet commenced. The main work involved here will comprise replacement of the roof, and presumably remedial works (*i.e.* re-pointing) to the walls.

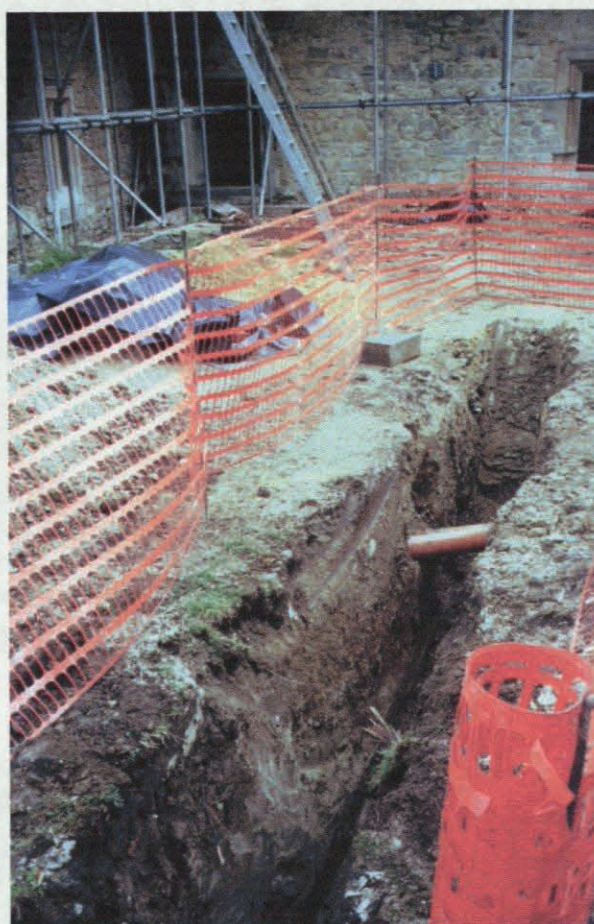
Plate 8: Watching brief: large pit or ditch near house

- a. Immediately west of the house was a large pit or broad ditch, at least 5m wide and 1.2m deep (Plate 8). Its east side was not located. Its lowest fill was orange gravelly soil about 0.5m thick, below a layer of light to medium brown soil 0.6m deep. There were no finds in section or in the spoil heaps. This feature had already been disturbed by an earlier service trench on a north-south alignment.

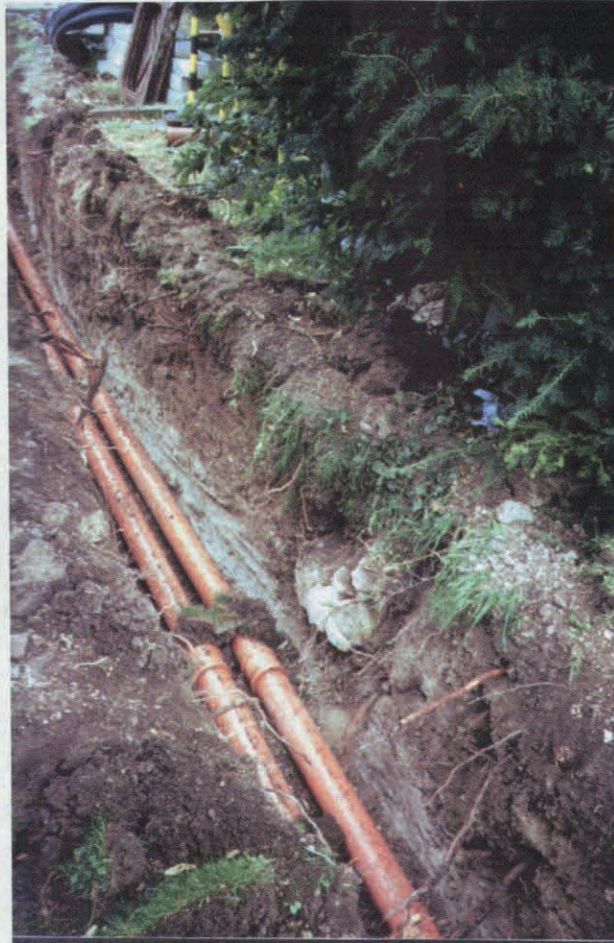
Plate 9: Watching brief: Wall footing

- b. About 26m west of the drawing room wall was a limestone wall footing aligned north-south (Plate 9). It was about 0.6m below the present ground level, and was 0.5m wide. It was aligned with the surviving wall to the south, and is probably the remains of the east wall of the old coach house and stables (para 5.2.14).
- c. About 5.0m west of the wall footing was a pit or ditch (more likely the latter). It measured 1.7m wide, 0.9m deep with sloping sides, and was filled with a light brown loose soil (Plate 10). It contained no finds.

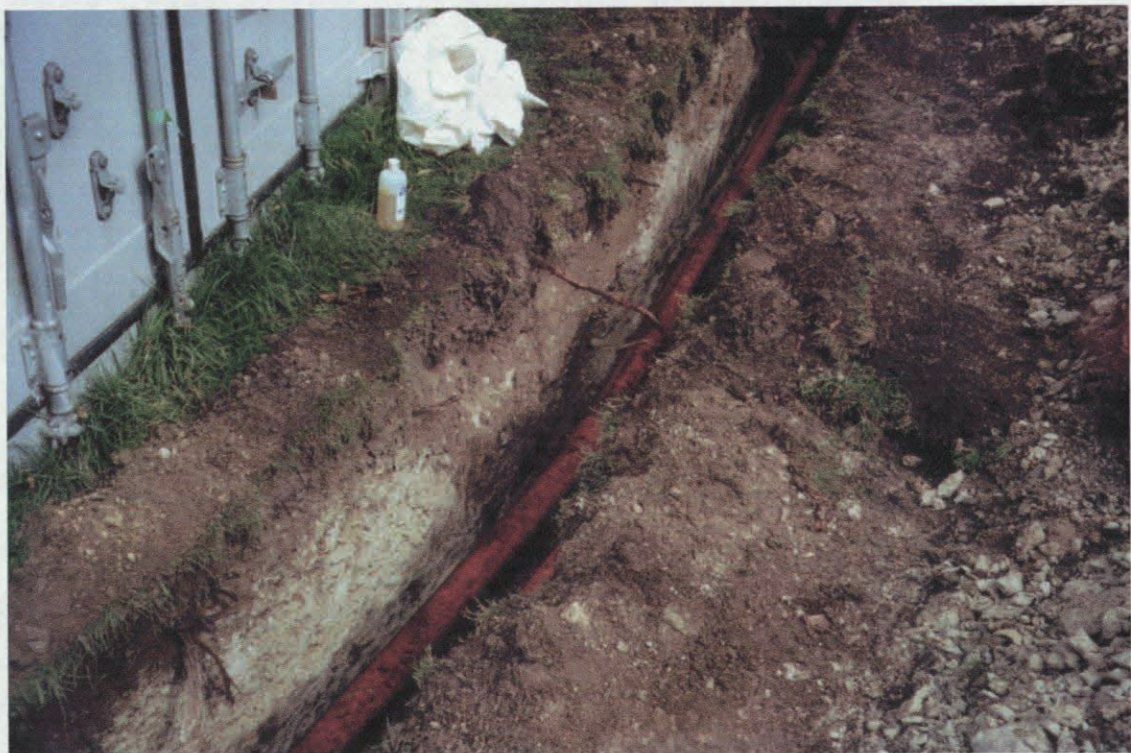
Plate 10: Watching brief: small pit or ditch.

Comments: SLOPING SIDES, FILLED WITH LIGHT BROWN LOOSE SOIL (SUBSOIL). NO FINDS.			
Completed by:

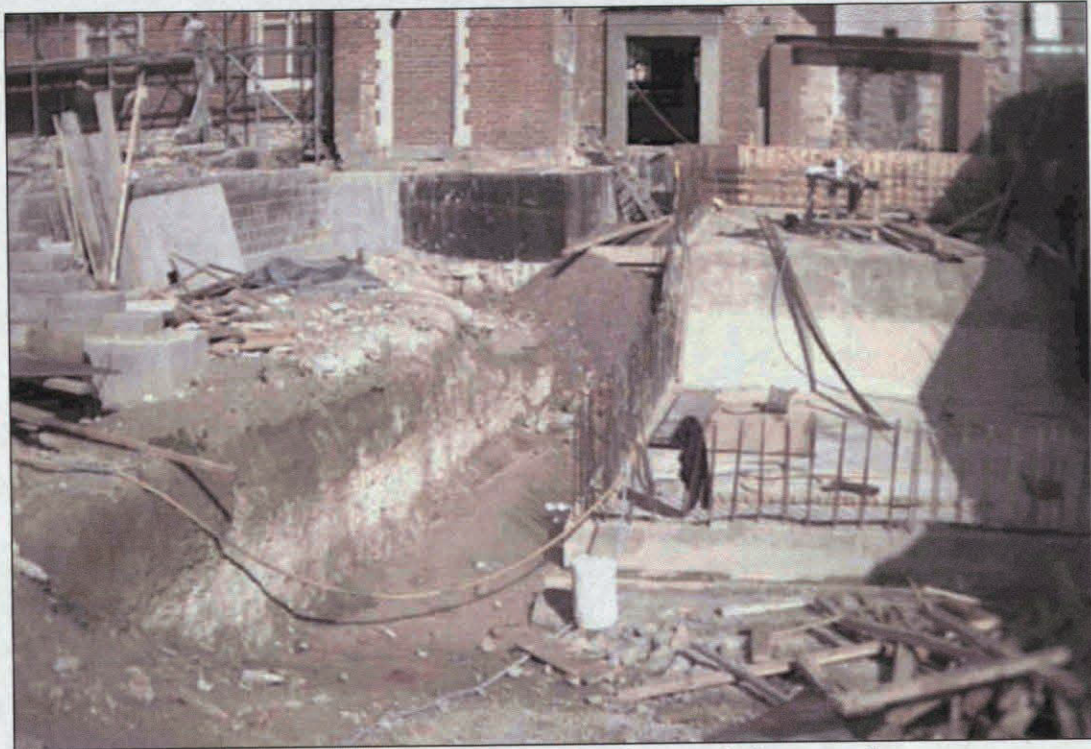
Plate 7: Excavation for swimming pool, from south.

- Construction of swimming pool adjacent to east corner of house
- Trenches for new service runs
- Extension of island in north pond, and construction of gazebo on it
- Construction of bridge to island

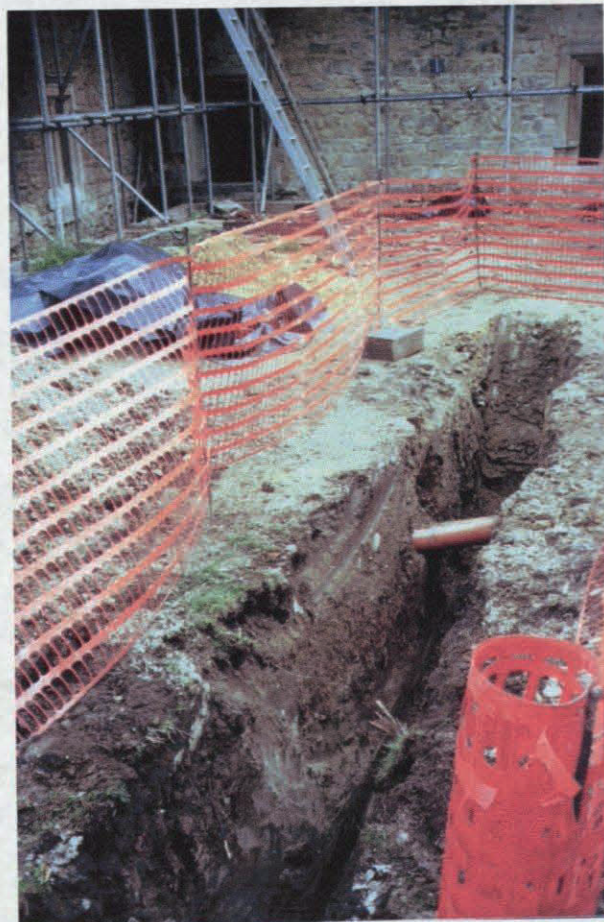
Plate 8: Watching brief: large pit or ditch near house

- a. Immediately west of the house was a large pit or broad ditch, at least 5m wide and 1.2m deep (Plate 8). Its east side was not located. Its lowest fill was orange gravelly soil about 0.5m thick, below a layer of light to medium brown soil 0.6m deep. There were no finds in section or in the spoil heaps. This feature had already been disturbed by an earlier service trench on a north-south alignment.

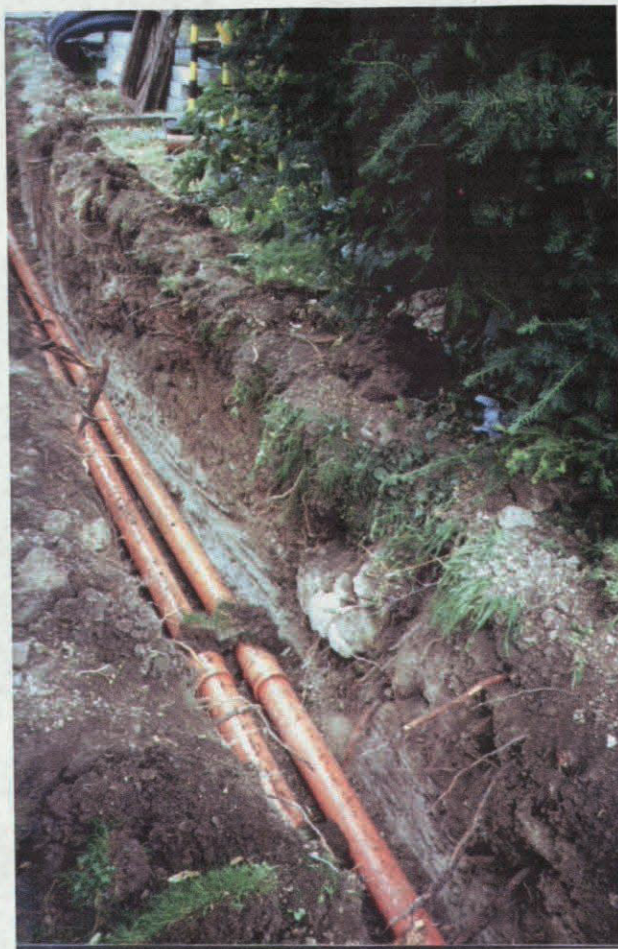
Plate 9: Watching brief: Wall footing

- b. About 26m west of the drawing room wall was a limestone wall footing aligned north-south (Plate 9). It was about 0.6m below the present ground level, and was 0.5m wide. It was aligned with the surviving wall to the south, and is probably the remains of the east wall of the old coach house and stables (para 5.2.14).
- c. About 5.0m west of the wall footing was a pit or ditch (more likely the latter). It measured 1.7m wide, 0.9m deep with sloping sides, and was filled with a light brown loose soil (Plate 10). It contained no finds.
