Home Inspection Report

PROPERTY INSPECTED:
107 Hiltz Avenue
Toronto, ON M4L 2N7

Date of Inspection: 02/11/2026

Inspection No. 141467-1441

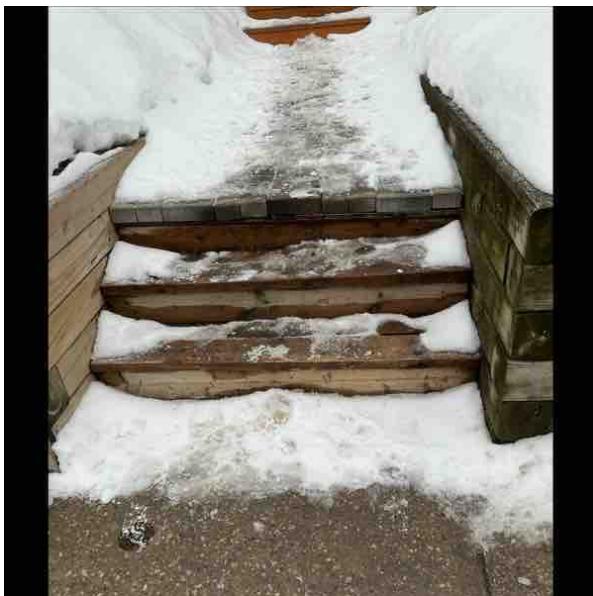
2.3 Walkway(s)

2.3.1 Add a handrail to the front steps for safety, if this is a concern to you

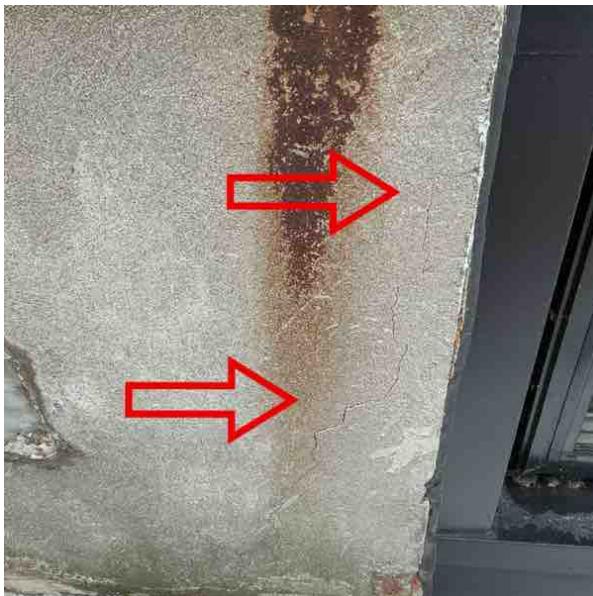
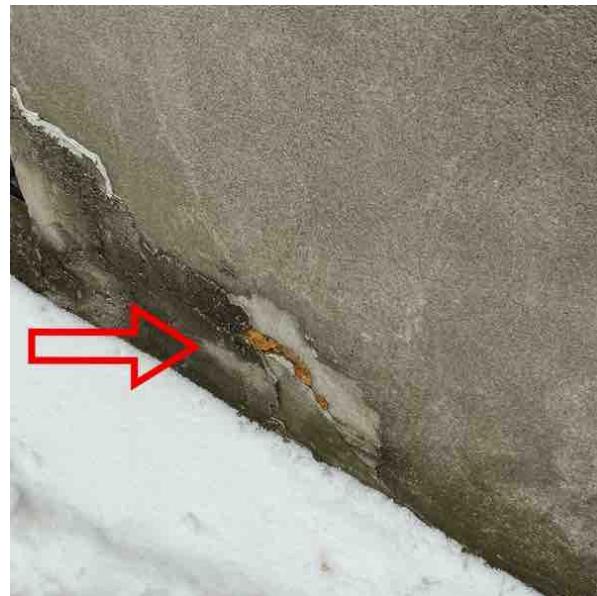
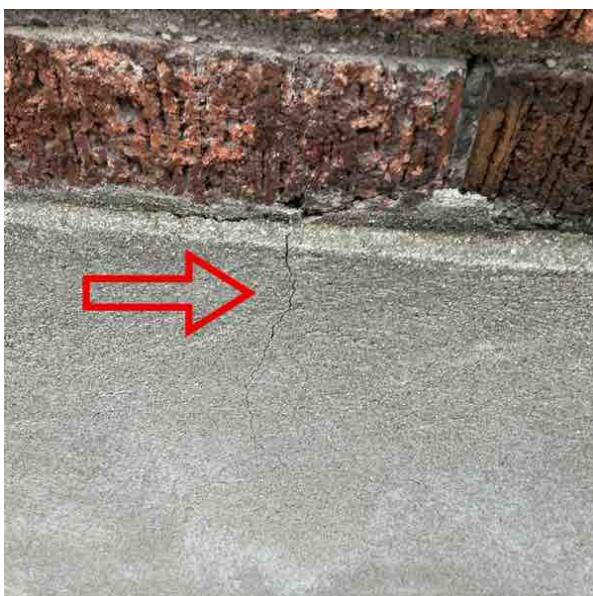
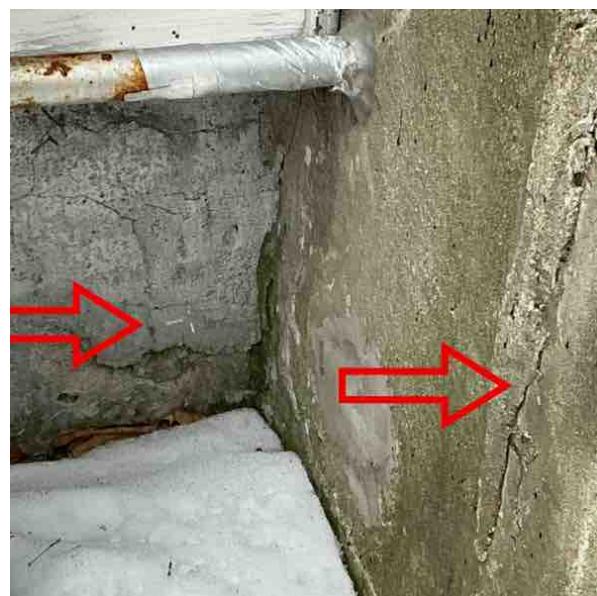
3.3 Foundation Surface

3.3.2 The parging on the foundation has cracked sections. Repair to prevent further damage to the foundation.

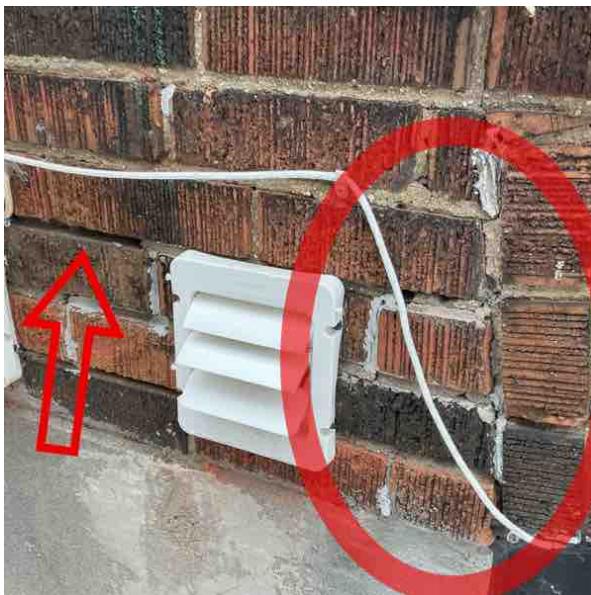
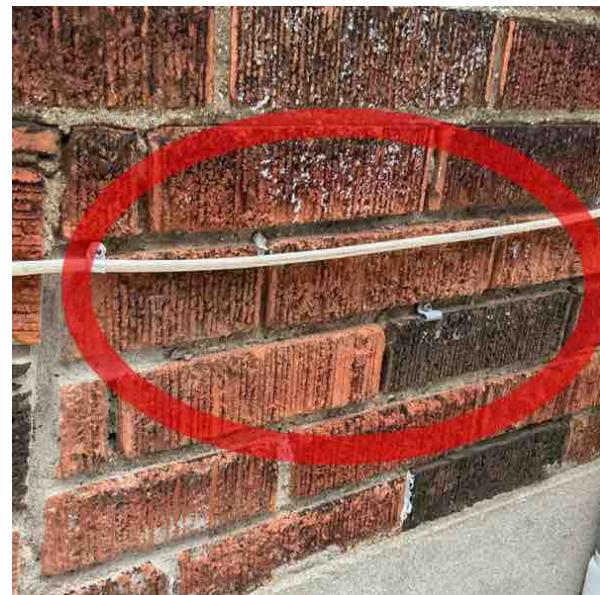
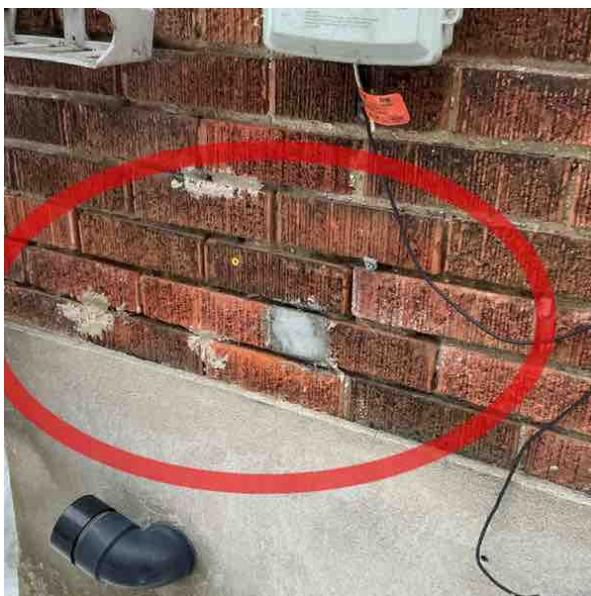
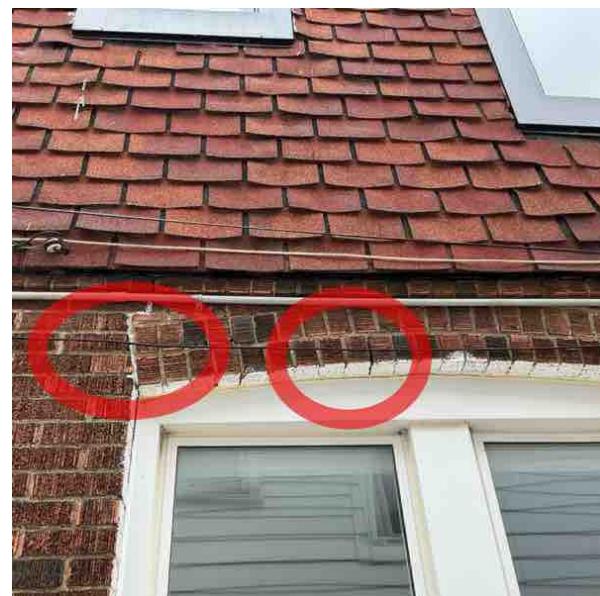
3.4 Wall Surface

3.4.1 Mortar is worn/damaged in areas. This should be repaired to shed water and minimize ongoing wear.

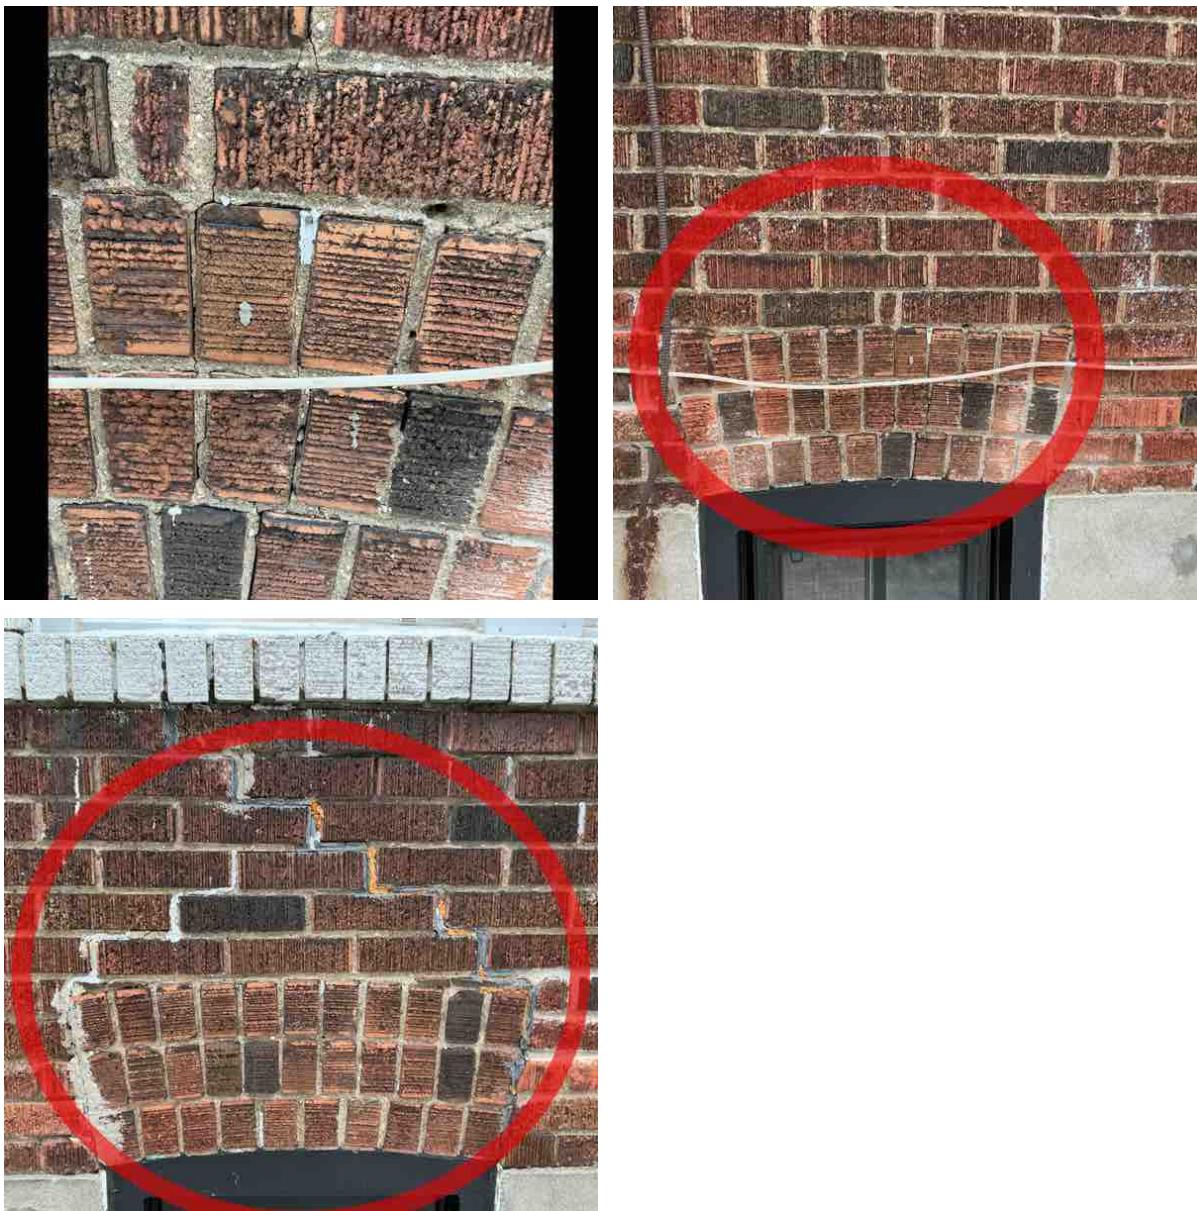
3.4.2 Typical step cracking noted. Recommend repointing or sealing to prevent further deterioration.

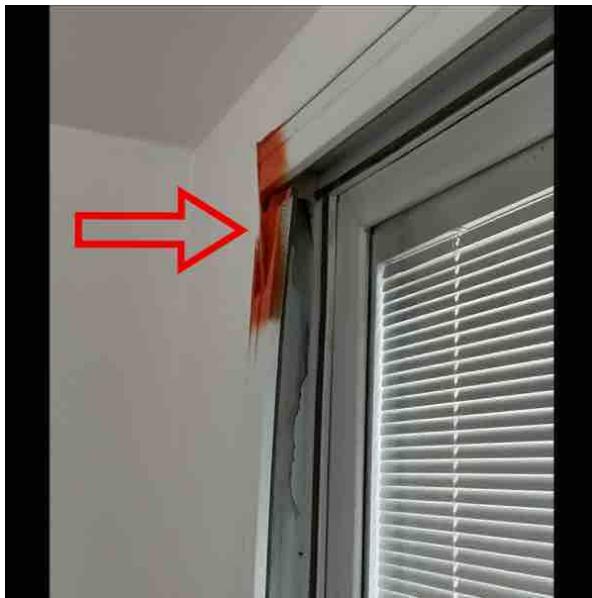
3.6 Exterior Doors

3.6.1 Some damage noted to the frame of the sliding door. Still functioning repair or replace for aesthetics if it's a concern to you.

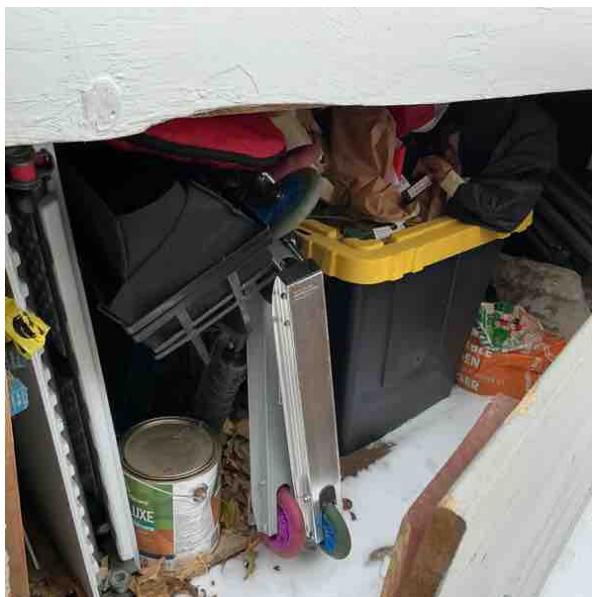
3.7 Porch(es)

3.7.1 Unable to inspect due to homeowners contents

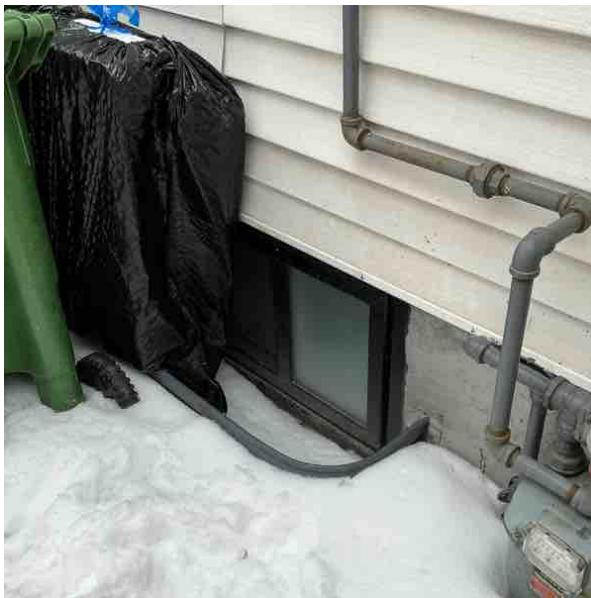
3.9 Window Wells

- 3.9.1 • Install window well covers to help shed water away from structure.
- Keep window wells clear and free of debris for proper drainage.

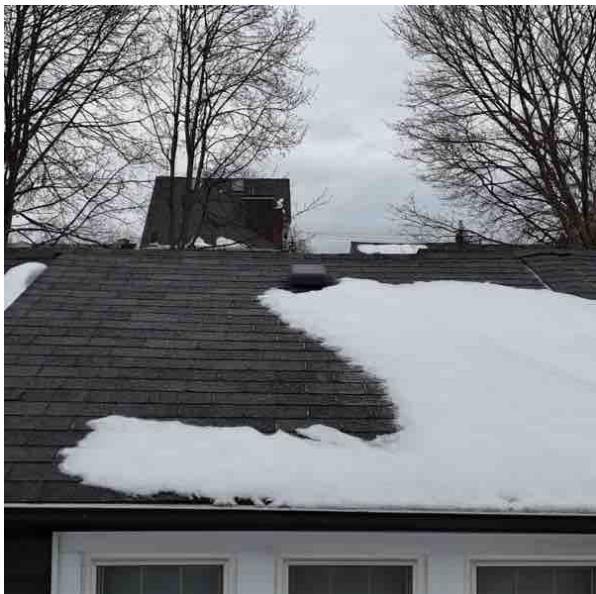
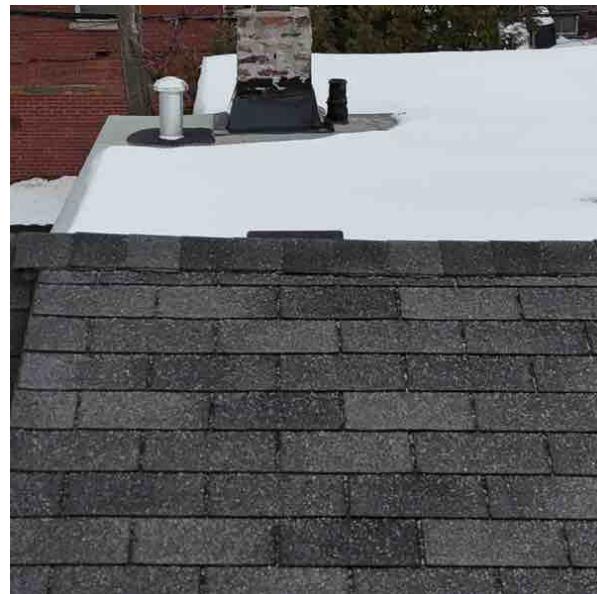
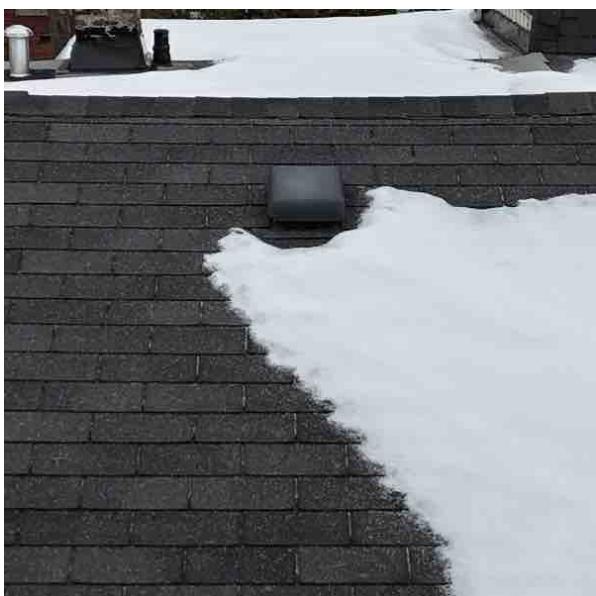
4.3 Sloped Surface(s)

- Asphalt shingles

- 4.3.1 The sloped surfaces were inspected and no significant deficiencies were observed.

4.3.2 The sloped roof looks to be approximately in the first half of its typical life expectancy of twenty years, if maintained annually

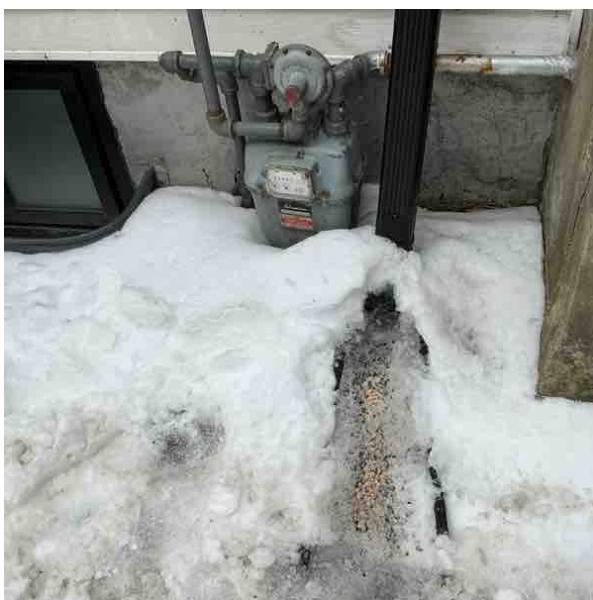
4.5 Roof Drainage

4.5.2 Extend gutters 5-6 feet away from the house or use a rain barrel for better water management. And to reduce any potential water penetration through the foundation.

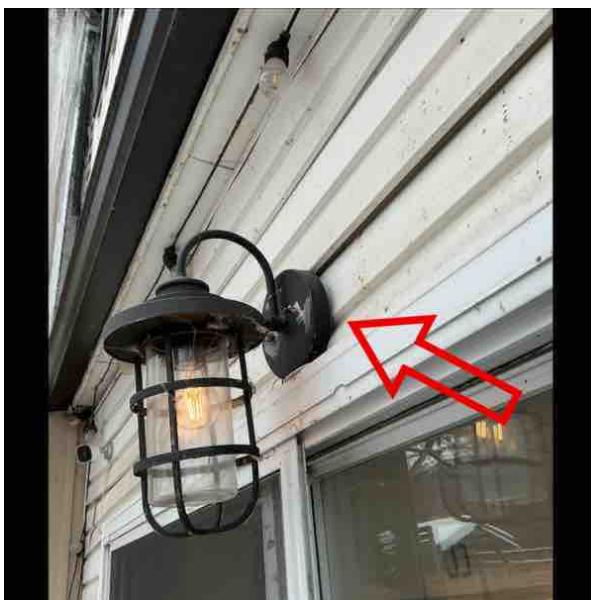
7.7 **Lighting / Ceiling Fan(s)**

7.7.1 **Seal the light fixture to the wall for electrical safety**

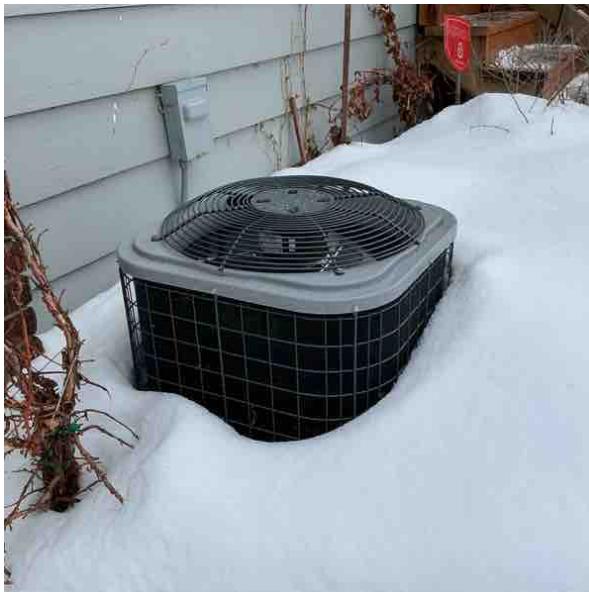
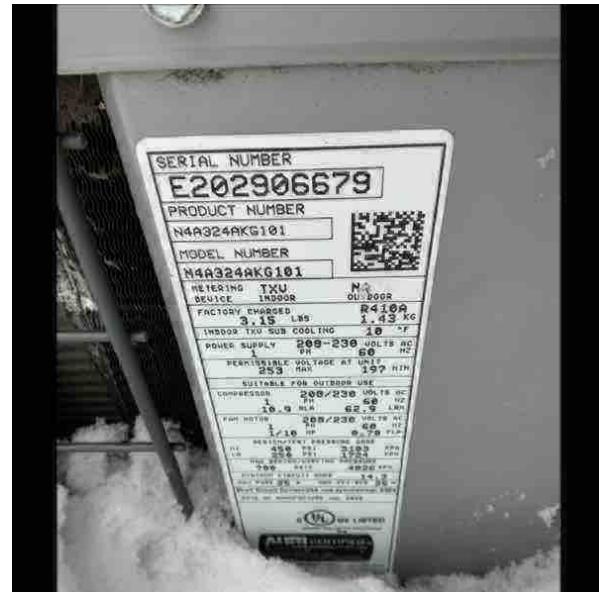
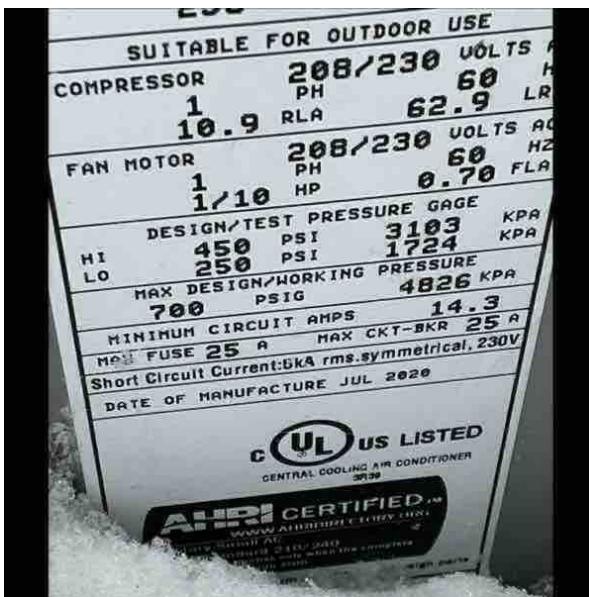
8.6 AC / Heat Pump System(s)

8.6.1 2020 Keeprite ac

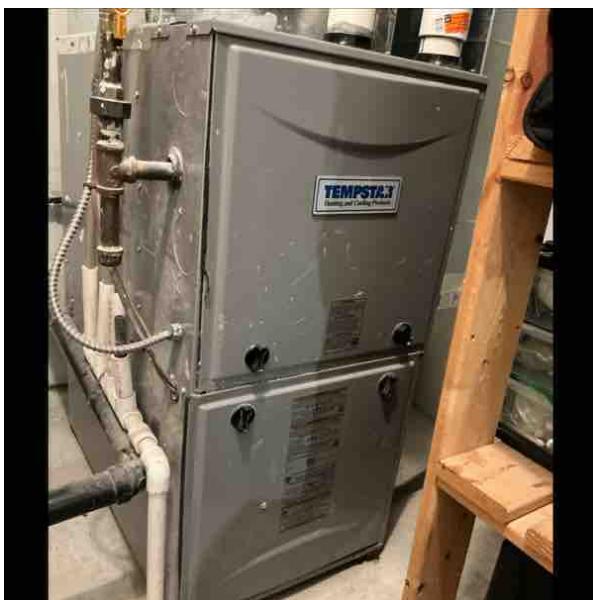
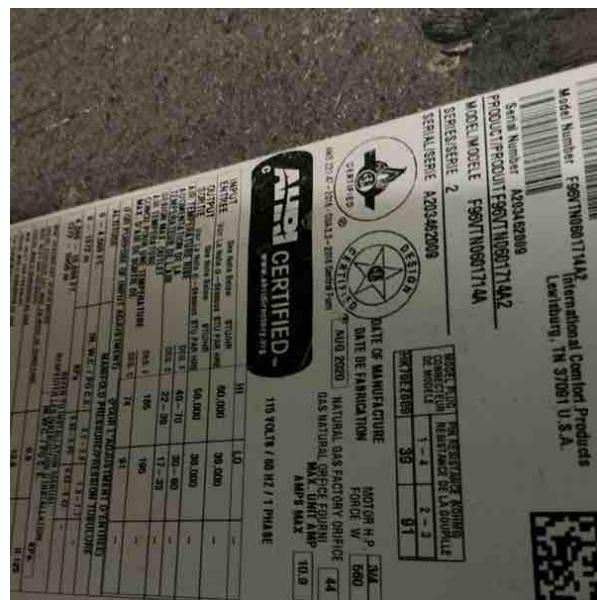
8.7 Forced Air Furnace(s)

- High Efficiency

8.7.1 The forced air furnace(s) were operated for primary function and worked as intended.

8.7.2 2020 Tempstar furnace

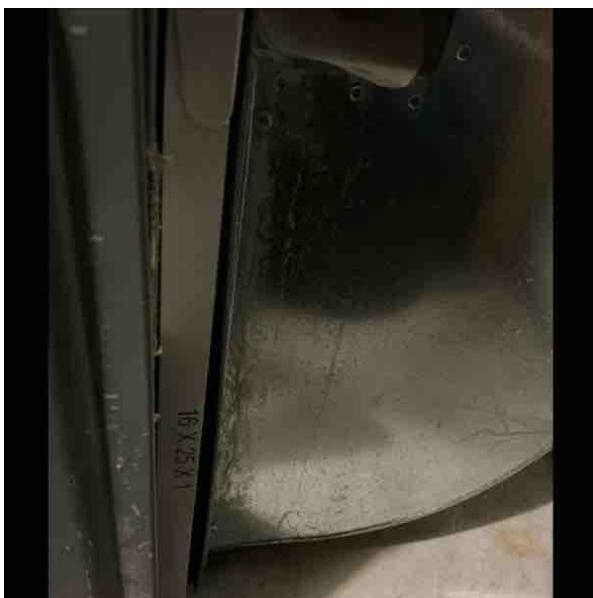
8.8 Filter

8.8.1 1" disposable filter

Size 16/25/1

Change every 1-3 months

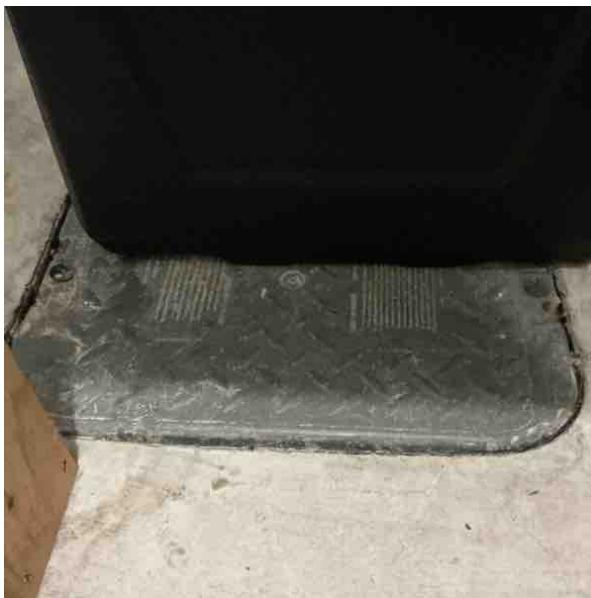
9.1.2 Back flow valve

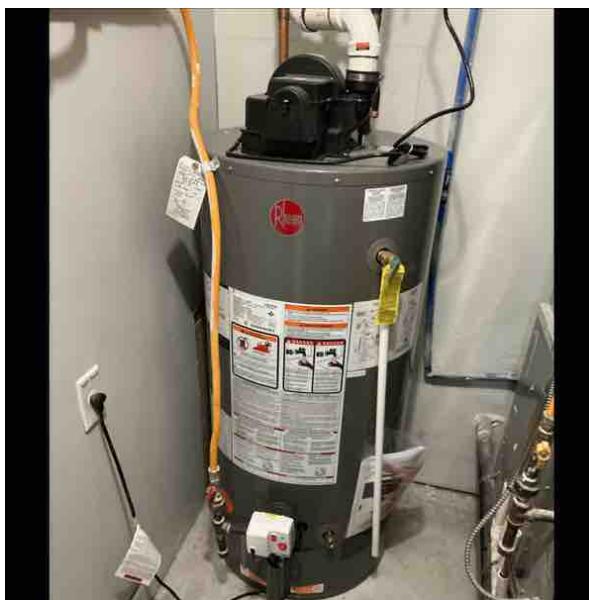
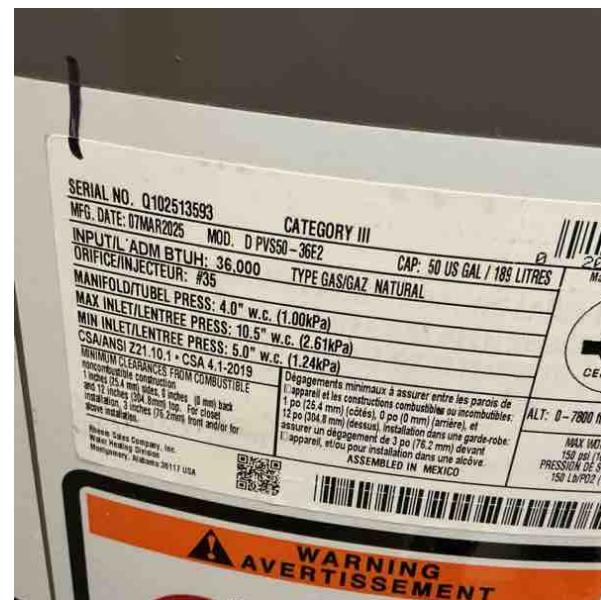
9.5 Water Heating Equipment

- Fuel source is natural gas.
- 50 Gallon

9.5.1 The water heating equipment was inspected and no significant deficiencies were observed.

9.5.2 2025 Rheem water heater

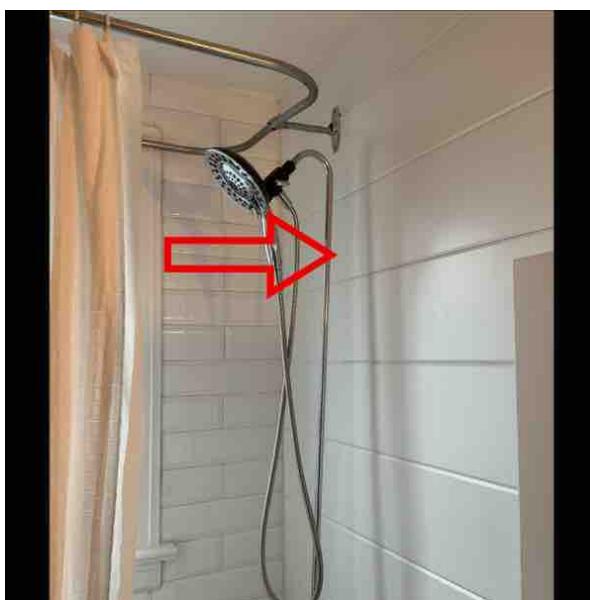
9.10 **Tub(s) / Shower(s)**

9.10.2 **Secure the waterline to the showerhead for safety. Contact a qualified contractor.**

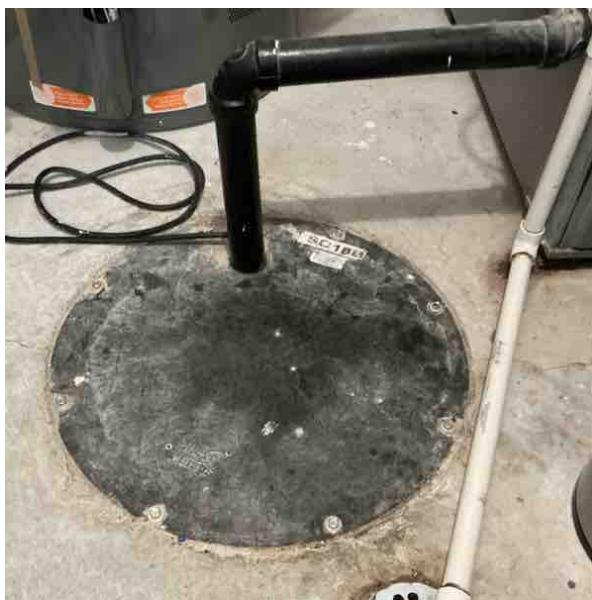
**9.12 Sump Pump**

9.12.1 Sealed shut unable to inspect
