# Uniform Mitigation Verification Inspection Form

| Owner Name: David Gansky | | Contact Person: |
| Address: 3502 Washington Rd. | | Home Phone: |

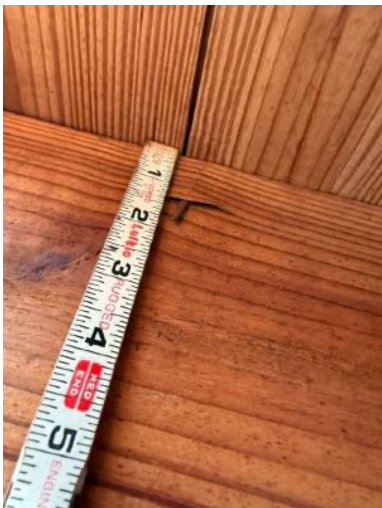
- ☒ C. Plywood/OSB roof sheathing with a minimum thickness of 7/16" inch attached to the roof truss/rafter (spaced a maximum of 24" inches o.c.) by 8d common nails spaced a maximum of 6" inches in the field. -OR- Dimensional lumber/Tongue & Groove decking with a minimum of 2 nails per board (or 1 nail per board if each board is equal to or less than 6 inches in width). -OR-

Roof deck fastener

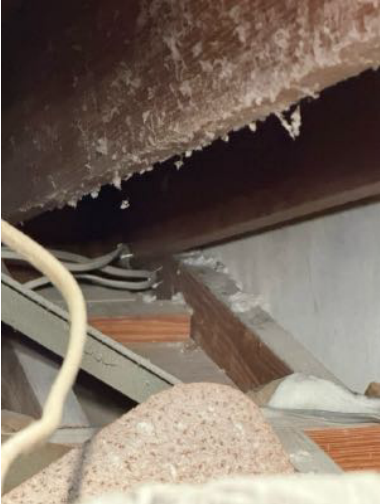
- ☒ A. Toe Nails
  - ☒ Truss/rafter anchored to top plate of wall using nails driven at an angle through the truss/rafter and attached to the top plate of the wall, or
  - ☐ Metal connectors that do not meet the minimal conditions or requirements of B, C, or D

Toenail

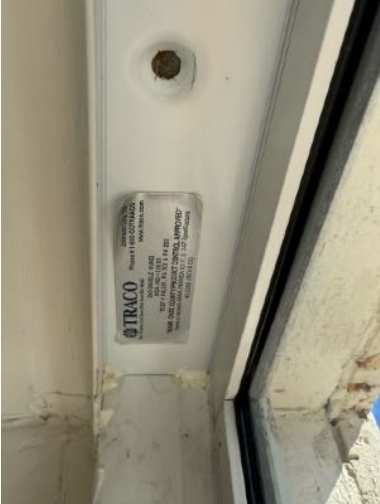
| Opening Protection Level Chart<br>Place an "X" in each row to identify all forms of protection in use for each opening type. Check only one answer below (A thru X), based on the weakest form of protection (lowest row) for any of the Glazed openings and indicate the weakest form of protection (lowest row) for Non-Glazed openings. | | Glazed Openings | | | | Non-Glazed Openings | |
|---|---|---|---|---|---|---|---|
| X | No Windborne Debris Protection | X | | X | | X | X |

Glazed label
