## SELLER'S DISCLOSURE NOTICE

CONCERNING THE PROPERTY AT **4707 Reyes St #2, Austin, Texas 78721**

TREC REI 7-6

4707 Reyes St 2  
Austin, TX 78721

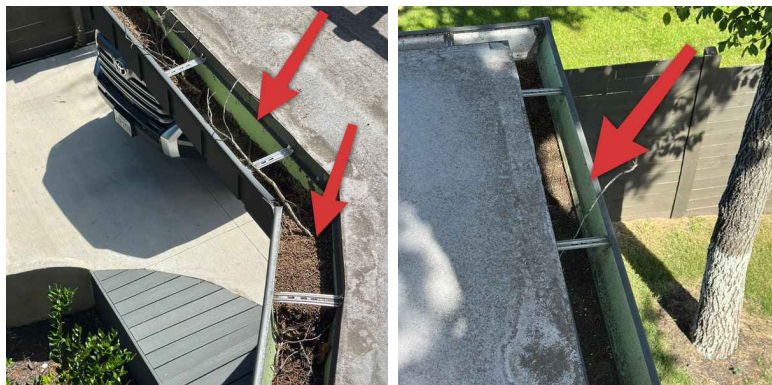
#### **1: Down Spouts and rain gutters - materials and debris found inside of the rain gutters.**

There were materials and debris found inside of the rain gutters. This can block the flow of the water draining in the gutters, or block the drain. Gutters should be free and clear of debris and materials.

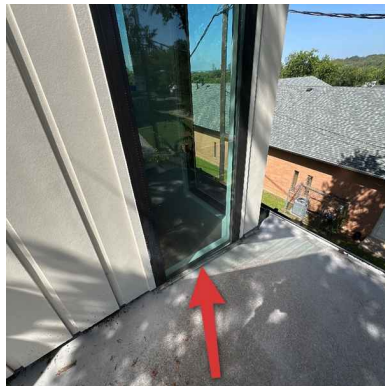
**2: Flashing - missing headwall flashing-Repaired, See Photo**

Headwall flashing is located where the roof to wall intersection is located directly in front of a wall. At this location there was one more areas that was missing headwall flashing. This can allow moisture to intrude into the structure. This location is required to have flashing.

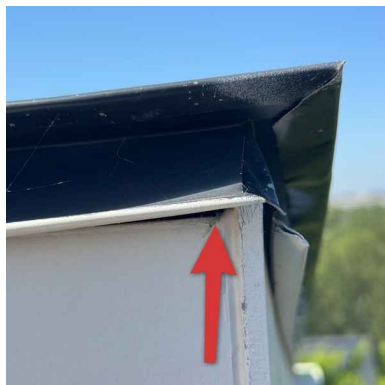
**3: Drip edge flashing - Not overlapping wall-Repaired, See Photo**

The drip edge flashing should lap over the top of the wall. There were areas that were not overlapped. These areas can allow moisture to enter between the roof and the wall.

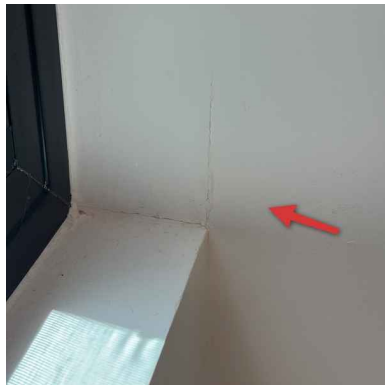
## 2: Interior wall - crack / cracks present

There were wallboard cracks present at interior corners and the wall ceiling intersection.

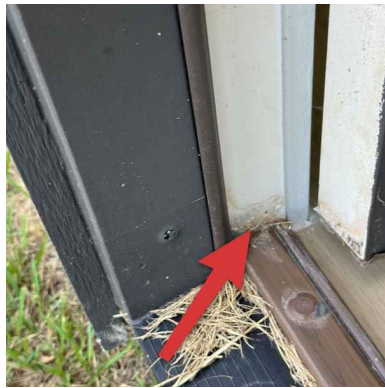
**2: Exterior door jam and door had signs weathered wood**

Exterior door jam and door had signs of weathered wood. This can be a sign that the door does not seal properly and is allowing water intrusion.

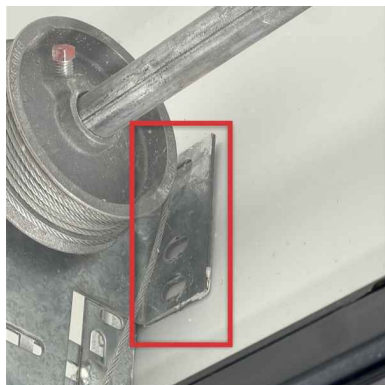
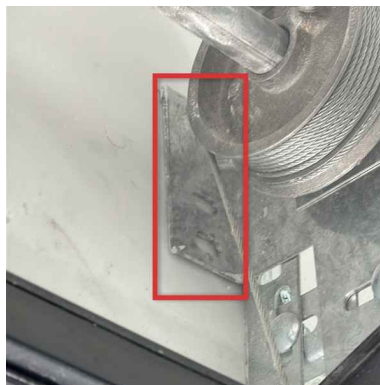
**3: Garage door - missing fasteners - Spring bracket**

The garage door spring brackets were missing fasteners. The spring is under tension and should be secured to the structure.

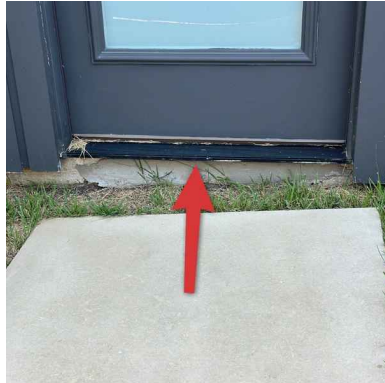
**4: Pan flashing - missing**

Pan flashings should be installed between the foundation or sub floor and the door frame threshold. This is a code requirement.

**Per the builder, these are installed with liquid flashing, they don't install them with sill pans.**

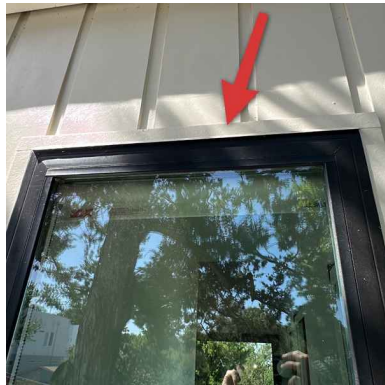
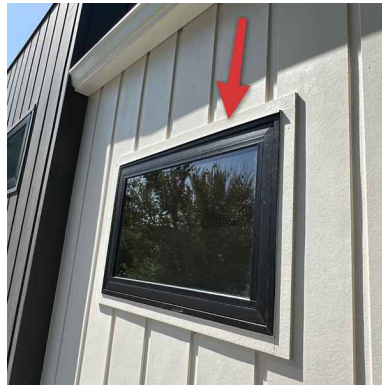
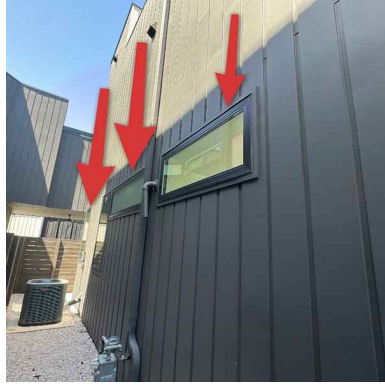
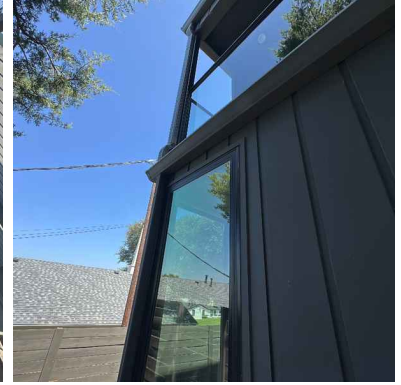
Top of window trim

**1: Flashing - missing above window frame trim**

Missing flashing at exterior walls where there is continuous horizontal wood trim or cement board trim that is installed passed the water table / vapor barrier in areas such as above window frames, door jambs, and garage header trim. Flashing above siding trim should be used to prevent weather damage such as wind driven rain to the trim, siding, window openings, and or door openings on wood products and or cement boards. See siding or trim manufacture specifications. There are No exceptions for under porches or below soffits.

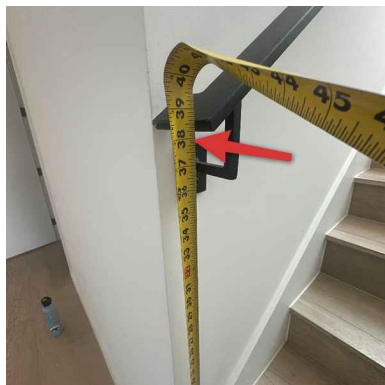
**2: Handrails - greater than 38 inches in height**

The handrail height was greater than 38 inches in height. Hand rails are measured vertically from the sloped plane adjoining the tread nosing, or the surface of the ramp slope. The height shall be not less than 34 inches and not greater than 38 inches.

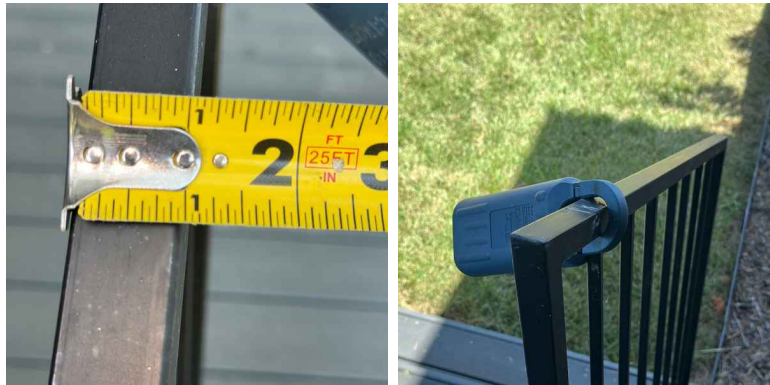
### 3: Handrails - did not meet the handrail code

The guardrail did not meet the handrail code. Type 1 handrail shall be a minimum of 1 1/4 inches not greater than 2 inches. If the handrail is not circular, it shall have a perimeter dimension of not less than 4 inches and not greater than 6 1/4 inches with a cross section of dimension of not more than 2 1/4 inches. Edges shall have radius of not less than .01 inch.

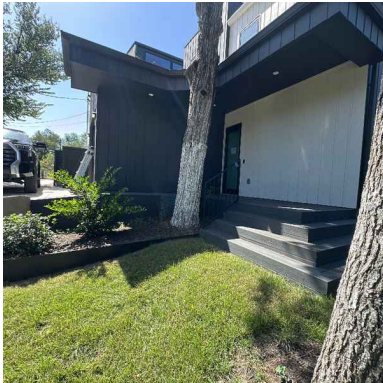
*Deck frame not accessible :*  
There was skirting around the exterior of the deck that prevented entry to inspect underneath the deck. The deck could not be inspected to the standards of practice. The deck was visually inspected from the exterior looking through the skirting.

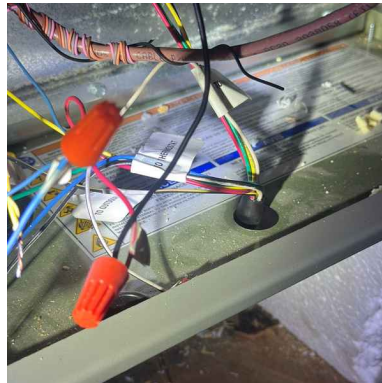
#### **1: Furnace sealed unit - nonventilated attic space - openings in furnace cabinet-See Repair Receipt**

The attic space was nonventilated. There was an open flame inside of the furnace. There were many holes, allowing combustion air to escape outside of the furnace cabinet into nonventilated attic. space. This can be considered a hazard. The furnace cabinet should be sealed. I recommend further evaluation from the builders HVAC contractor.

- **ITEM #4.1:** SEALED OFF FURNACE CABINET OPENINGS.
- **ITEM #4.2.1:** ADDED P TRAP WITH CLEANING PORT AT START OF CONDENSATION DRAIN.
- **ITEM #4.2.3:** SEALED REFRIGERANT PIPING COVER IN INDOOR UNIT.
- **ITEM #4.3.3:** FRESH AIR INTAKE HOUSING INSTALLED PROPERLY TO ALLOW COVER TO OPEN FREELY.

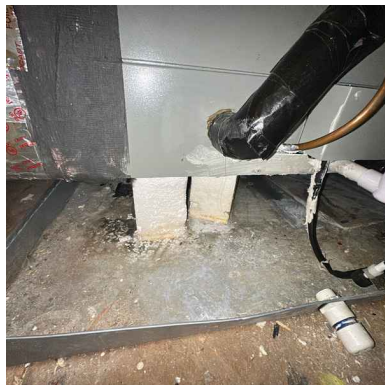
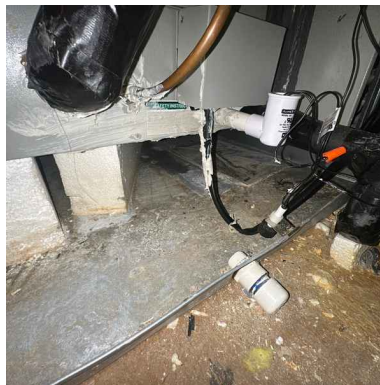
*Auxiliary drain pan - Signs of previous leaks:*

There were signs of previous leaks inside the auxiliary drain pan. I would recommend further evaluation of all air conditioning systems with signs of previous leaks in the auxiliary drain pan, by a licensed HVAC contractor in the state of Texas

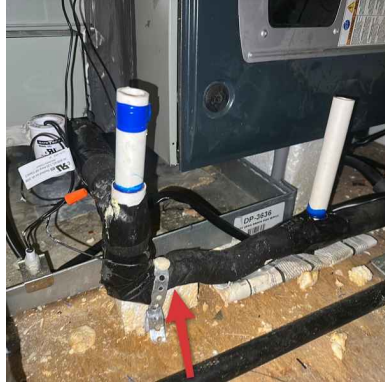
### **1: Condensation Drain - missing P-Trap-See Repair Receipt**

The condensation drain was not plumbed to today's building standard. The condensation drain terminates above a sink drain P-trap. When this occurs there should be a P-trap added with a cleaning port to the beginning of the condensation drain at the air handling unit

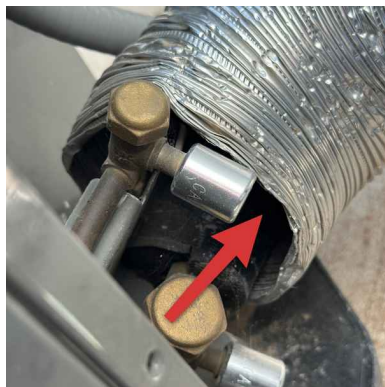
## 3: Refrigerant piping cover - open end-See Repair Receipt

The end of the refrigerant piping cover should be sealed.

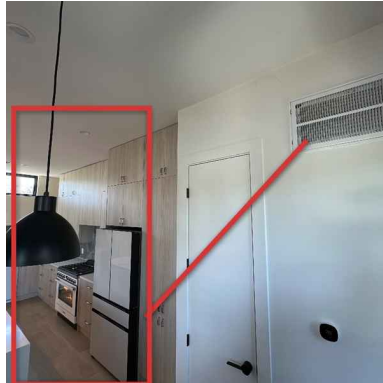
## **2: Return air-taken from kitchen-Per Builder & HVAC Contractor, Not Necessary. Passed City of Austin Inspection.**

Return air should not be taken from the kitchen. This is an prohibited location to pull return air for the air conditioning system. This code can be found in chapter 16 under return air. The code does not disclose a return register location. It stated that return air can not be taken from a kitchen. The return register was close enough to the kitchen that it will draw air from the kitchen. For that reason this is a deficiency.

1. Taking return air from a kitchen is not prohibited where such return air openings serve the kitchen only, and are located not less than 10 feet (3048 mm) from the cooking appliances.
2. Dedicated forced-air systems serving only the garage shall not be prohibited from obtaining return air from the garage. 5. For other than dedicated HVAC systems, return a

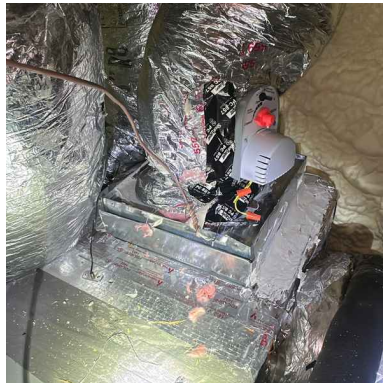
**3: Fresh air intake filter housing cover - not opening-Per HVAC Contractor housing cover is opening.**  
The cover did not open. This should be accessible to change out filters.

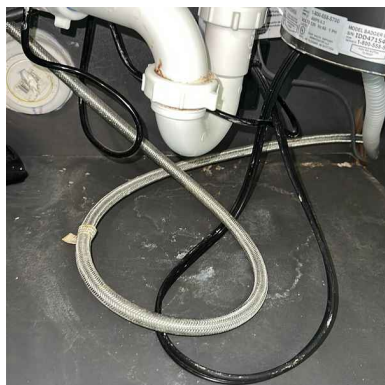
*Previous leaks found - sink drain piping:*

There were previous signs of leaks underneath one or more plumbing drain in the cabinet below. The bottom of the cabinet appeared to have moisture damage.

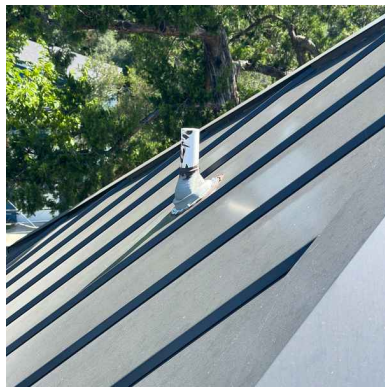
**1: Vents - exposed vents above roof missing uv protection-Repaired, See Photo**

The PVC vent that were exposed above the roof we're missing a UV protection. Schedule 40 PVC cannot be exposed to sunlight. Sunlight can damage the PVC overtime.

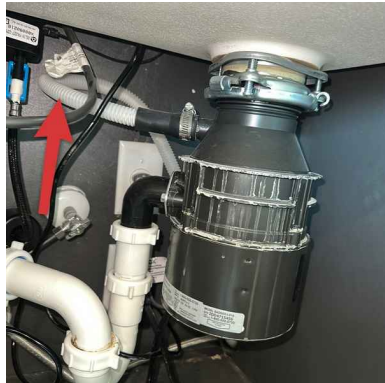
#### 1: Dishwasher drain hose - missing high loop-**Repaired, See Photo**

Dishwasher is missing back flow prevention called a high loop. The loop should be installed above the dishwasher drain line to the sink connection. The drain line should be tied up underneath the sink a minimum of 1 inch above the drain connection point.

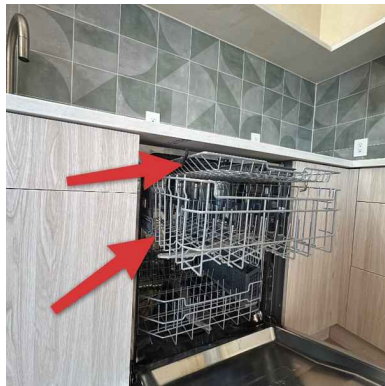
#### 3: Shelves squeaked and did not slide open and closed very easily

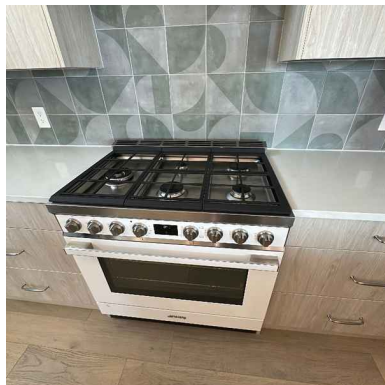
**1: Range - missing anti tip device**

Missing anti tip device. An anti tip device is a bracket used for the range cleat / foot to prevent the range from tipping over.

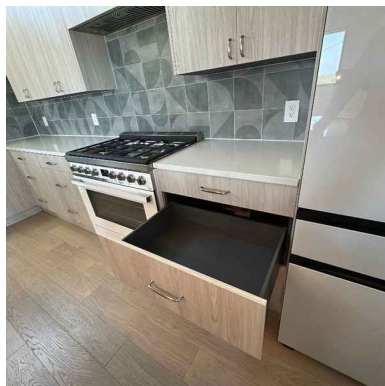
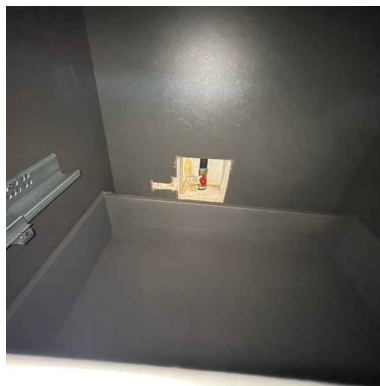
**3: Cooktop gas valve - behind drawer - not accessible**

The gas valve has to be accessible within 6 feet of the cooktop. If the drawer is easily removable and completely accessible, the gas valve, then it can be considered accessible.
