Residential Building Inspection Report

121 Drake Drive, Pine Township, PA 15090

Inspection Date:
4/1/2026

Report Number:
0401260104CN

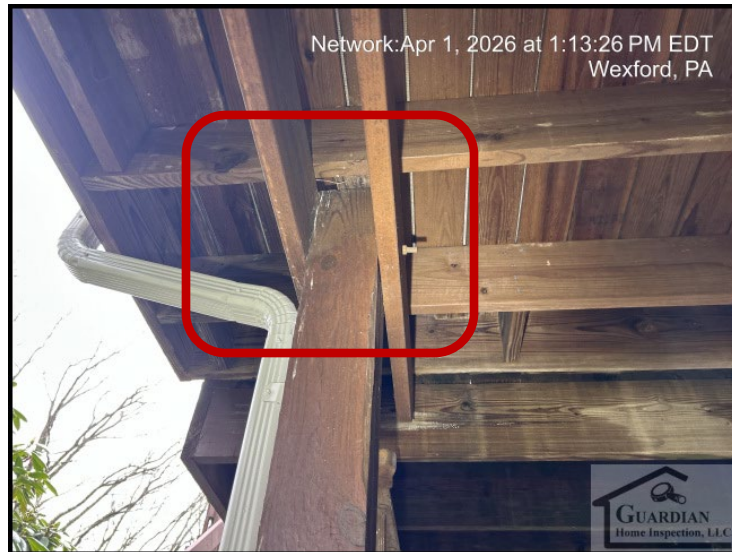
Figure 1 The vertical support posts, on the rear exterior decking, have been poorly connected to the connecting horizontal double header beams

- **Improve:** The vertical support posts, on the rear exterior decking, have been poorly connected to the connecting horizontal double header beams (see photo). Generally, the vertical support post is partially notched (for the double header beam to sit inside) and through-bolts be installed at the connection. Consult a qualified decking contractor for further evaluation and improvement options.
- **Improve:** Several of the securing hardware (screws), supporting the vertical balusters on the rear deck, are significantly rusted. Consult a qualified decking contractor for more information.
- **Improve:** The vertical balusters have not been properly cut at angles to shed water. The end-grain of vertical posts and balusters should be cut at an angle.

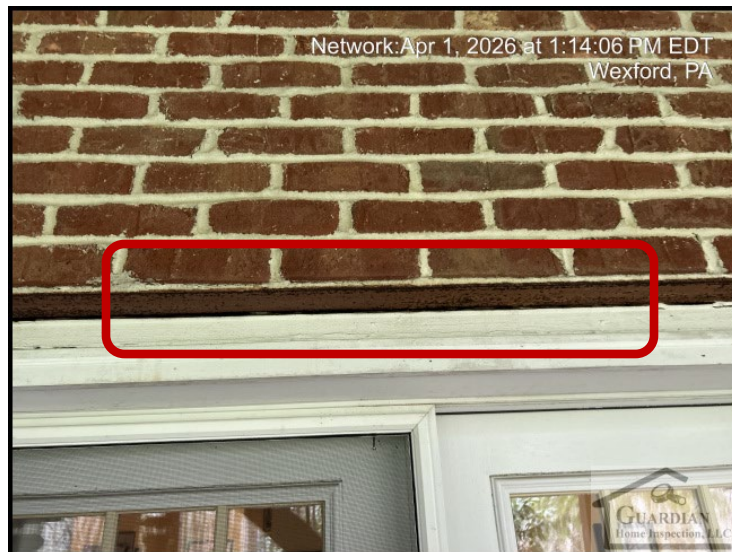
Figure 2 Several of the steel lintels, installed to support brick above door or window openings, are beginning to rust

- **Improve:** Several of the steel lintels, installed to support brick above door or window openings, are beginning to rust. This condition has the potential adversely affect the wall structure in these areas due to expansion. Cracking along the mortar joints will occur unless this condition is improved. The lintels should be painted with a rust-inhibiting paint and caulked annually.

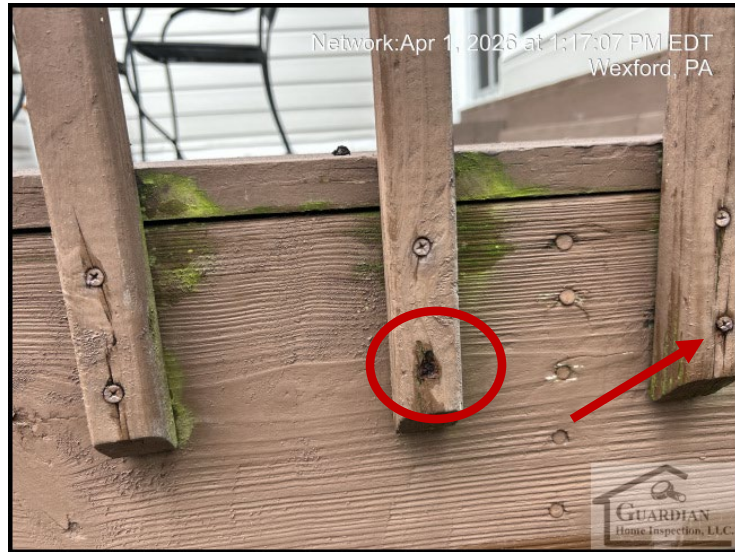
Figure 3 Several of the securing hardware (screws), supporting the vertical balusters on the rear deck, are significantly rusted.

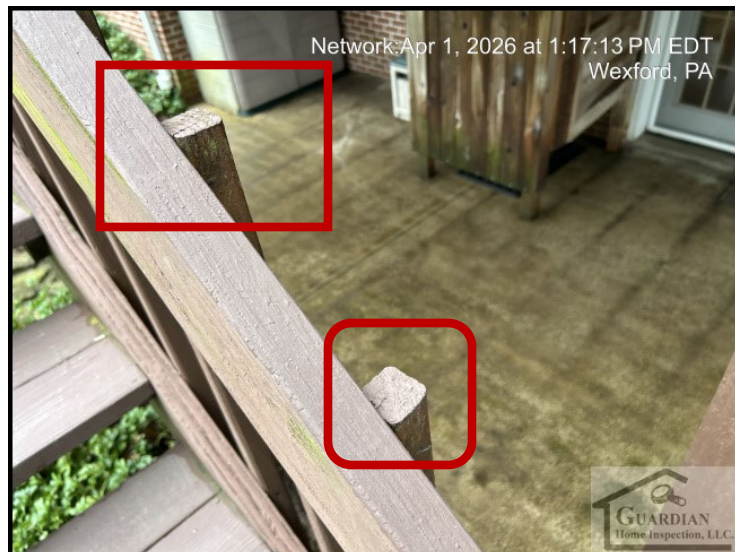
Figure 4 The vertical balusters have not been properly cut at angles to shed water.

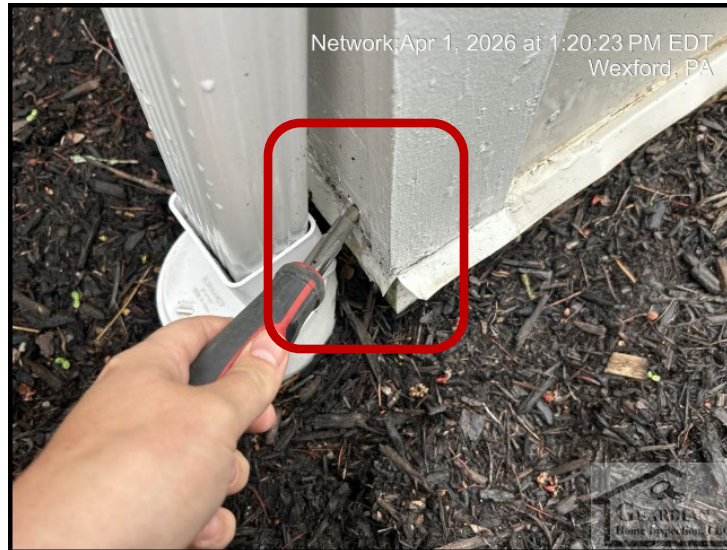
Figure 5 An area of moderately rotted siding, along the front facing exterior wall, was noted.

- **General Repair Item:** An area of moderately rotted siding, along the front facing exterior wall, was noted. A qualified siding installation contractor should repair as needed.

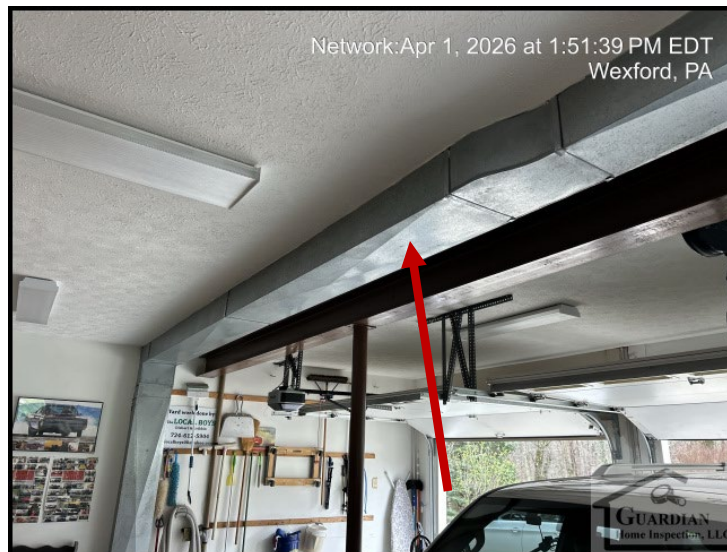
Figure 6 The supply ductwork in the garage should be insulated to prevent unnecessary heat/cooling loss.

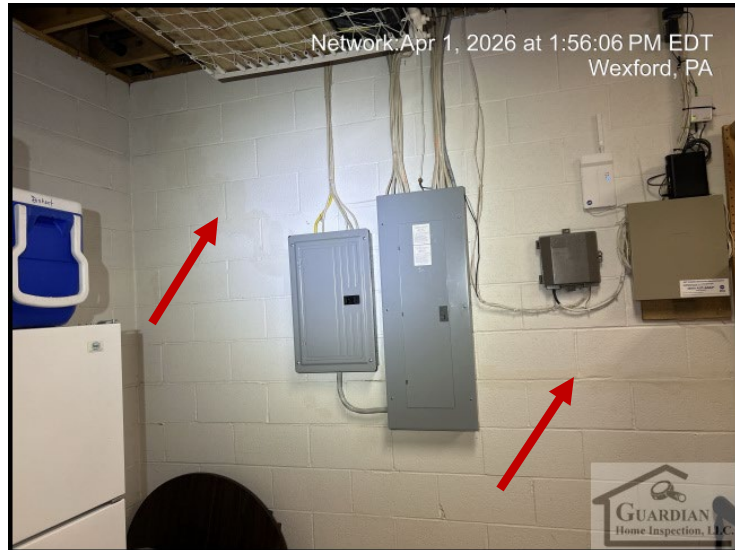
Figure 7 A limited amount of past repairs & horizontal and step cracking was observed along left facing block foundation wall.

- **Monitor:** A limited amount of past repairs & horizontal and step cracking was observed along left facing block foundation wall. The nature and location of the crack implies that some hydrostatic pressure from behind the wall exists or existed in the past. The amount of movement which has occurred has not caused any visible damage to the structure; however, the effected wall should be closely monitored and the conditions responsible for the cracking (exterior grading & gutters) should be corrected (see also Exterior Section). If left uncorrected, additional movement may occur leading to more costly repairs. The rate of movement cannot be predicted during a one-time inspection.

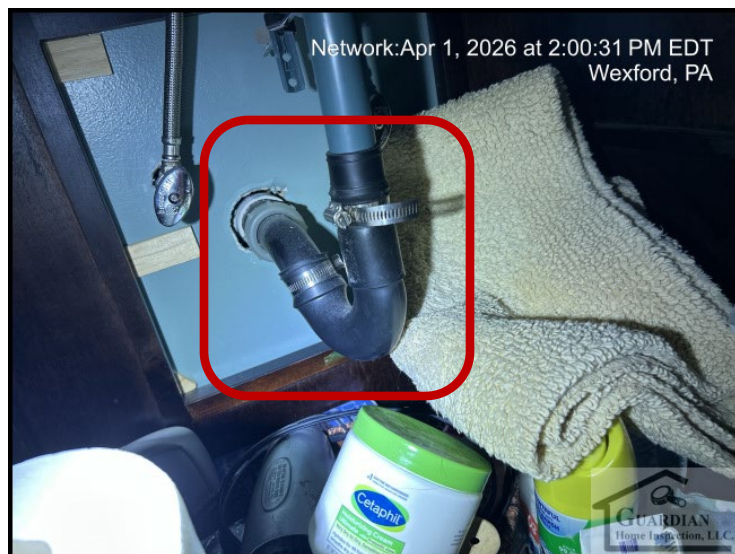
Figure 8 The rubber flex piping, under the basement bathroom sink, should be replaced with more common PVC piping.

- **Improve:** The rubber flex piping, under the basement bathroom sink, should be replaced with more common PVC piping. While flex piping may not cause any issues, the trap may accumulate hair, debris, and soap scum, opposed to a smoother self-cleaning PVC pipe. In addition, PVC piping is much more rigid and can handle more impact if stored items were to hit the drain pipe. A qualified plumber can provide improvements.

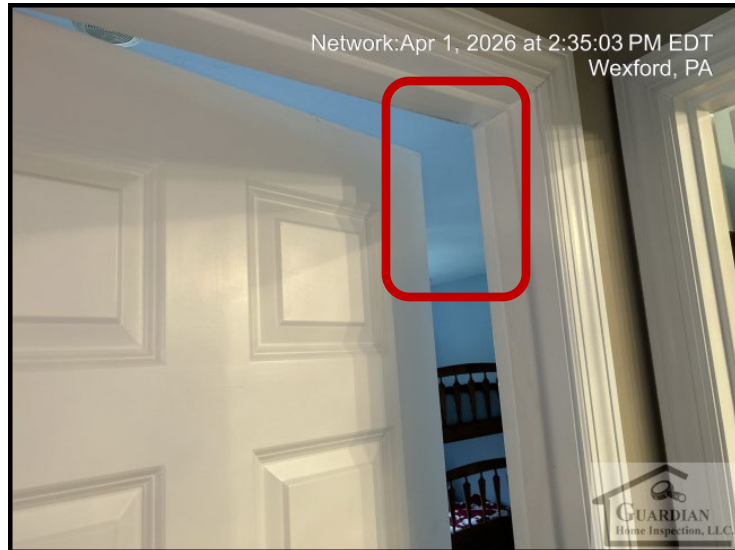
Figure 9 The 2nd floor bedroom door does not open/close smoothly and should be trimmed or adjusted as necessary.

- **General Repair Item:** The 2nd floor bedroom door does not open/close smoothly and should be trimmed or adjusted as necessary.

- **General Repair Item:** The 2nd floor rear right facing bedroom door does not open/close smoothly and should be trimmed or adjusted as necessary.

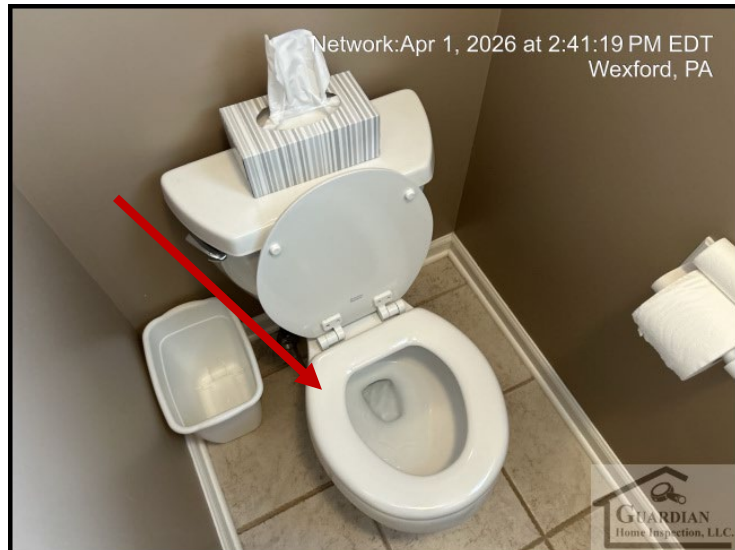
Figure 10 The toilet, in the 2nd floor primary bathroom, is loose from the floor.

- **General Repair Item:** The toilet, in the 2nd floor primary bathroom, is loose from the floor. A moderate tightening of the bolts will usually eliminate all movement; however, loose toilet fixtures often conceal leakage at the seal. If the subfloor is constructed of wood, moisture seepage at the seal can result in serious damage to wood members. To ensure against fungus and dry rot repairs, replacement of the wax seal and inspection of the connecting flange is recommended when repairing loose toilets. A qualified plumber should repair as needed.

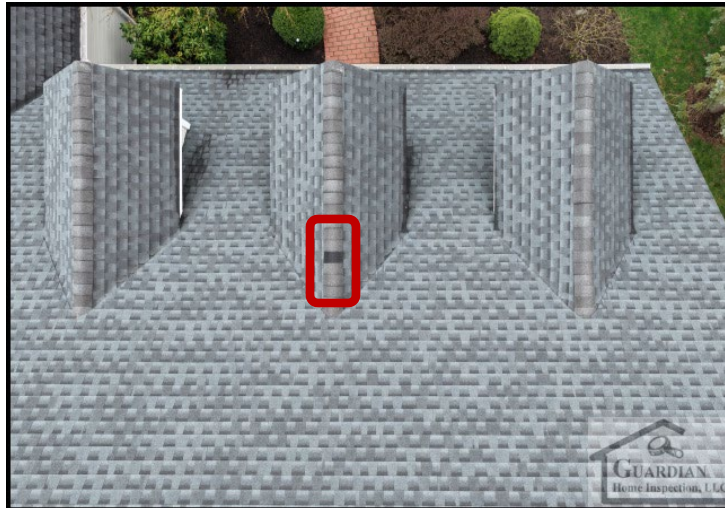
Figure 11 An asphalt shingle, along the front slope of the roof (cap shingle), is missing and should be replaced.

- **General Repair Item:** An asphalt shingle, along the front slope of the roof (cap shingle), is missing and should be replaced. If left uncorrected this area will be prone to leakage. Repairs should be performed by a qualified roofing contractor.

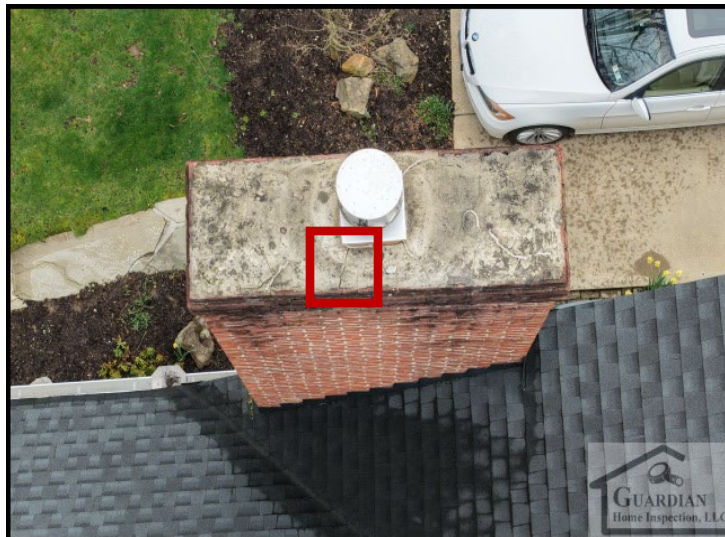
Figure 12 The masonry crown, on the chimney, is cracked.

- **General Repair Item:** The masonry crown, on the chimney, is cracked. This is a common condition in colder climates where freeze-thaw cycles are prevalent. The chimney crown serves two purposes. First, it seals the area between the chimney flue and the masonry structure, preventing rain water from running down the outside of the flue within the chimney. Second, the crown generally extends beyond the masonry structure so that the water drips off the edge, rather than wicking into the brick or block work. The chimney crown, which is usually made of poured concrete, should be pitched downward, and away from the chimney flue. Consult a qualified mason for improvements.
