# Residential Building Inspection Report

**4677 Bayard St, Pittsburgh, PA 15213**

**Inspection Date:**  
2026-06-11

**Report Number:**  
0611260104CN

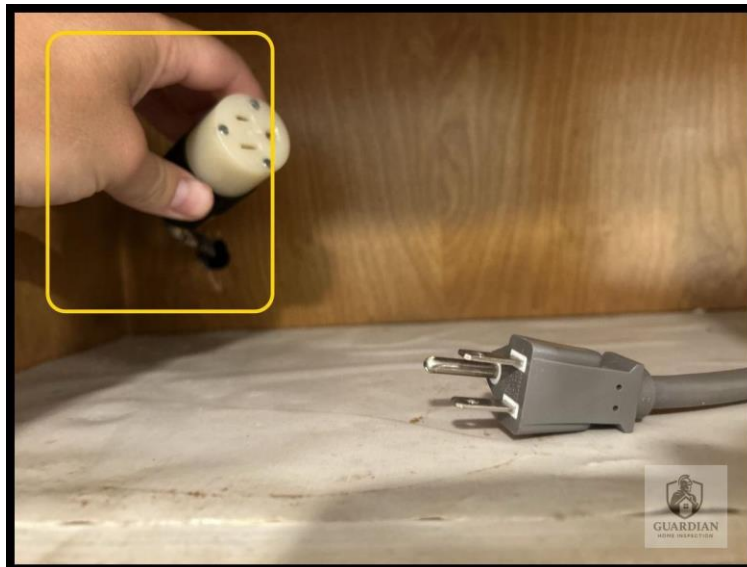
**Safety Concern:** In the kitchen, NM (Romex) cable was observed spliced directly into an extension-cord style plug serving the microwave, which is an improper use of permanent wiring and indicates a noncompliant cord connection. This condition can create shock and fire hazards due to inadequate strain relief, improper terminations, and lack of approved junction/connection methods. Have the wiring corrected by removing the improper splice and installing a proper, code-compliant permanent receptacle/circuit connection for the microwave as needed. Repairs should be performed by a Licensed Electrician. (Figure [1](#))

**Figure 1: In the kitchen, NM (Romex) cable was observed spliced directly into an extension-cord style plug serving the microwave, which is an improper use of permanent wiring and indicates a noncompliant cord connection.**

**Safety Concern:** In the kitchen, NM (Romex) cable was observed spliced directly into an extension-cord style plug serving the microwave, which is an improper use of permanent wiring and indicates a noncompliant cord connection. This condition can create shock and fire hazards due to inadequate strain relief, improper terminations, and lack of approved junction/connection methods. Have the wiring corrected by removing the improper splice and installing a proper, code-compliant permanent receptacle/circuit connection for the microwave as needed. Repairs should be performed by a Licensed Electrician. (Figure [1](#))

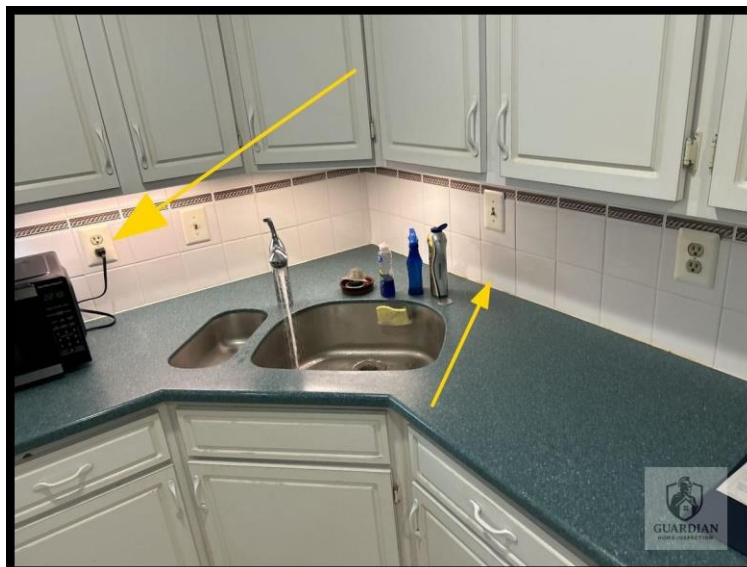
**Safety Concern:** Kitchen countertop receptacles were observed without GFCI protection. This is a safety concern because countertop outlets in kitchens are prone to shock hazards due to proximity to water sources. Have GFCI protection added (via GFCI receptacles and/or a GFCI breaker as appropriate) and verify proper operation. Repairs should be performed by a Licensed Electrician. (Figure [2](#))

**Figure 2: Kitchen countertop receptacles were observed without GFCI protection.**

**Safety Concern:** Kitchen countertop receptacles were observed without GFCI protection. This is a safety concern because countertop outlets in kitchens are prone to shock hazards due to proximity to water sources. Have GFCI protection added (via GFCI receptacles and/or a GFCI breaker as appropriate) and verify proper operation. Repairs should be performed by a Licensed Electrician. (Figure [2](#))

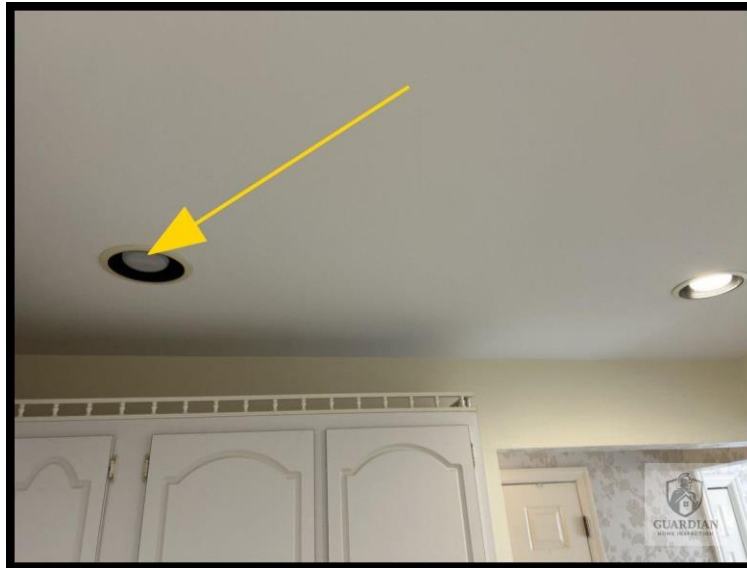
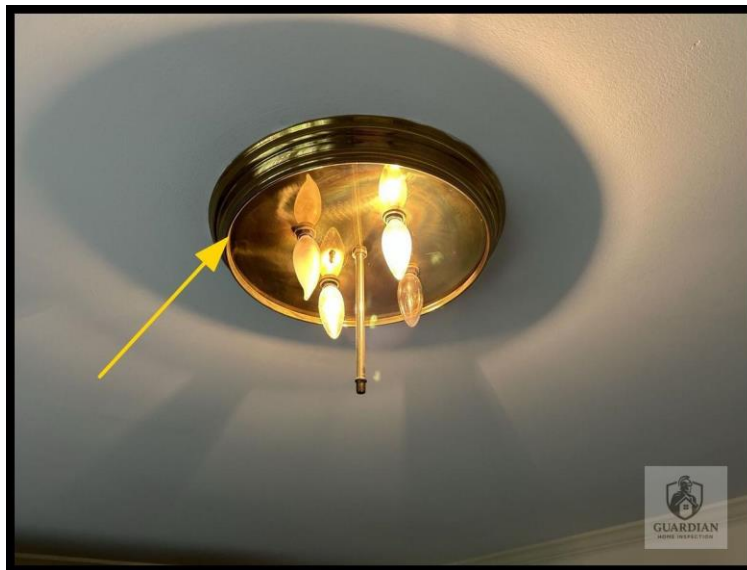
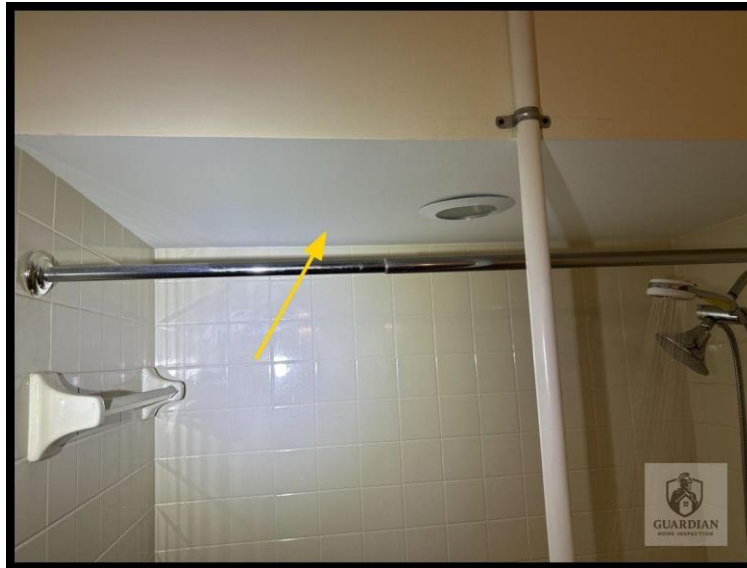
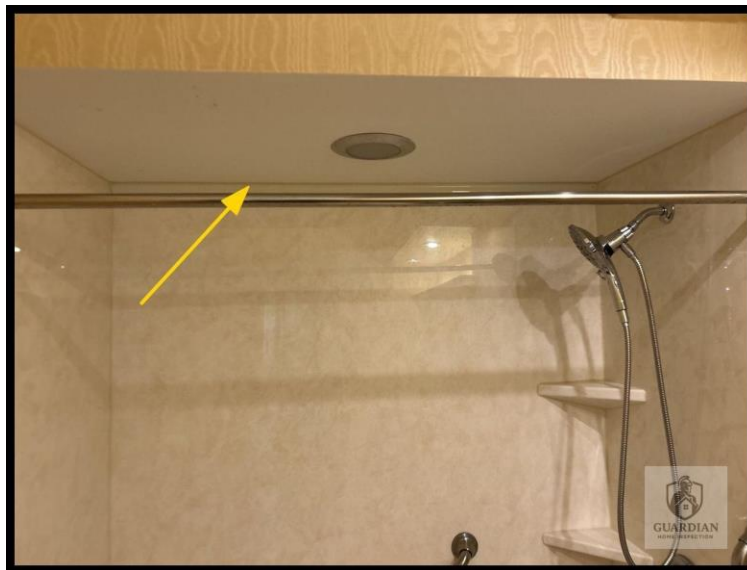
**General Repair:** Several light bulbs were observed to be blown/non-functional at light fixtures in the living room, bathroom, and kitchen. Inoperative lamps reduce lighting levels and can indicate a maintenance issue that should be corrected for safe use of the spaces. Replace the failed bulbs with new bulbs of the correct type and wattage rating for each fixture; if any fixture remains inoperative after bulb replacement, have the circuit and fixture evaluated and repaired. Repairs and any needed troubleshooting beyond bulb replacement should be performed by a licensed electrician. (Figures [3](#), [4](#), [5](#), [6](#))

**Figure 3: Several light bulbs were observed to be blown/non-functional at light fixtures in the living room, bathroom, and kitchen.**

**Figure 4: Several light bulbs were observed to be blown/non-functional at light fixtures in the living room, bathroom, and kitchen.**

**Figure 5: Several light bulbs were observed to be blown/non-functional at light fixtures in the living room, bathroom, and kitchen.**

**Figure 6: Several light bulbs were observed to be blown/non-functional at light fixtures in the living room, bathroom, and kitchen.**

**General Repair:** Several light bulbs were observed to be blown/non-functional at light fixtures in the living room, bathroom, and kitchen. Inoperative lamps reduce lighting levels and can indicate a maintenance issue that should be corrected for safe use of the spaces. Replace the failed bulbs with new bulbs of the correct type and wattage rating for each fixture; if any fixture remains inoperative after bulb replacement, have the

circuit and fixture evaluated and repaired. Repairs and any needed troubleshooting beyond bulb replacement should be performed by a licensed electrician. (Figures [3](#), [4](#), [5](#), [6](#))

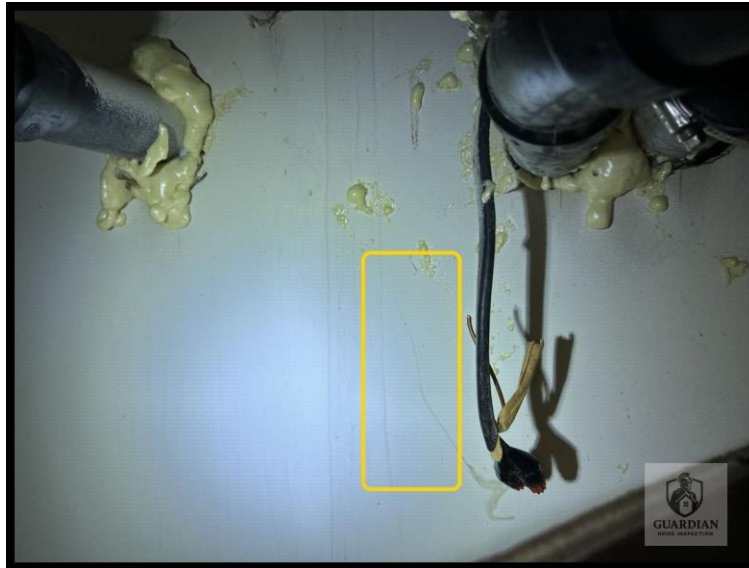
**General Repair:** In the kitchen, abandoned electrical wiring reportedly for a waste disposal was observed hanging loose and not properly terminated within an approved junction box. Exposed or improperly terminated conductors can present shock, arcing, and fire hazards. The wiring should be de-energized as needed, properly capped with wire connectors, and enclosed in a covered electrical junction box or removed if no longer required. Have a Licensed Electrician perform the correction. (Figure [7](#))

**Figure 7: In the kitchen, abandoned electrical wiring reportedly for a waste disposal was observed hanging loose and not properly terminated within an approved junction box.**

**General Repair:** In the kitchen, abandoned electrical wiring reportedly for a waste disposal was observed hanging loose and not properly terminated within an approved junction box. Exposed or improperly terminated conductors can present shock, arcing, and fire hazards. The wiring should be de-energized as needed, properly capped with wire connectors, and enclosed in a covered electrical junction box or removed if no longer required. Have a Licensed Electrician perform the correction. (Figure [7](#))

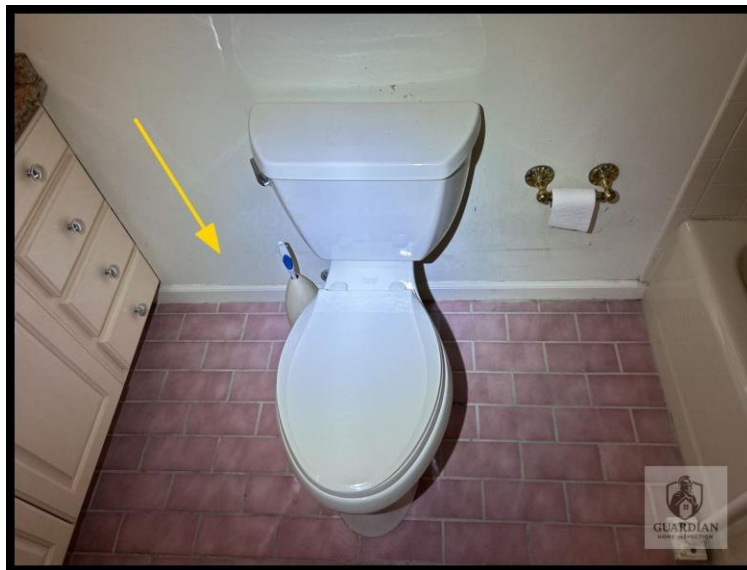
**General Repair:** The toilets observed in the bathrooms were loose at the floor attachment. Loose toilets can compromise the wax ring seal and allow leakage that may damage flooring and subflooring and contribute to unsanitary conditions. Have the toilets reset and properly secured to the flange, and replace the wax ring and any damaged flange/hardware as needed. Repairs should be performed by a Licensed Plumber. (Figures [10, 11](#))

**Figure 10: The toilets observed in the bathrooms were loose at the floor attachment.**

**Figure 11: The toilets observed in the bathrooms were loose at the floor attachment.**

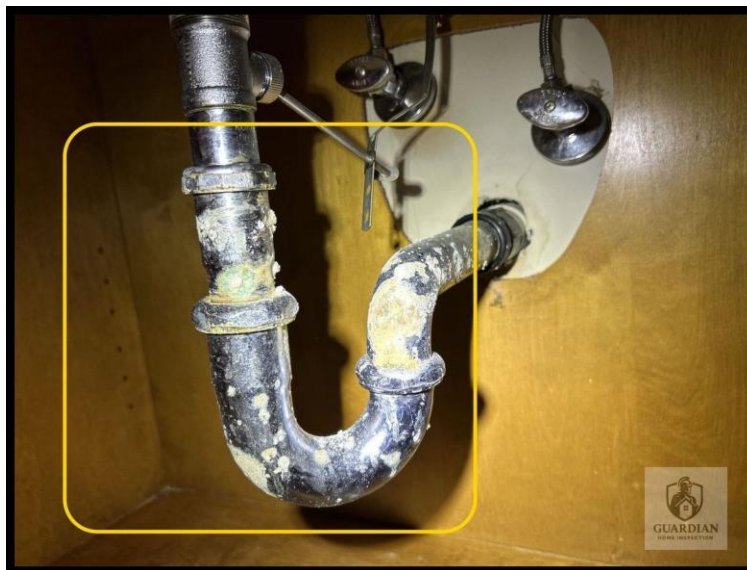
**General Repair:** The drain piping (P-trap assembly) under the hallway bathroom sink was observed to be severely pitted/corroded. This condition can weaken the pipe and lead to leaks and water damage within the cabinet and surrounding finishes. Replace the affected drain piping promptly and verify the repaired assembly is watertight. Repairs should be performed by a licensed plumber. (Figure [12](#))

**Figure 12: The drain piping (P-trap assembly) under the hallway bathroom sink was observed to be severely pitted/corroded.**

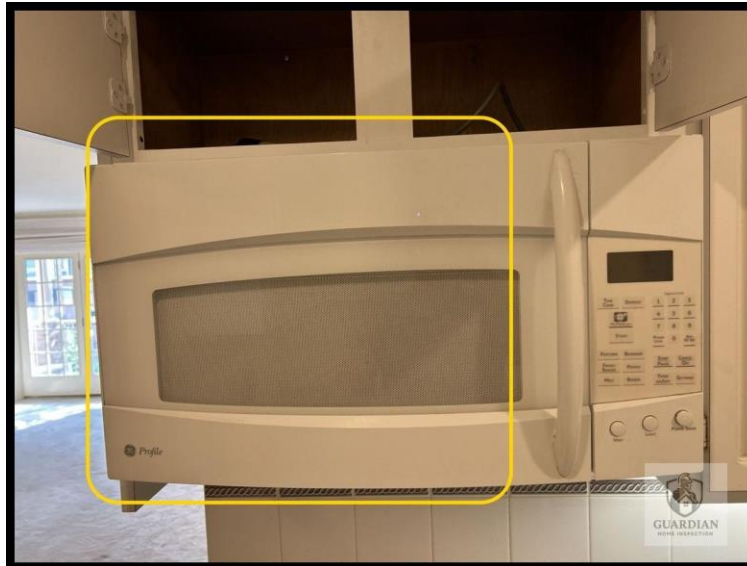
**General Repair:** The over-the-range microwave in the kitchen appeared to be inoperable at the time of inspection. An inoperative microwave may indicate an electrical supply issue or an internal appliance failure

**Figure 15: The over-the-range microwave in the kitchen appeared to be inoperable at the time of inspection.**

and should be corrected to ensure safe, reliable operation. Have the unit and its power supply/connection evaluated and repair or replace the microwave as needed. Repairs should be performed by a qualified appliance service technician (and a licensed electrician if a wiring or receptacle issue is found). (Figure [15](#))

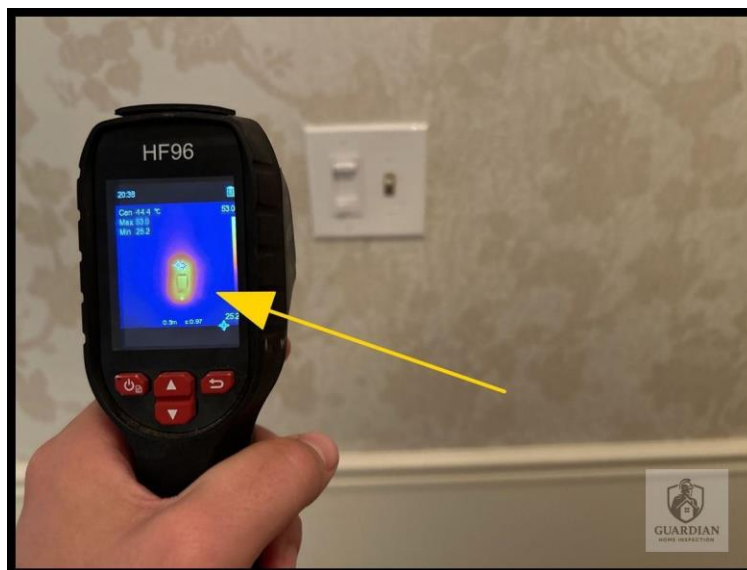
**Investigate:** The dining room chandelier dimmer switch exhibited evidence of overheating when evaluated with a thermal camera. Overheating at a switch can indicate an overloaded/incorrectly rated device, loose connections, or internal failure, which presents a potential fire and shock hazard. The dimmer and associated wiring should be evaluated and repaired or replaced as needed, and the chandelier load verified to be compatible with the dimmer rating. Have this work performed by a Licensed Electrician. (Figure [16](#))

**Figure 16: The dining room chandelier dimmer switch exhibited evidence of overheating when evaluated with a thermal camera.**

**Investigate:** The dining room chandelier dimmer switch exhibited evidence of overheating when evaluated with a thermal camera. Overheating at a switch can indicate an overloaded/incorrectly rated device, loose connections, or internal failure, which presents a potential fire and shock hazard. The dimmer and associated wiring should be evaluated and repaired or replaced as needed, and the chandelier load verified to be compatible with the dimmer rating. Have this work performed by a Licensed Electrician. (Figure [16](#))

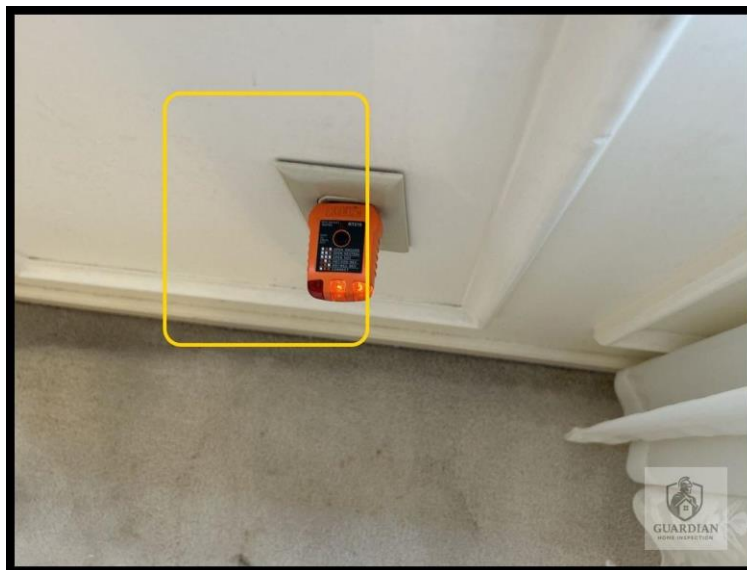
**Improve:** Several electrical outlets were observed to be loose from the wall in the Bedroom and Kitchen; the pictured receptacle plate appears not securely seated/flush to the wall surface. Loose receptacles can allow wiring terminals to loosen and increase the risk of arcing, shock, or damage during use. Have the affected outlets properly secured to the electrical boxes and repaired as needed (e.g., add proper box extenders/shims, tighten mounting, and verify wiring terminations). Repairs should be performed by a Licensed Electrician. (Figure [20](#))

**Figure 20: Several electrical outlets were observed to be loose from the wall in the Bedroom and Kitchen; the pictured receptacle plate appears not securely seated/flush to the wall surface.**

**Improve:** Several electrical outlets were observed to be loose from the wall in the Bedroom and Kitchen; the pictured receptacle plate appears not securely seated/flush to the wall surface. Loose receptacles can allow wiring terminals to loosen and increase the risk of arcing, shock, or damage during use. Have the affected outlets properly secured to the electrical boxes and repaired as needed (e.g., add proper box extenders/shims, tighten mounting, and verify wiring terminations). Repairs should be performed by a Licensed Electrician. (Figure [20](#))

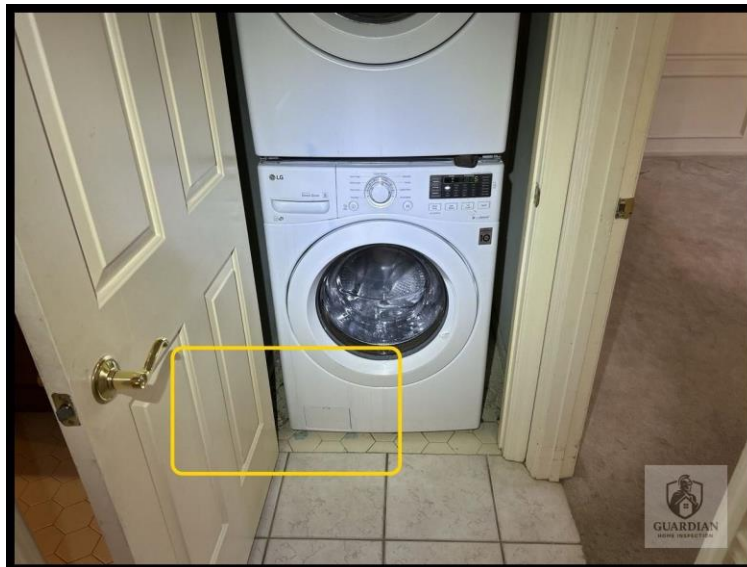
**Improve:** A catch pan was not observed under the clothes washer in the laundry room. Without a pan, leaks or hose failures can allow water to spread into adjacent finishes and flooring, increasing the risk of property damage and mold conditions. Install an appropriately sized washer drain pan (and route the pan drain to an approved discharge point where feasible) to help contain and direct incidental leakage. Have a qualified plumber install the pan and any associated drain piping. (Figure [22](#))

**Figure 22: A catch pan was not observed under the clothes washer in the laundry room.**

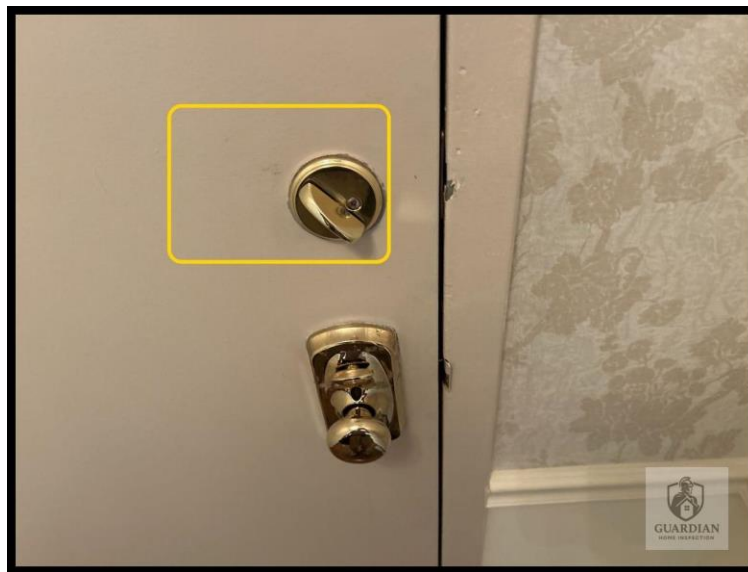
**Improve:** The main entry door deadbolt at the living room would not fully lock/engage during operation. A deadbolt that does not fully engage can reduce security and may indicate misalignment between the lock and strike plate. Adjust the door/strike alignment and deadbolt hardware so the bolt fully seats in the strike and locks properly; repairs should be performed by a qualified locksmith or door/finish carpenter. (Figure [23](#))

**Figure 23: The main entry door deadbolt at the living room would not fully lock/engage during operation.**
