# YOUR INSPECTION REPORT

FOR THE PROPERTY AT:  
2116 Randas Wy  
Rockwall, TX 75087

INSPECTION DATE:  
Friday, June 6, 2025

# PROPERTY INSPECTION REPORT FORM

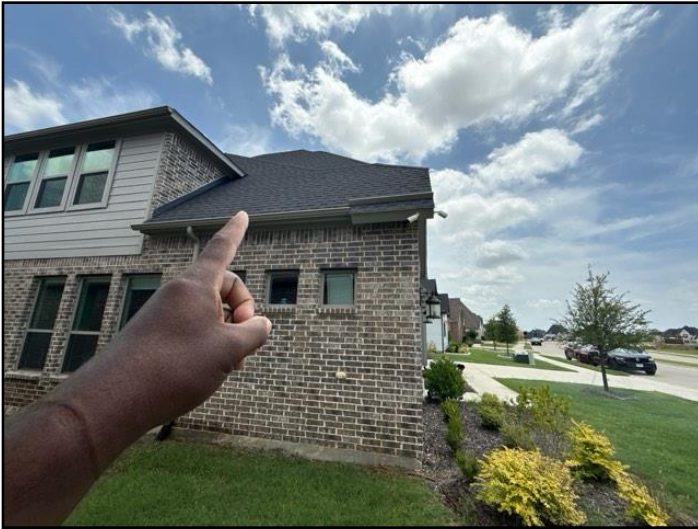
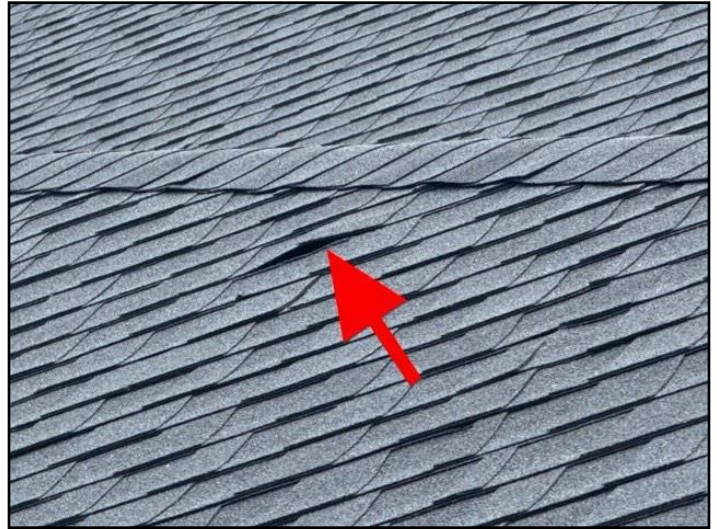
3. Condition: • [Buckled shingles](#)

This condition is common with new roof installations however applying manual adhesive may be needed. If the property is new construction it is recommended that the buyer review the builders warranty for coverages related to installation defects. This condition is also common if deck fasteners (h-clips) are missing.

**Implication(s):** Premature shingle wear / leaks

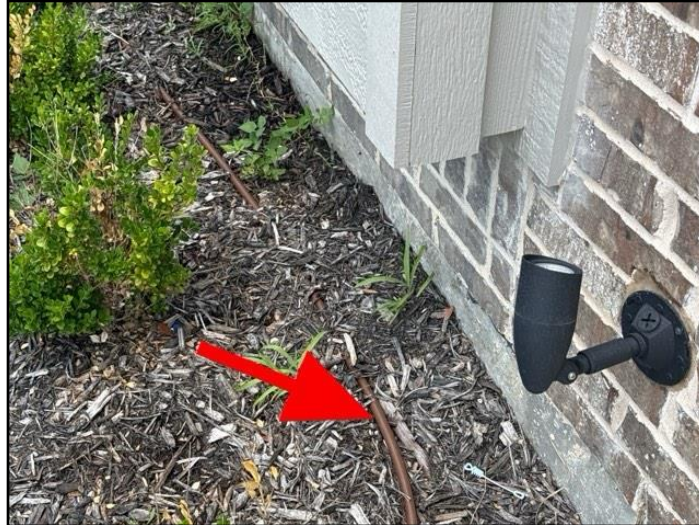
4. **Condition:** • It is recommended for drip irrigation to be 3-5" below grade

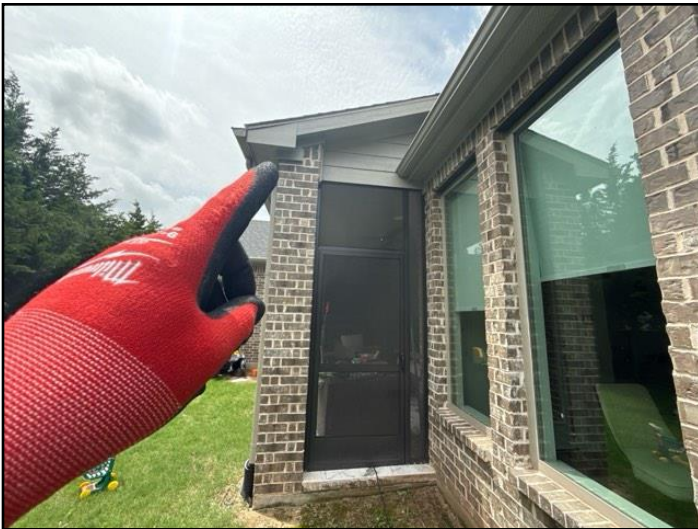
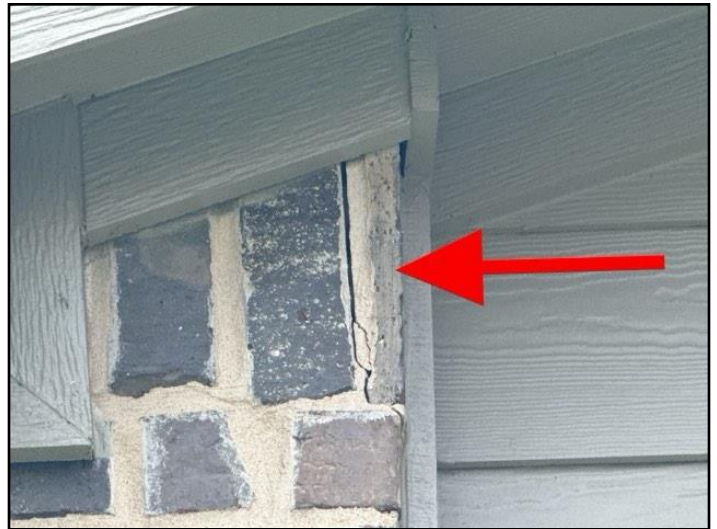
5. **Condition:** • Separation(s) in the brick/mortar was observed in one or more locations

**Implication(s):** Additional expansion/ water and pest intrusion/ Evidence of possible structural movement

**Task:** Repair with mortar or caulk

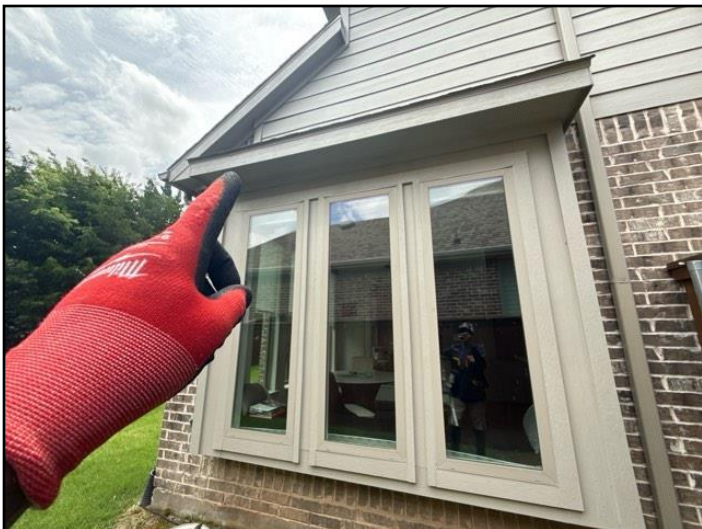
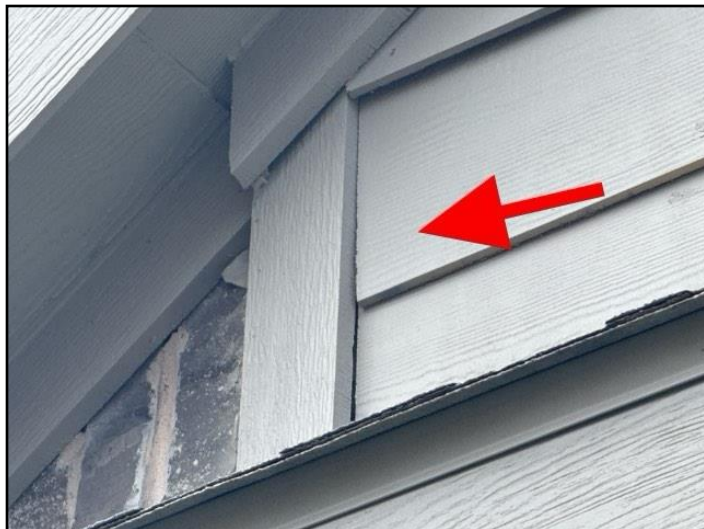
6. **Condition:** • Caulking needed - Exterior

Opportunity for water and pest intrusion.

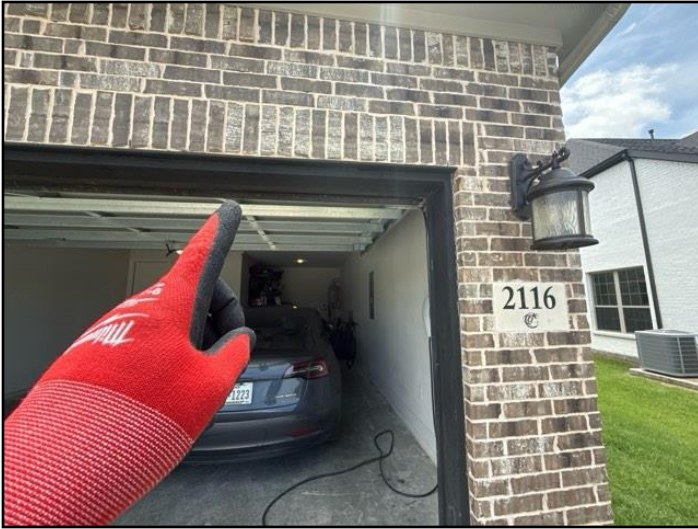
**7. Condition:** • Caulking is needed in one or more locations at the garage door

**Implication(s):** Water and pest intrusion

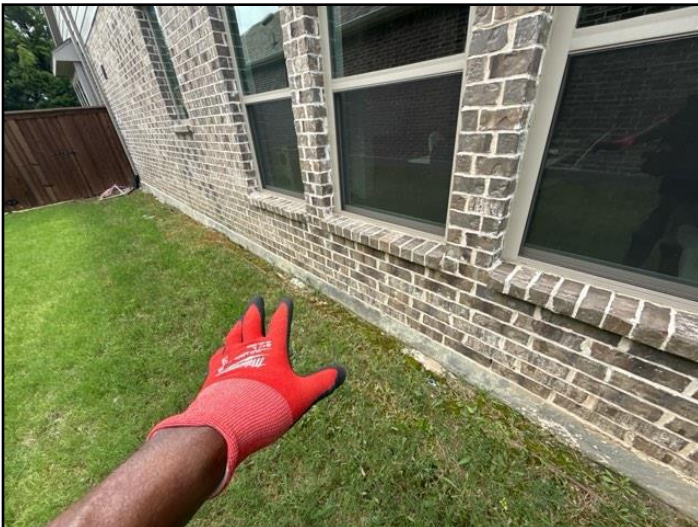
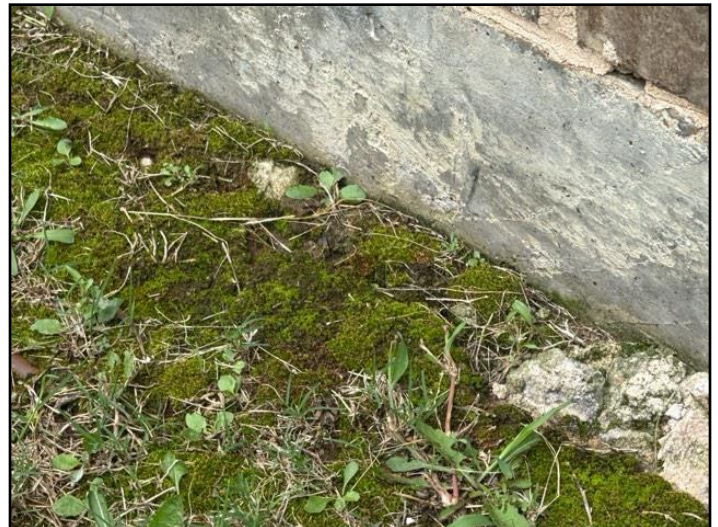
**8. Condition:** • [Evidence of standing water/poor grading or grading that slopes towards the property. Recommend](#) improving the slope so that water properly drains from around the property, installing gutters or installing a drainage system. This condition is common when new sod is installed however future correction may be needed. Please click on the link to access the current code requirement for residential grading and drainage (R-401.3)

**Implication(s):** Poor grading can have a negative impact on the performance of the foundation.

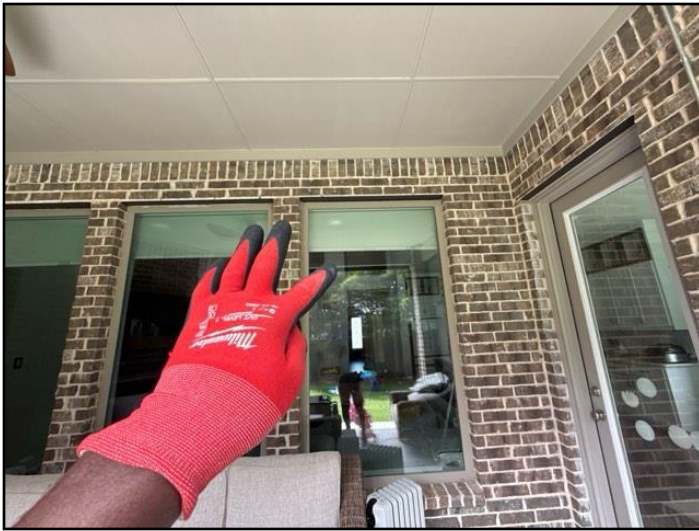
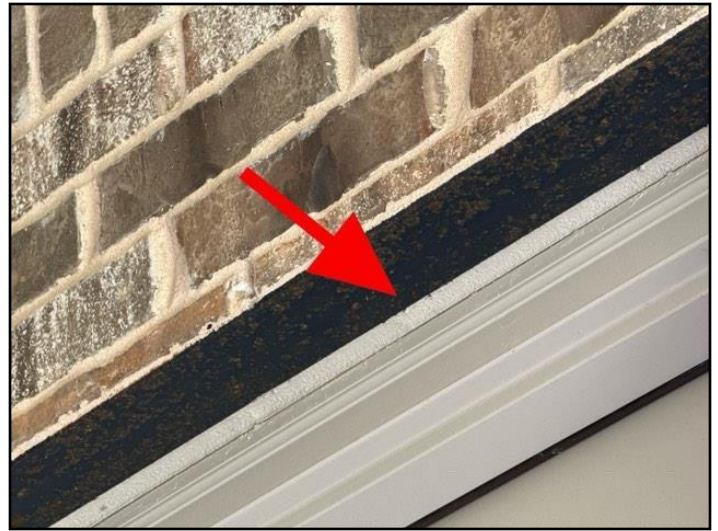
**9. Condition:** • Rusted or unpainted lintels were observed in one or more locations Lintels are located above windows/doors and are used to support brick/masonry. Recommend painting them to avoid rusting/deterioration.

**Implication(s):** Damage to brick walls

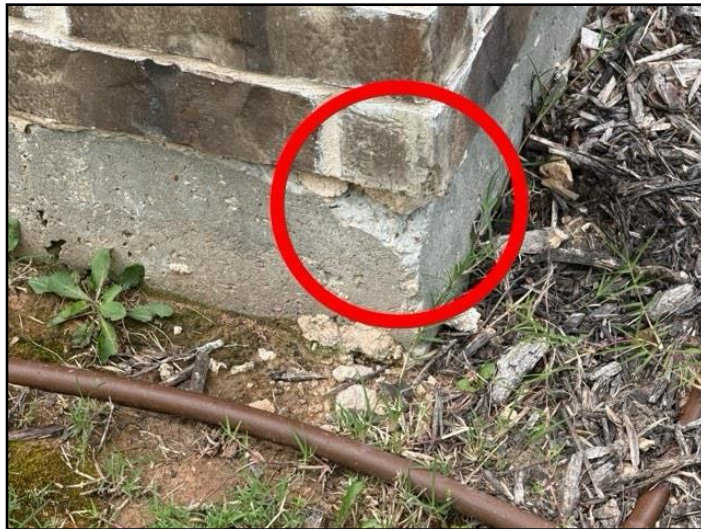
**11. Condition:** • Corner cracks/spalling was observed in one or more locations. These are typically cosmetic however it is recommended to repair these defects to avoid additional deterioration.

**Implication(s):** Recommend repair to avoid additional expansion

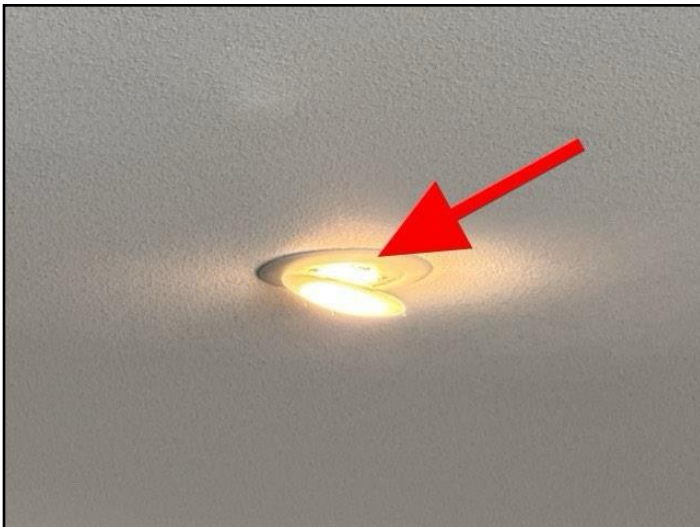
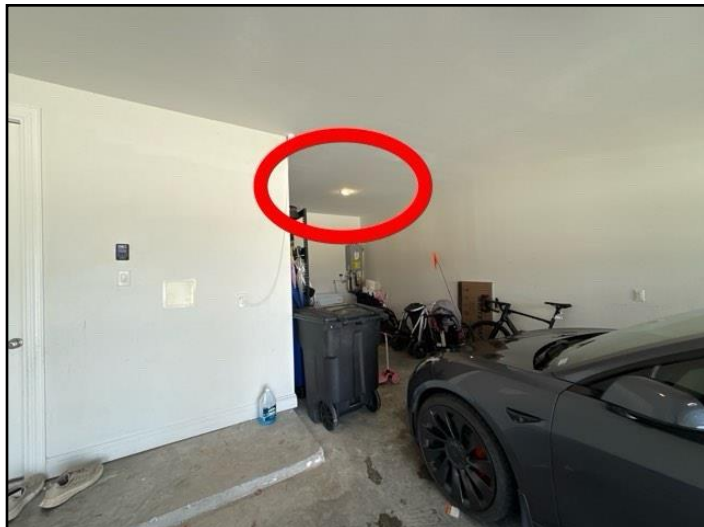
**12. Condition:** • The light cover is not properly installed

**Location:** Garage

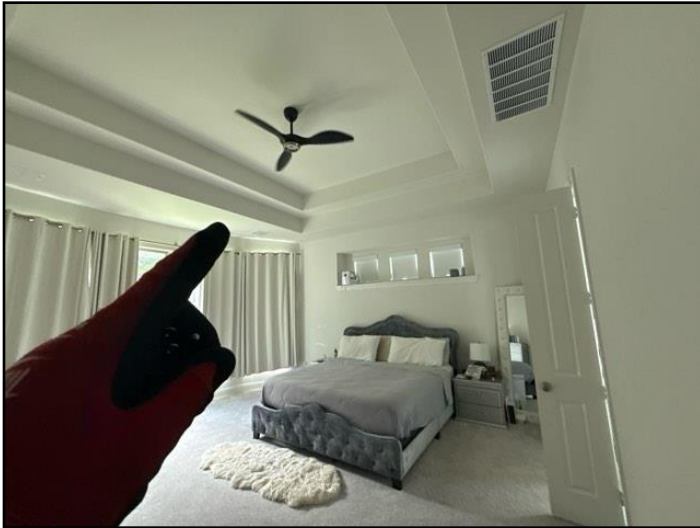
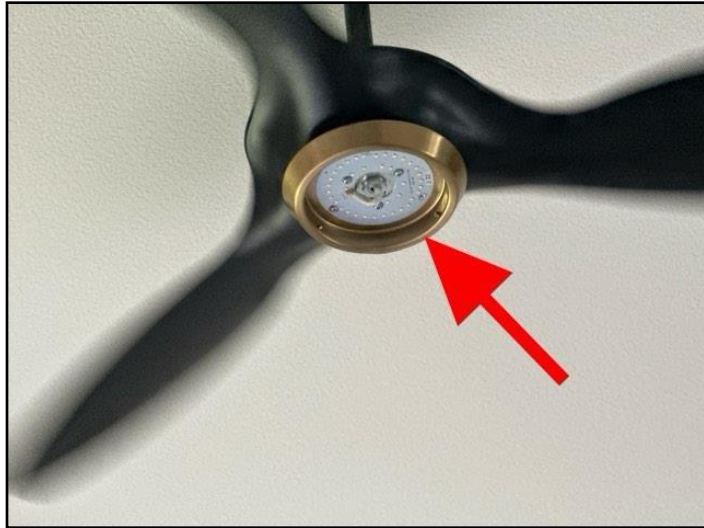
**13. Condition:** • Missing light fixture

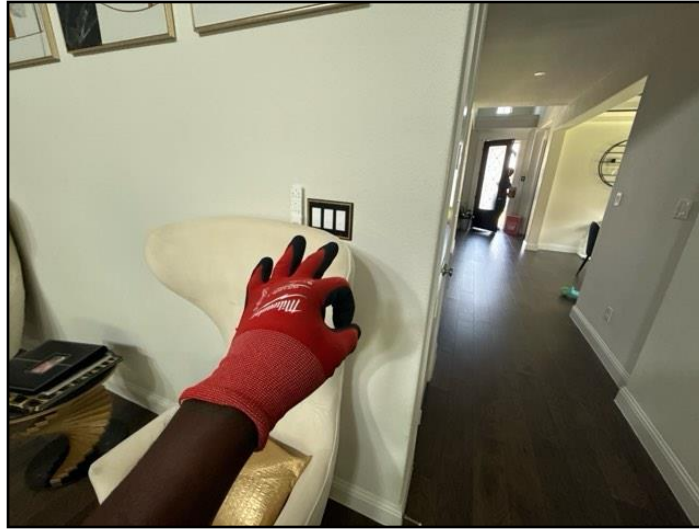
**14. Condition:** • The lights did not engage

**Location:** Family Room

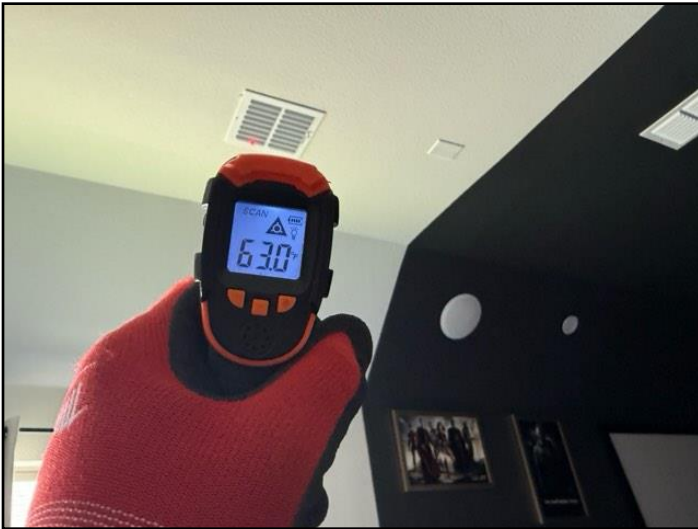
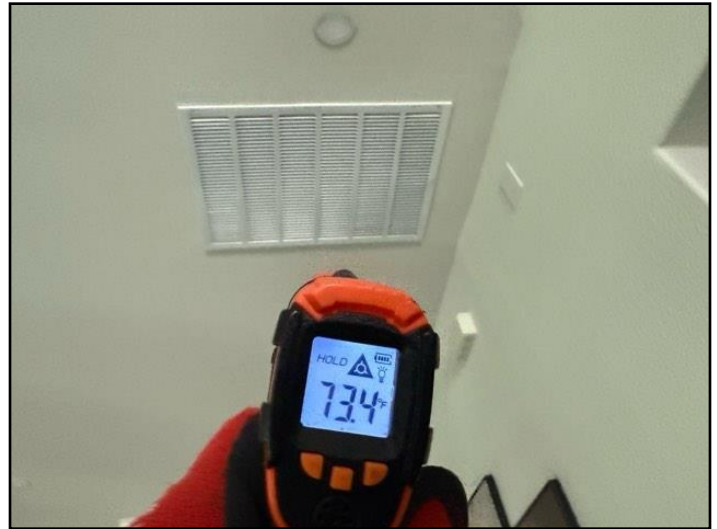
**15. Condition:** • Unacceptable AC differential (Failed under test). This typically means that the air conditioning systems differential did not fall between 15° through 21°. Further evaluation of the system is recommended by a licensed HVAC specialist. If the property is new construction it is recommended that the buyer request a system rebalance from the builder/ contractor. The acceptable differential may be different when sprayed foam is present

**Implication(s):** Higher utility cost

**Location:** Second Floor

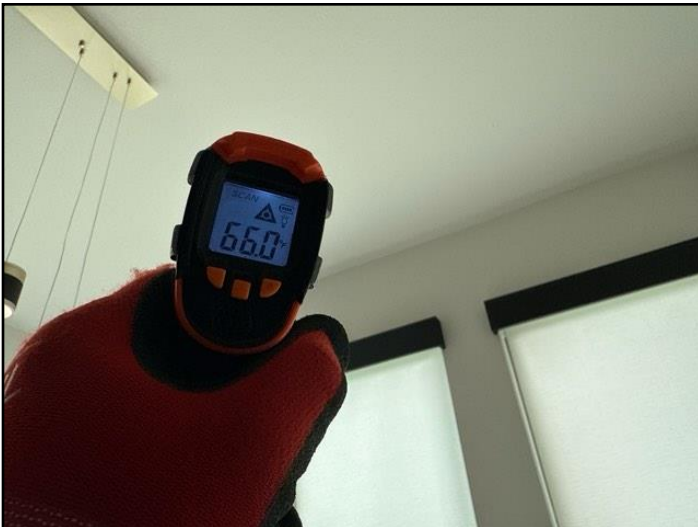
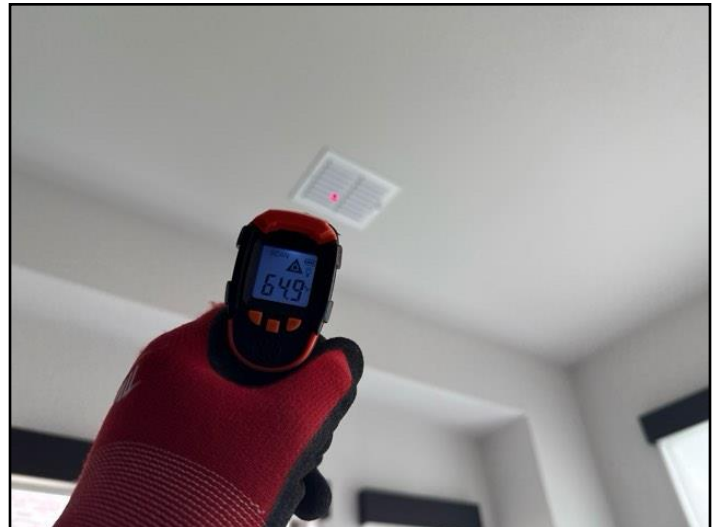
**16. Condition:** • Unacceptable AC differential (Failed under test). This typically means that the air conditioning systems differential did not fall between 15° through 21°. Further evaluation of the system is recommended by a licensed HVAC specialist. If the property is new construction it is recommended that the buyer request a system rebalance from the builder/ contractor. The acceptable differential may be different when sprayed foam is present

**Implication(s):** Higher utility cost

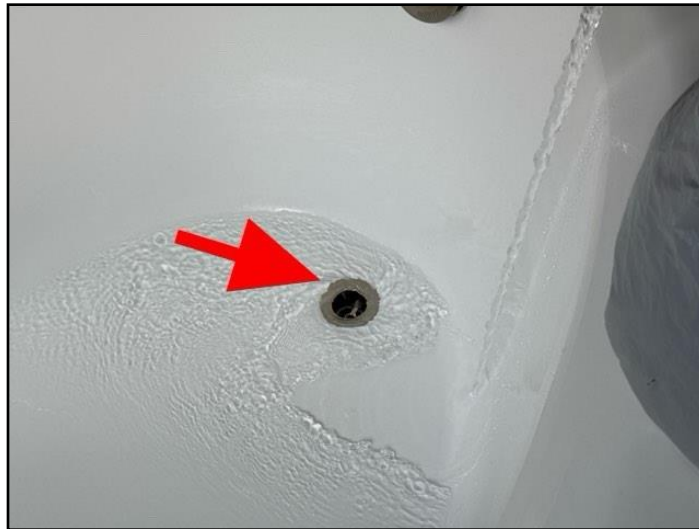
**17. Condition:** • Missing drain stop. Not able to test if sink/tub holds water. This condition was observed in one or more locations.

**Location:** Owners Bathroom

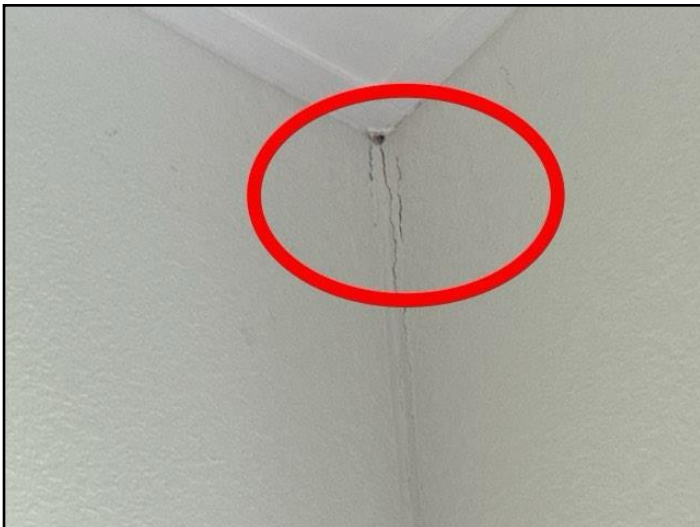
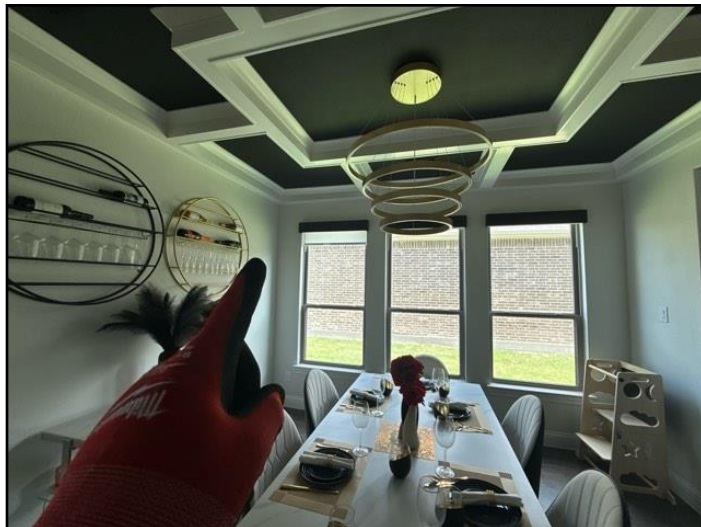
**18. Condition:** • Drywall defects were observed in one or more locations

**Location:** Dining Room

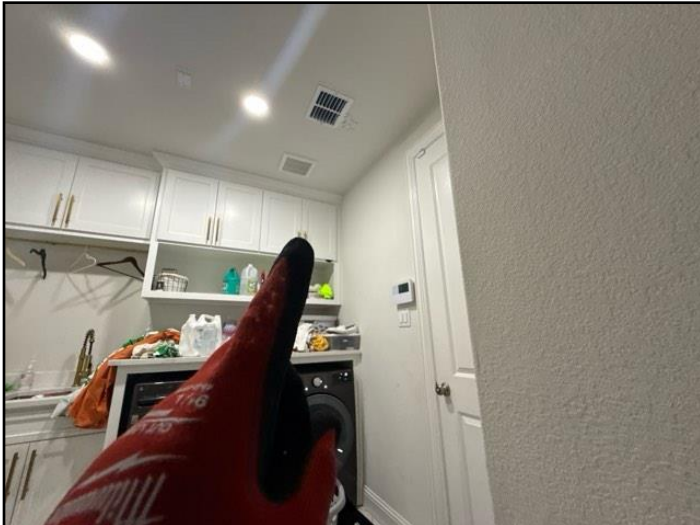
**19. Condition:** • Drywall defects were observed in one or more locations

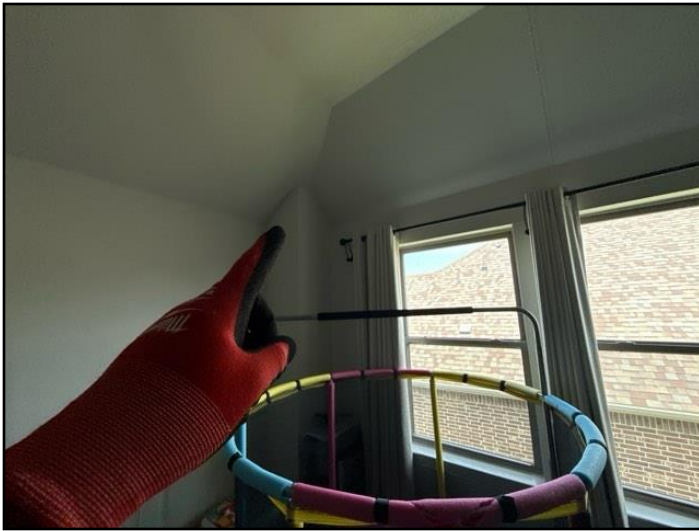
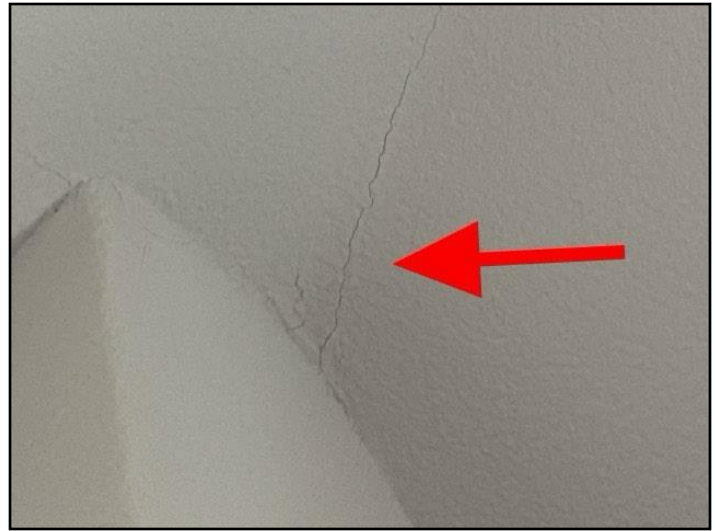
**20. Condition:** • Drywall defects were observed in one or more locations

**Location:** Second Floor Family Room

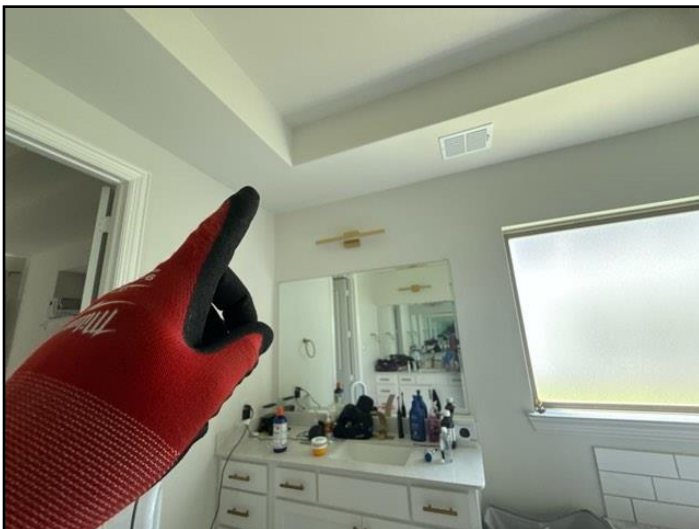
**21. Condition:** • Drywall defects were observed in one or more locations

**Location:** Owners Bathroom

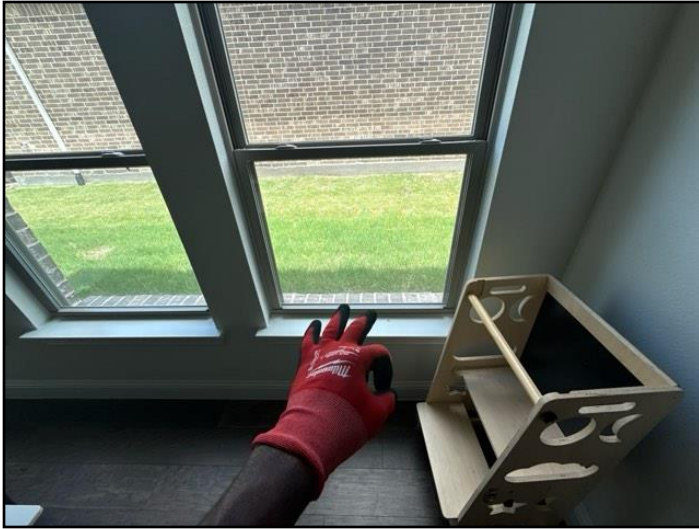
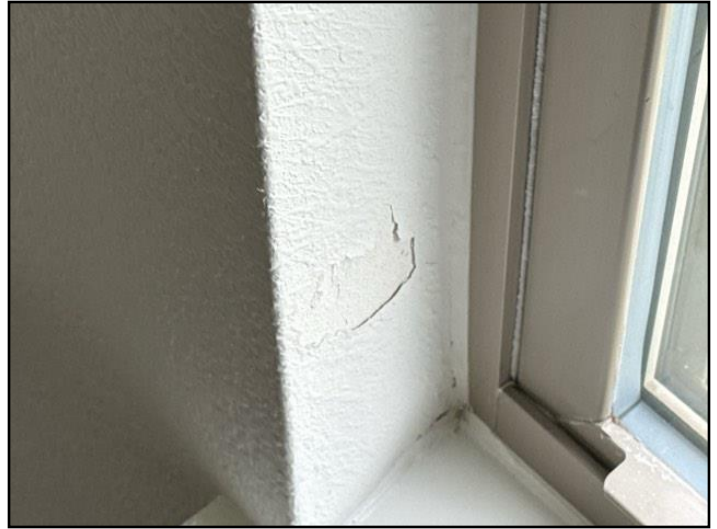
**22. Condition:** • Painting/ caulking needed.

**Implication(s):** Water or pest intrusion or possible reduction in energy efficiency
