Uniform Mitigation Verification Inspection Form

Inspection Date: 1/29/2026		
Owner Information		
Owner Name: Sandra Schenck		Contact Person: Sandra Schenck
Address: 4115 Cape Cole Blvd, Punta Gorda, FL 33955		Home Phone:
City: Punta Gorda	Zip: 33955	Work Phone:
County: Charlotte		Cell Phone:
Insurance Company:		Policy #:
Year of Home: 1999	# of Stories: 1	Email: sandrajeanschenck@gmail.com

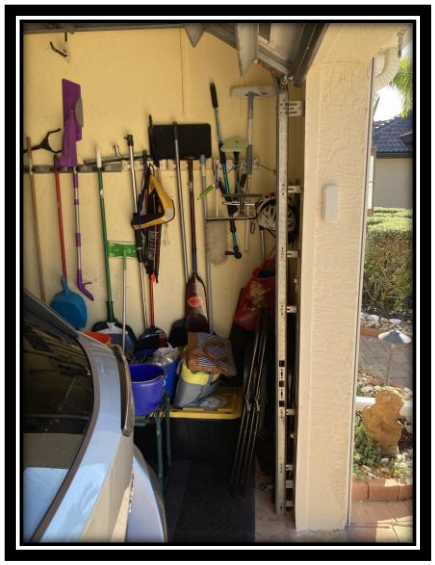
WALL TO DOOR CONNECTIONS

BACKSIDE OF GARAGE DOOR

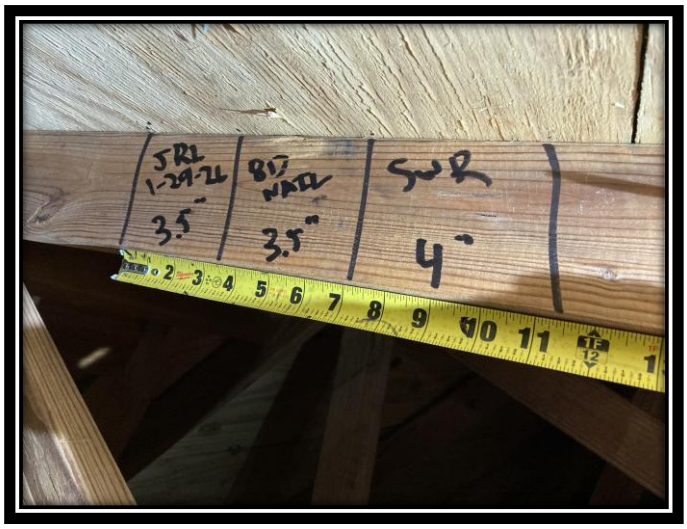
SINGLE WRAPS

8D NAILS EVERY 6 INCHES OR LESS
