Uniform Mitigation Verification Inspection Form

Inspection Date: Aug 1, 2022		
Owner Information		
Owner Name: RICHARD MILLER		Contact Person:
Address: 2061 BIG PASS LN. PUNTA GORDA, FL. 33955		Home Phone:
City: PUNTA GORDA	Zip: 33955	Work Phone:
County: LEE		Cell Phone:
Insurance Company:		Policy #:
Year of Home: 1994	# of Stories: 1	Email:

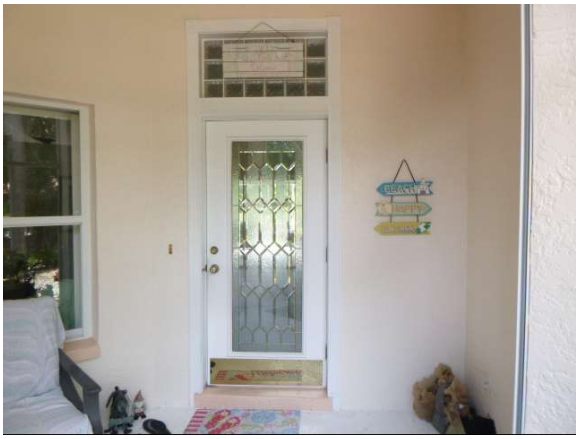
FE-2 ADDRESS VALIDATION
