Jeffrey J. Moss, P.E.
Senior Structural Engineer

Re: Structural Investigation
319 Park Avenue
Sanford, NC 27330
Project #24177

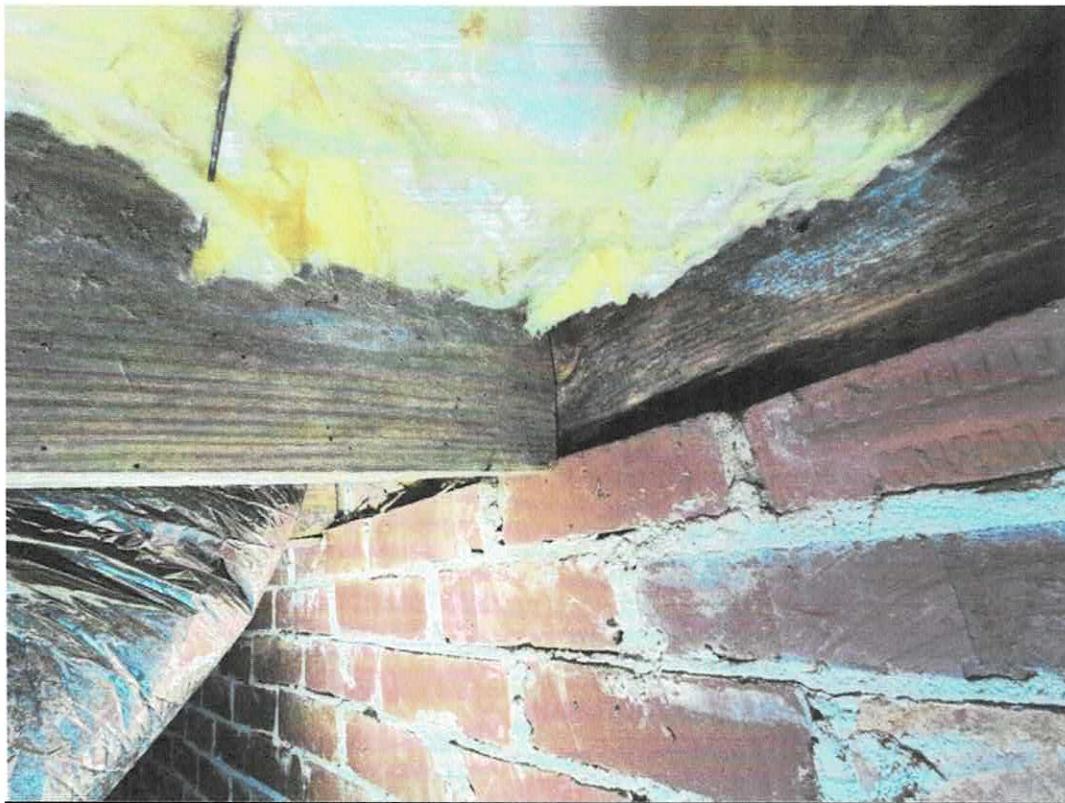
PHOTO 28

- There were several temporary supports in the crawl space supporting the floor joists (photos 20 to 25).
- There was wood rot in at least one of the floor joists at the front (photo 26).
- The bearing of the floor joists at the front of the crawl space was inadequate (photos 28 to 29).
- There were splices in the girder at the center (photos 30 & 31).
- There was a piece of the girder missing in the girder (photo 32).

- Provide a (3) 2x10 girder to support the floor joists at the front and rear.
- These girders shall be supported by brick piers similar to photo 33 or metal posts.
- The piers or metal posts shall be supported by concrete footings.
- Repair the wood rot at the front floor joist.
- Provide hangers similar to photo 34 at the front and rear floor joists at the front and rear crawl space walls.
- Provide new 2x10s each side of the girders where the splices are located.
- Provide new 2x10's where the piece of girder is missing.
