# Four-Point Inspection Form

Address Inspected: 3502 Washington Rd. West Palm Beach, FL 33405

Date Inspected: 2/11/2025

Affordable Home Inspection  
 Company Name

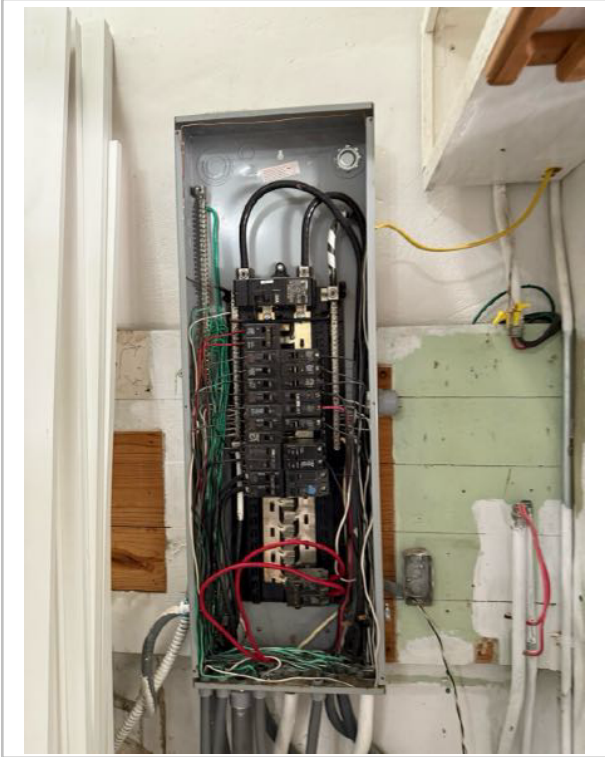
Electrical panel

Several areas of exposed wiring. Improper splice under kitchen sink. main house panel is obstructed

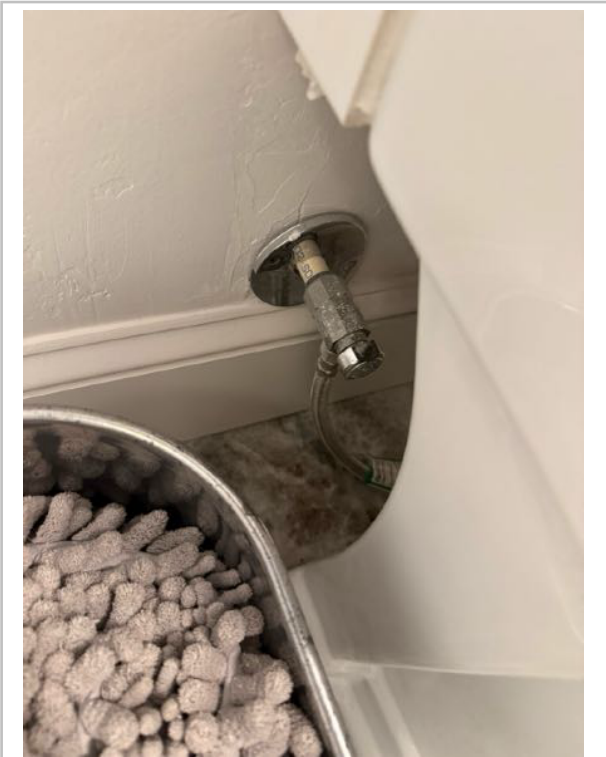
Water damage right of sink guest apartment bath, missing shutoff guest apt. Washer stem  
 Leak at store room toilet. Work in progress master bathroom

Toilet shutoff
