STEADFAST HOME INSPECTION

## PROPERTY INSPECTION REPORT

118 Chapala St  
Santa Barbara, CA 93101

11/20/2025

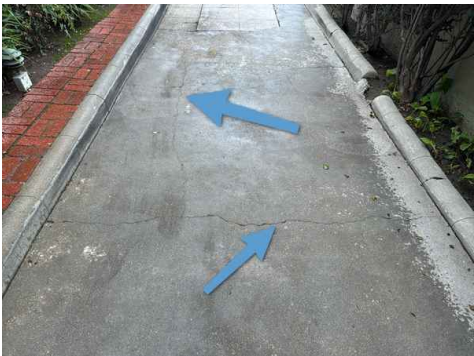
### CRACKS - TYPICAL

Surface had cracks that appeared typical and should be monitored. If condition worsens, correction may be necessary in order to ensure stability of the surface.

Recommend monitoring.

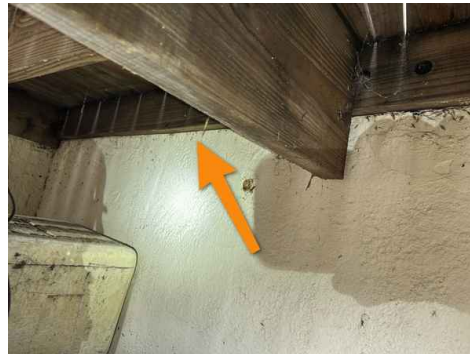
**LEDGER BOARD IMPROPERLY INSTALLED**

The ledger board was not properly attached to the building. This can cause the added structure to pull away from the building and possibly collapse. Recommend that the ledger board be properly attached by qualified contractor.

Common defects include being attached over the siding and not having the proper number or spacing of bolts or lag screws.

Contact a qualified general contractor.

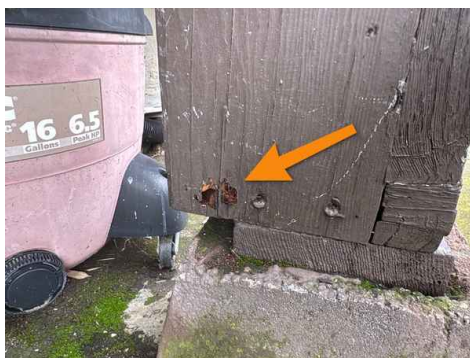
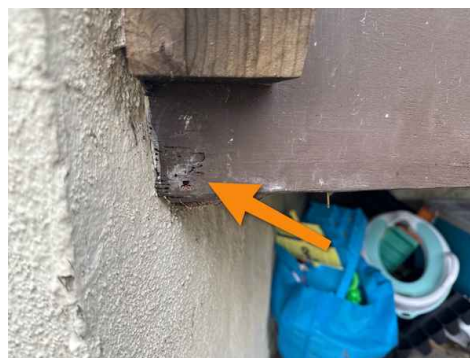
**PEST DAMAGE**

Damage from wood destroying pests (e.g., termites) observed, which may be ongoing or from a prior infestation. Recommend further evaluation by a qualified pest control company. Damaged members should be repaired or replaced.

Contact a qualified pest control specialist.

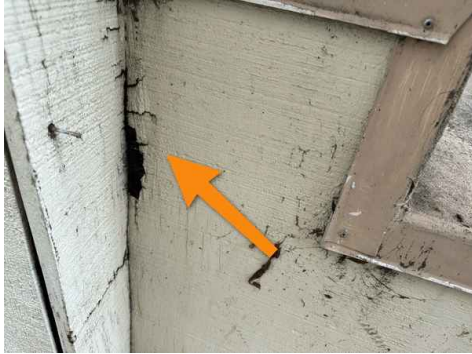
North West Stairs

**WOOD DECAY**

Wood decay observed, which should be repaired or replaced to reduce chances of further decay or moisture intrusion. Source of moisture should also be investigated and eliminated.

Contact a qualified carpenter.

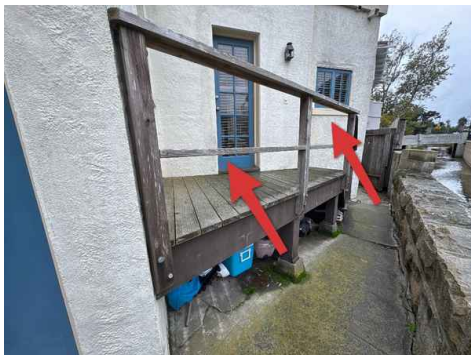
North East Deck

**GUARDRAIL DEFECT**

Guardrail was loose, missing or improperly installed.

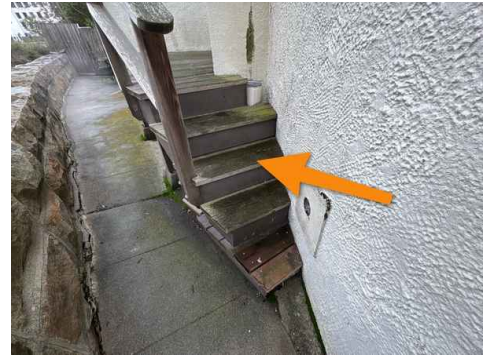
**CRAWLING PLANTS ON STRUCTURE**

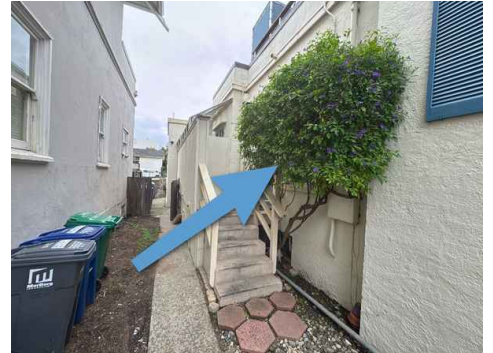
**PLANTS NEAR BUILDING**

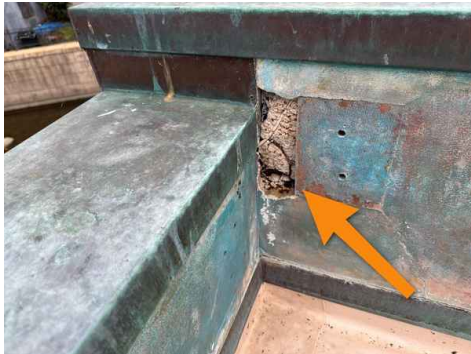
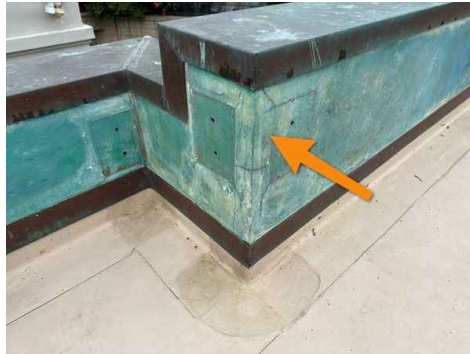
**PEST DAMAGE**

Contact a qualified pest control specialist.

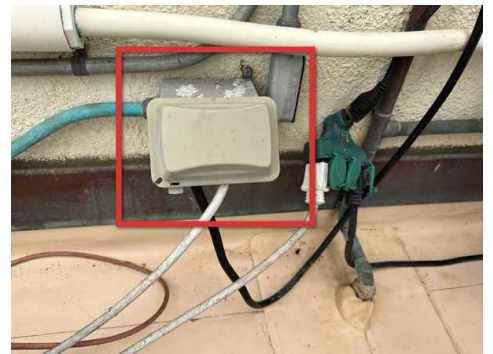
**GROUND PIN OBSTRUCTION**

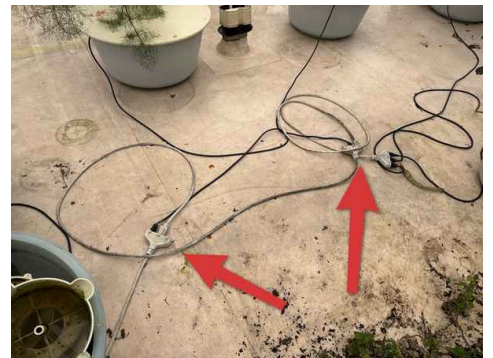
## 5.9.4 Exterior Electrical

**PERMANENT EXTENSION CORD**

An extension cord was observed in use as "permanent" wiring. Extension cords should not be used to supply power to items that will be plugged in continuously. Recommend running power to reach the supplied power cord of the device or fixture.

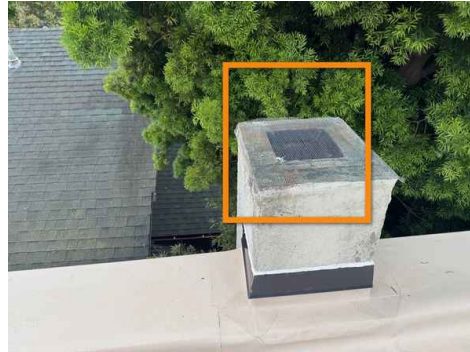
## 6.9.1 Chimneys &amp; Skylights

**CHIMNEY CAP DEFECT**

Chimney cap was loose, damaged or missing. A cap should be installed to protect the crown of the chimney, as well as to help keep rain and pests out of the flue.

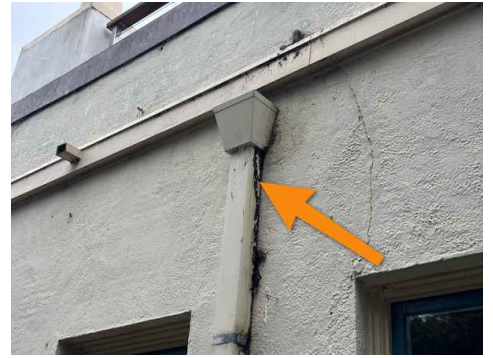
## 7.1.1 Gutters

**GUTTER LEAK**

Gutter leak observed or suspected in one or more areas. This can result in excessive moisture in the soil at the foundation, which can lead to foundation/structural movement. Gutters should be repaired.

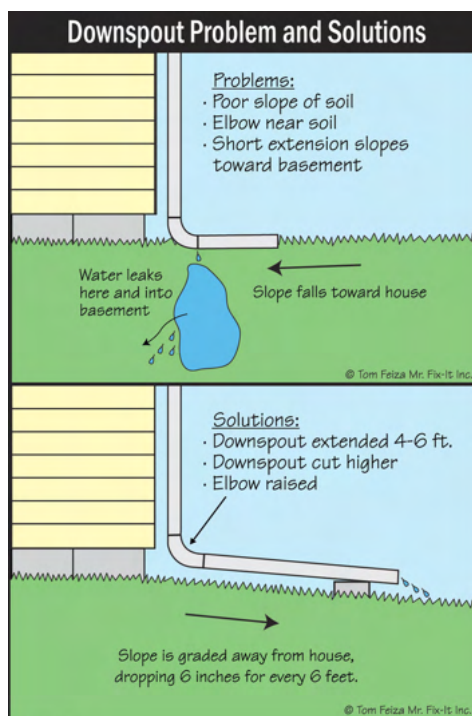
## 7.2.1 Downspouts

**DOWNSPOUT LOCATION**

One or more downspouts discharged too close to the home's foundation. This can result in excessive moisture in the soil at the foundation, which can lead to foundation/structural movement. Downspouts should drain at least 6 feet from the home.

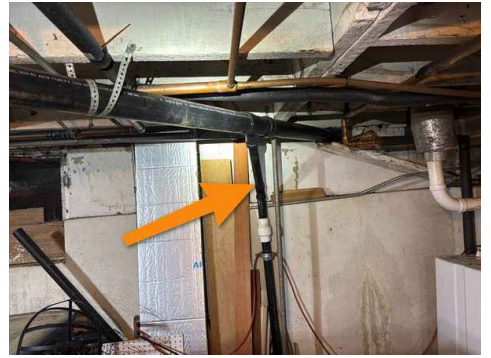
## 7.4.1 Drainage

**IMPROPER PLUMBING AT SUMP DISCHARGE**

The discharge plumbing for the sump pump was plumbed improperly. Current practice allows a sump to discharge into the main drain line only under certain conditions. Important factors include the discharge having a check valve (or backwater valve), a gate or ball valve shut-off being installed downstream from the check valve, and the discharge entering the main sewer line from above. Recommend correction.

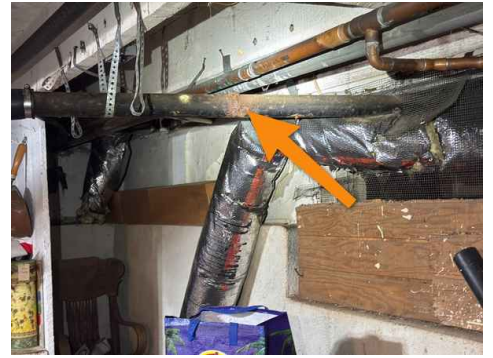
**POSSIBLE PINHOLE LEAK(S)  
OBSERVED**

The cast iron drain had signs of a pinhole leak, including build-up and staining on the outside of the pipe. Recommend further evaluation of the drain line.

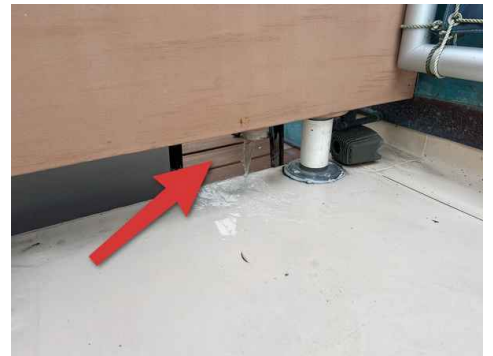
## 8.2.2 Drains &amp; Vents

**IRREGULAR DRAIN PLUMBING**

The drain line for the rooftop deck drained onto the roof. While roof materials are made to shed water, prolonged exposure can cause premature wear or damage. Recommend plumbing the drain into an approved receptacle. Add caption

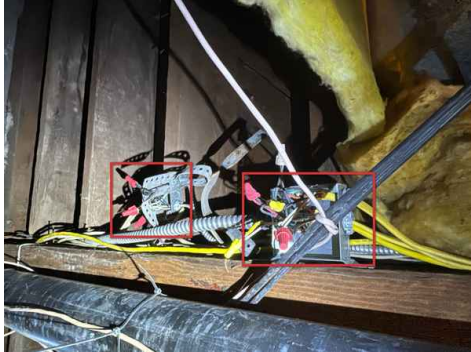
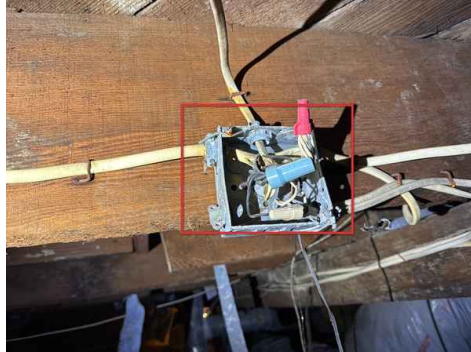
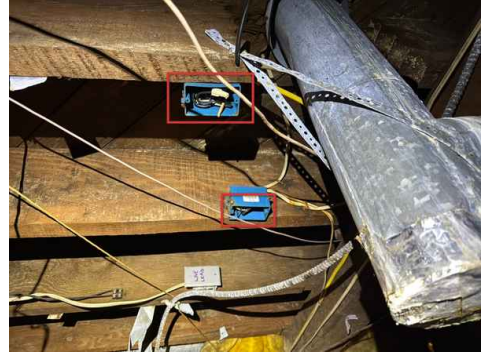
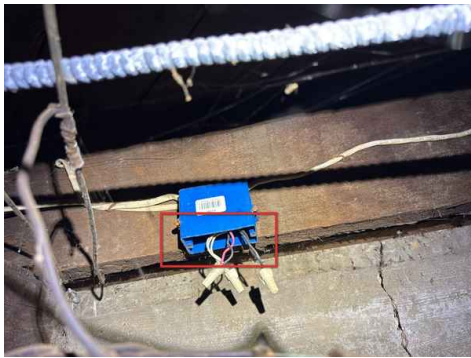
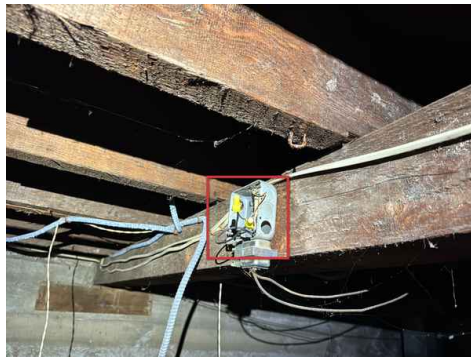
Junction box was missing a cover. A cover should be installed to help prevent access to live electrical conductors.

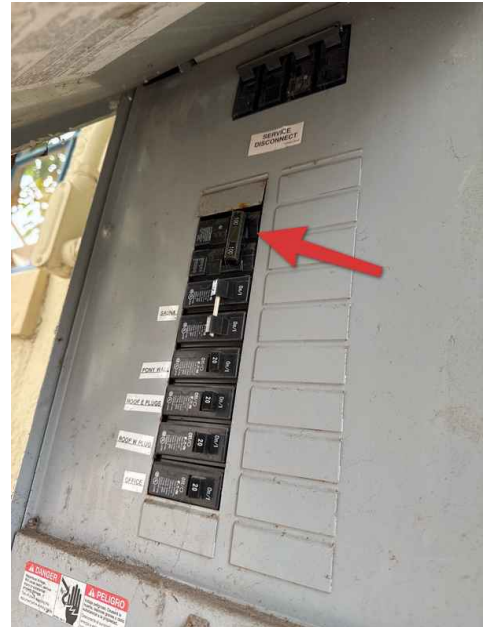
**LEGEND DEFECT**

Distribution panel was lacking a legend or legend was incomplete or outdated. The legend describes each circuit in a way that is clear and unambiguous. Recommend labeling each circuit.

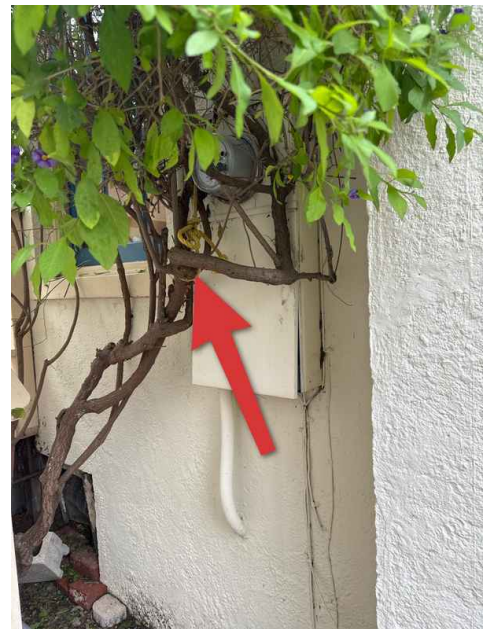
## 11.2.2 Service Panel

**IMPROPER CLEARANCE AT PANEL**

Current practice calls for at least 3 feet of clear working space in front of the electrical panel. Recommend removing obstructions.

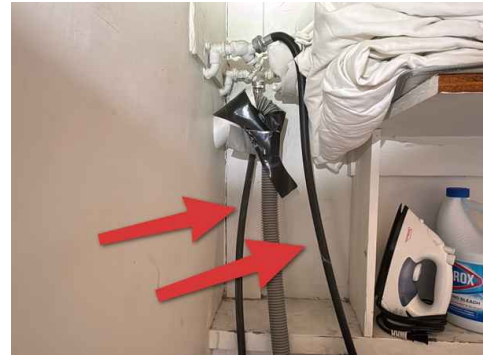
Rubber hose was in use for the washer supply. Rubber can be prone to rupture and at a minimum should be replaced every 5 years. Recommend switching to a stainless-steel braided type, which does not need replacement.

Contact a handyman or DIY project

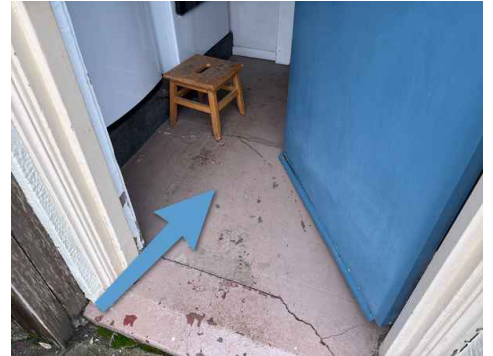
## 13.4.1 Floor

**FLOOR UNEVEN**

Floor had an area of unevenness that could be due to settling or imperfection of the installed flooring and subfloor. Unless paired with other signs of major damage, it is not likely to be a significant concern.

Recommend monitoring.

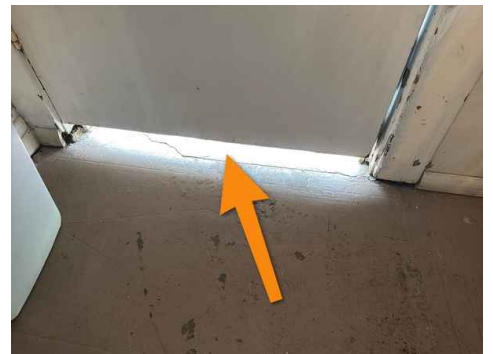
## 13.5.1 Door(s)

**GAP AT EXTERIOR DOOR**

The exterior door had gaps around it that will let outside elements and possibly pests into the home, as well as any conditioned air out of the home. Recommend weather-stripping or improving door alignment.

Contact a qualified door repair/installation contractor.

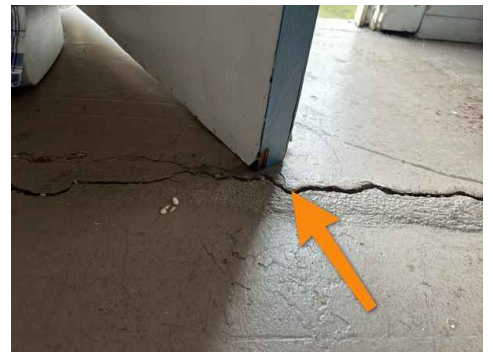
## 13.5.2 Door(s)

**ADJUSTMENT NEEDED**

Contact a qualified door repair/installation contractor.

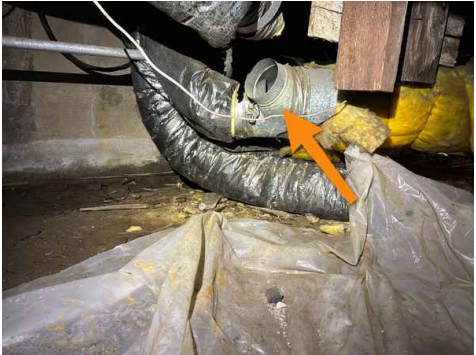
#### DUCT DEFECT

Duct was torn, crimped, broken or disconnected. This wastes conditioned air and may circulate dirty air into the home. Recommend repair.

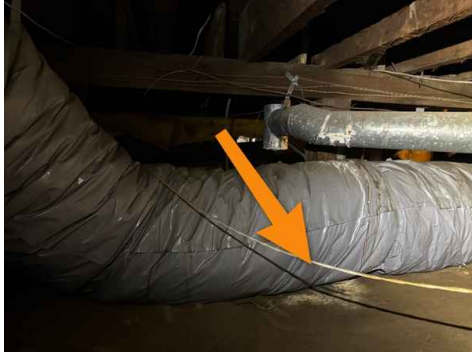
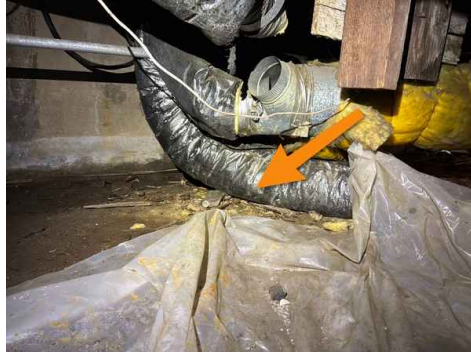
## 14.3.2 Distribution

**DUCT IN DIRT**

Duct was in contact with dirt in the crawlspace, which can lead to premature wear of ductwork. Recommend securing duct off dirt, or placing material between duct and dirt to help prevent wear.

Contact a qualified HVAC professional.

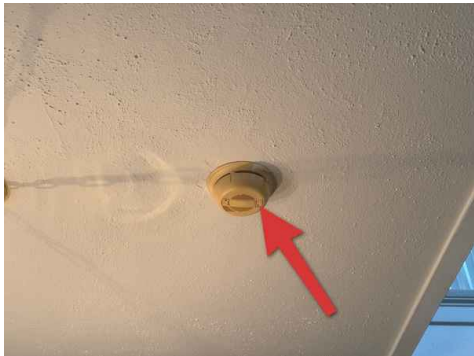
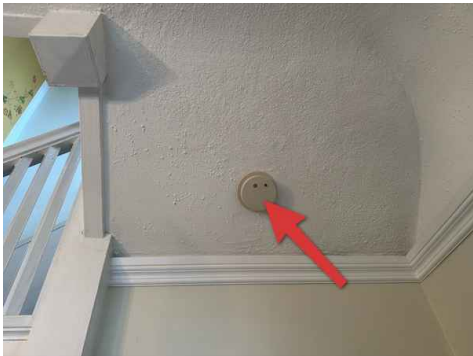
Installed smoke alarm appeared to be beyond 10 years old. Beyond ten years, smoke alarms have a diminished ability to detect smoke particles and should be replaced for occupants' safety.

Contact a handyman or DIY project

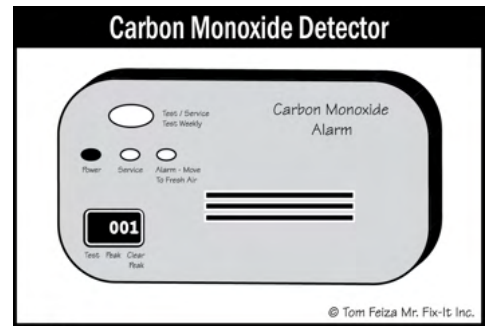
Current practice calls for a Carbon Monoxide (CO) Alarm outside of any sleeping area with at least **one on each level** of the home. Recommend installation for occupants' safety.

Contact a handyman or DIY project

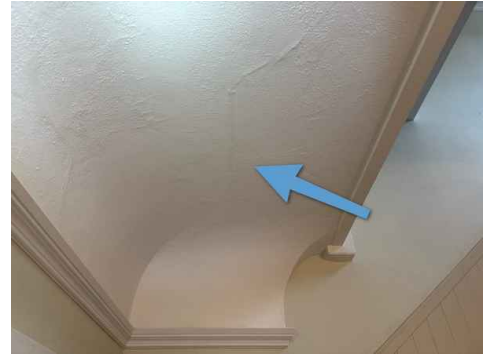
**REPAIRS OBSERVED**

Repairs were observed. This can indicate past damage, possibly moisture intrusion or pest damage. Recommend monitoring.

Recommend monitoring.

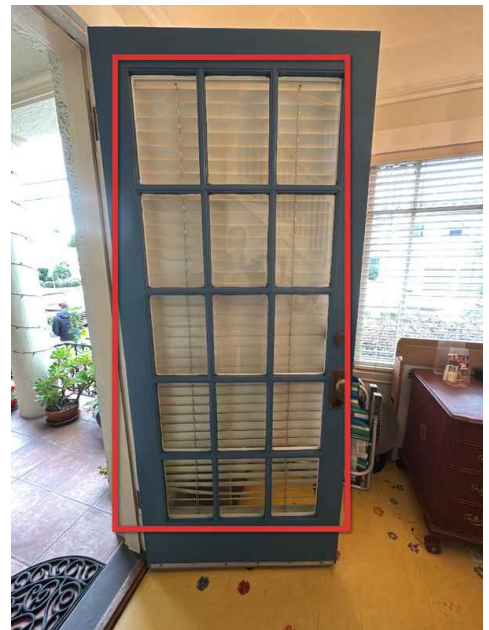
**SAFETY GLASS NOT OBSERVED**

Current practice calls for safety glass in doors, and any side lites or windows adjacent to doors. Recommend correction for occupants' safety.

Safety glass (or tempered glass) can be identified by a marking etched into the glass. In certain cases, it is possible that safety glass is present, but the etching was not observed.

Contact a qualified door repair/installation contractor.

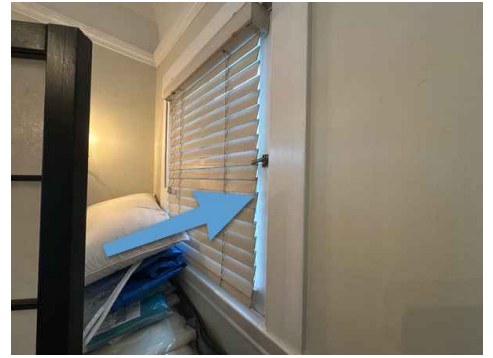
Window was difficult or not able to open/close. Recommend repair or adjustment.

Contact a qualified window repair/installation contractor.

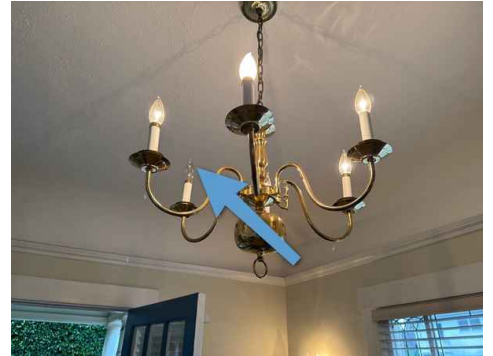
Light fixture had a bulb missing or burnt out. Recommend replacement of bulb and testing of fixture.

Contact a handyman or DIY project

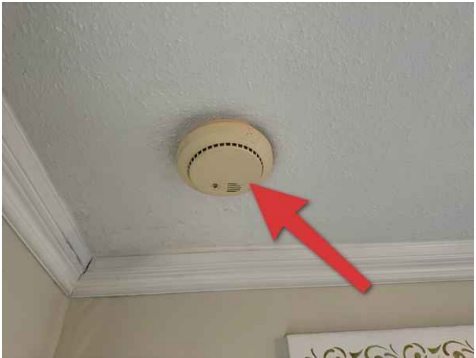
Installed smoke alarm appeared to be beyond 10 years old. Beyond ten years, smoke alarms have a diminished ability to detect smoke particles and should be replaced for occupants' safety.

Recommendation  
Contact a handyman or DIY project

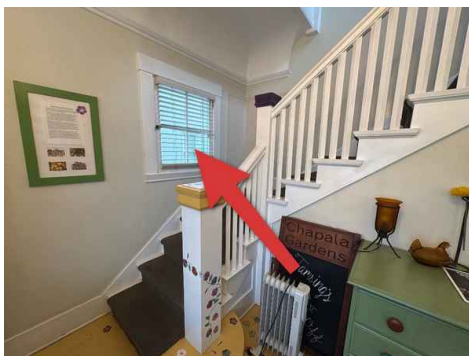
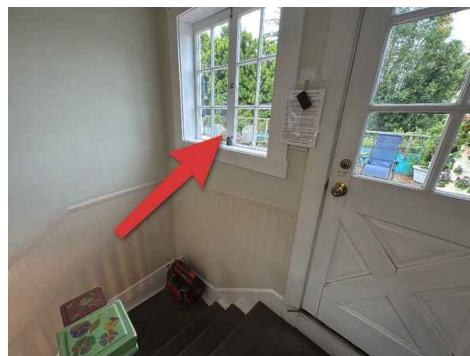
**SAFETY GLASS NOT OBSERVED AT STAIRWAY**

Current practice calls for windows in stairways or adjacent landings to be made of safety glass if the window is within 60 inches of the top of the nearest stair tread. Recommend installation of safety glass for occupants' safety.

Contact a qualified window repair/installation contractor.

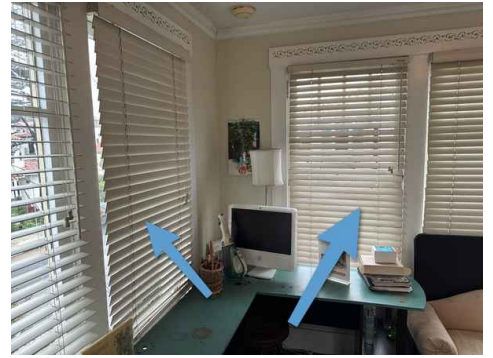
Window was difficult or not able to open/close. Recommend repair or adjustment.

Contact a qualified window repair/installation contractor.

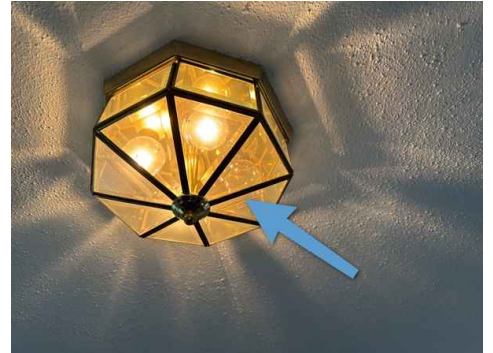
Light fixture had a bulb missing or burnt out. Recommend replacement of bulb and testing of fixture.

Contact a handyman or DIY project

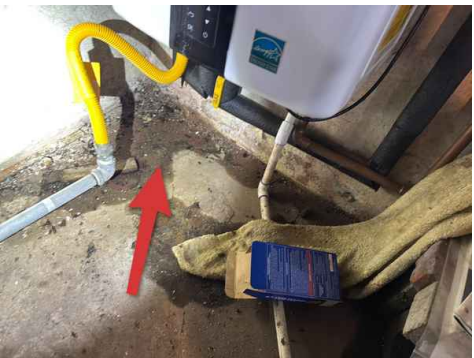
Evidence of rodents observed. Recommend further evaluation. The first steps to preventing rodent entry are sealing all penetrations through the roof, siding and foundation, and keeping plants and trees trimmed back from the house. Plants against the house, especially at the roof, provide a pathway for rodents to more easily access the home.

Recommendation  
Contact a qualified pest control specialist.

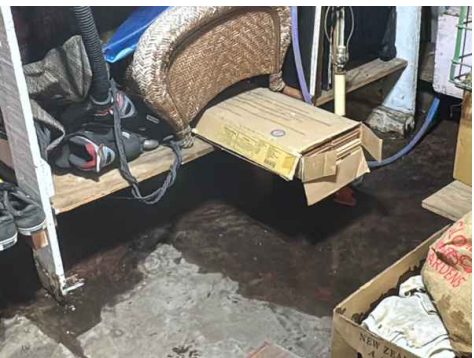
**STANDING WATER OBSERVED**

Standing water was observed in the basement. Recommend improving drainage to help prevent damage to structure or finishes.

Recommendation  
Contact a qualified soils & drainage engineer

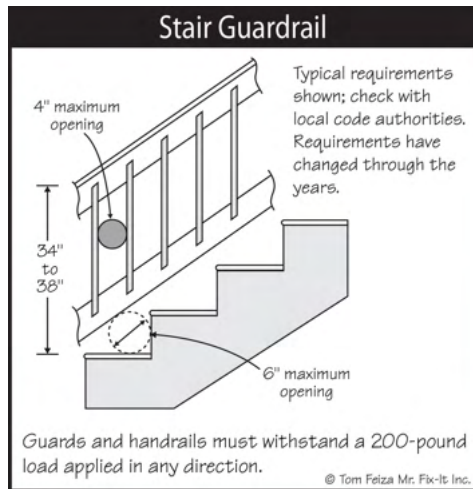
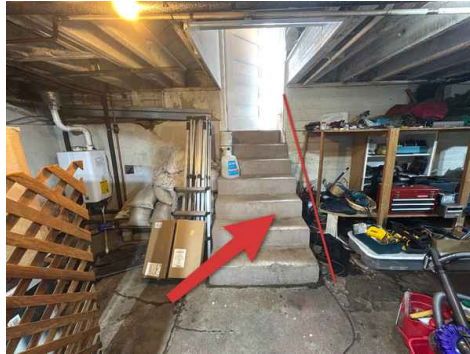
**HANDRAIL DEFECT**

Handrail was loose, missing or improperly installed.

Contact a qualified general contractor.

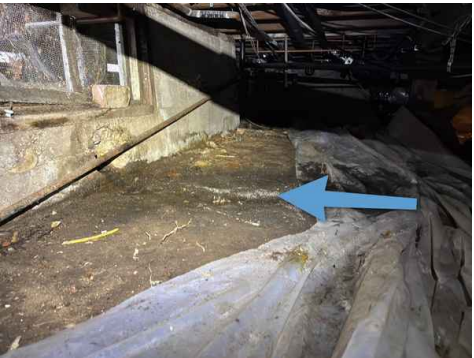
Dirt in the crawl space was damp, with no observed source of moisture. Some amount of moisture is normal and soil in the crawl space can take a long time to dry. But persistent moisture can be a sign of a drainage or plumbing defect and can affect indoor air quality. Recommend requesting information from Seller about any previous water intrusion and monitoring.

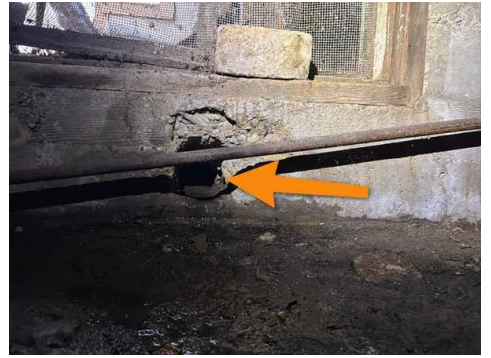
**WATER ENTRY THROUGH OPENING**

Water was entering the crawl space through an opening in the foundation wall. Common openings include vents, or holes for plumbing, electrical or conduits. Opening should be sealed to prevent water entry.

Contact a foundation contractor.

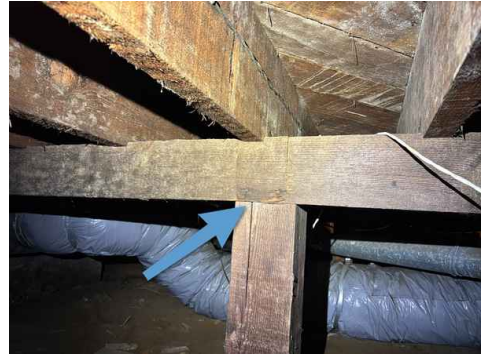
**POSTS & BEAMS NOT STRAPPED**

Best practice calls for posts to be secured with steel straps to their piers and beams. While there were no signs of posts slipping, recommend strapping all posts.

Contact a foundation contractor.

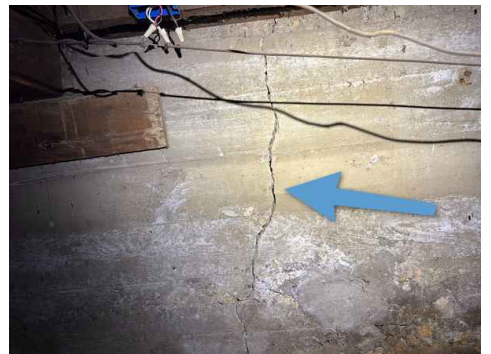
**TYPICAL CRACK AT FOUNDATION**

Foundation was cracked. The crack did not show signs of lateral movement and could be a result of typical settling. Further evaluation could be provided by a foundation contractor.

Recommend monitoring.

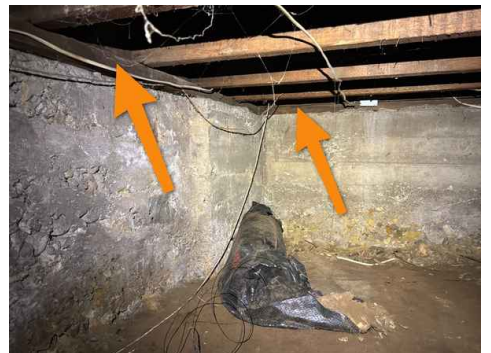
**FOUNDATION BOLTS NOT OBSERVED**

Framing did not appear to be bolted to the foundation wall. Current practice calls for bolts along the perimeter of the foundation, with at least 2 bolts per member. A foundation contractor can provide more information on current standards of foundation anchoring.

Contact a foundation contractor.

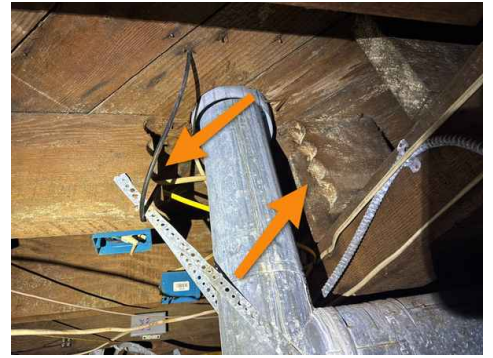
**IMPROPERLY NOTCHED FRAMING**

Contact a qualified general contractor.

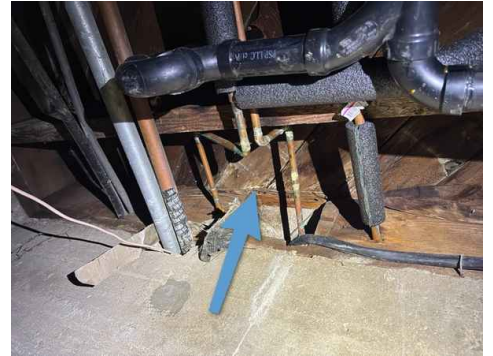
**MOISTURE DAMAGE**

Floor structure had area(s) of damage from past water intrusion. Damaged members may be weakened and should be replaced when accessible. No current leak was observed. Recommend monitoring.

Recommend monitoring.

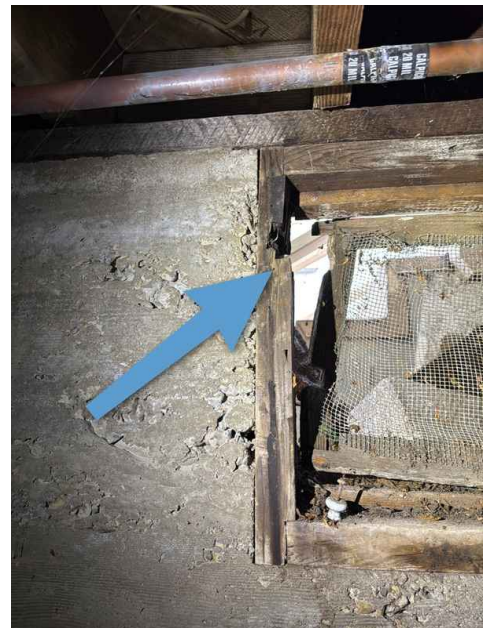
**VENT SCREEN DEFECT**

Vent screen was damaged or missing and should be corrected to allow air flow, but prevent entry of pests.

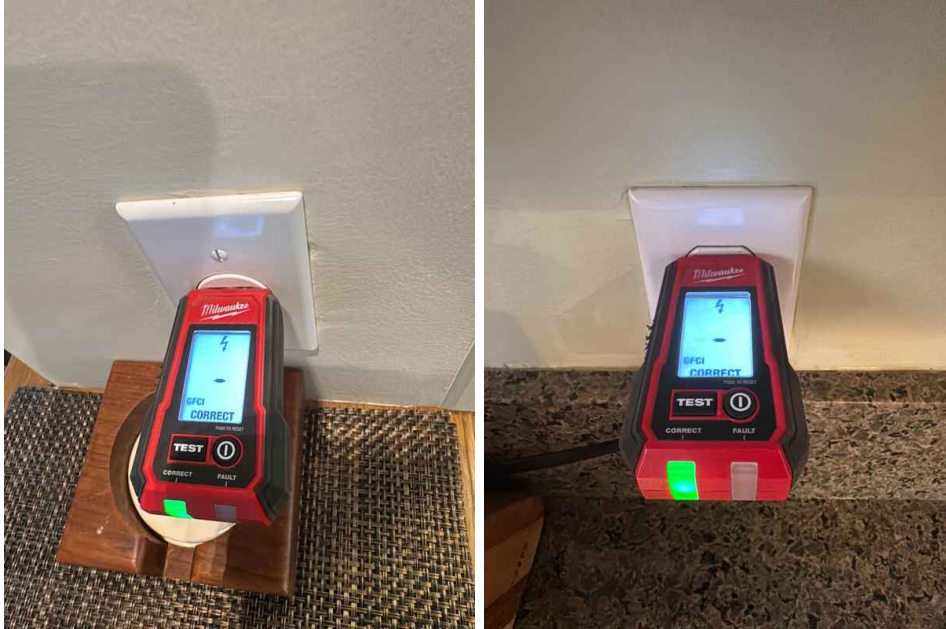
Receptacle at Kitchen counter was not GFI-protected. Current practice calls for all receptacles that serve Kitchen counters to be GFI-protected in order to help reduce the risk of shock in wet areas. Recommend installation for occupants' safety.

Contact a qualified electrical contractor.

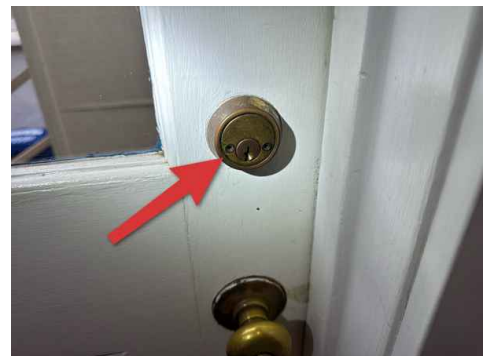
## 19.5.1 Door(s)

**KEYED DEADBOLT**

Door had a deadbolt operated by a key on both sides (dual cylinder). These are considered a danger, especially in case of a fire, and should be replaced with a lever-operated (single cylinder) deadbolt.

Contact a qualified door repair/installation contractor.

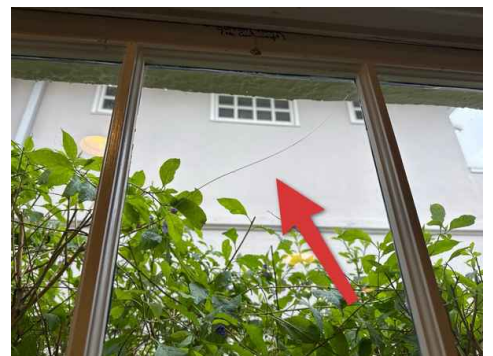
## 19.6.1 Windows

**GLASS DEFECT**

Window pane was cracked or damaged and should be replaced for occupants' safety.

Contact a qualified window repair/installation contractor.

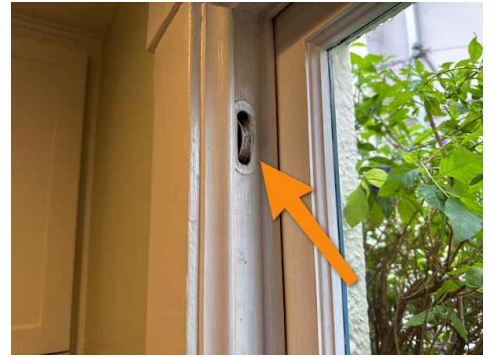
## 19.6.2 Windows

**BALANCE DEFECT**

Window balance or sash cord was broken. This helps counter-balance the weight of the sash when open. If the balance is broken, the sash is more likely to fall suddenly and can be more difficult to open and close.

Contact a qualified window repair/installation contractor.

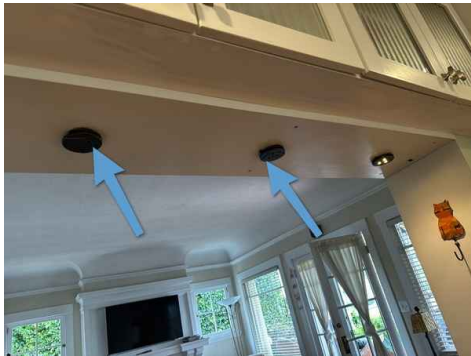
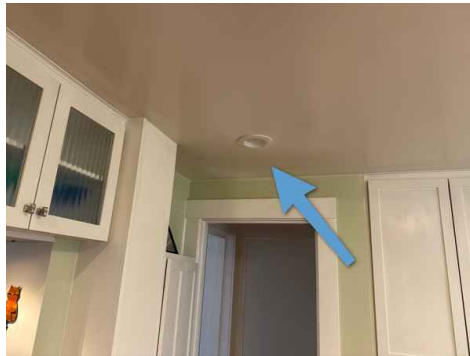
## 19.7.1 Lighting

Light fixture had a bulb missing or burnt out. Recommend replacement of bulb and testing of fixture.

Contact a handyman or DIY project

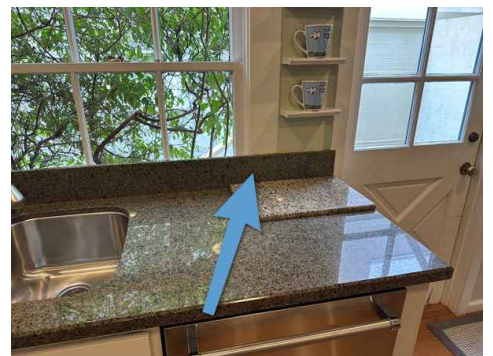
## 19.8.1 Electrical

Current practice calls for enough receptacles at kitchen counters such that no point on a counter is more than 24 inches from an receptacle. Recommend further evaluation by a qualified electrician.

Contact a qualified electrical contractor.

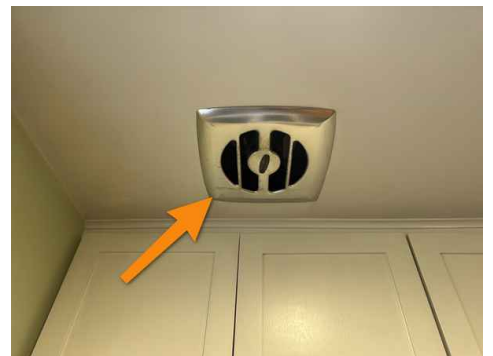
## 19.16.1 Ventilator

Exhaust fan was inoperable. Recommend repair so that there is proper ventilation in the Kitchen.

Contact a qualified appliance repair professional.

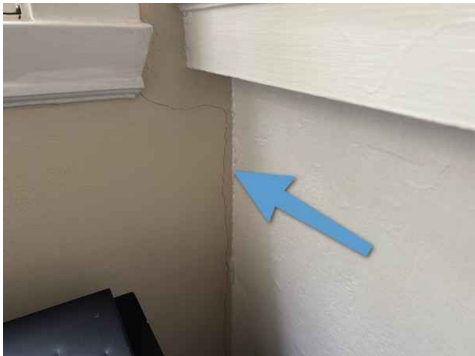
### CRACKS - TYPICAL

Surface was cracked. Crack appeared typical of normal settling and not indicative of a larger problem.

Recommendation  
Recommend monitoring.

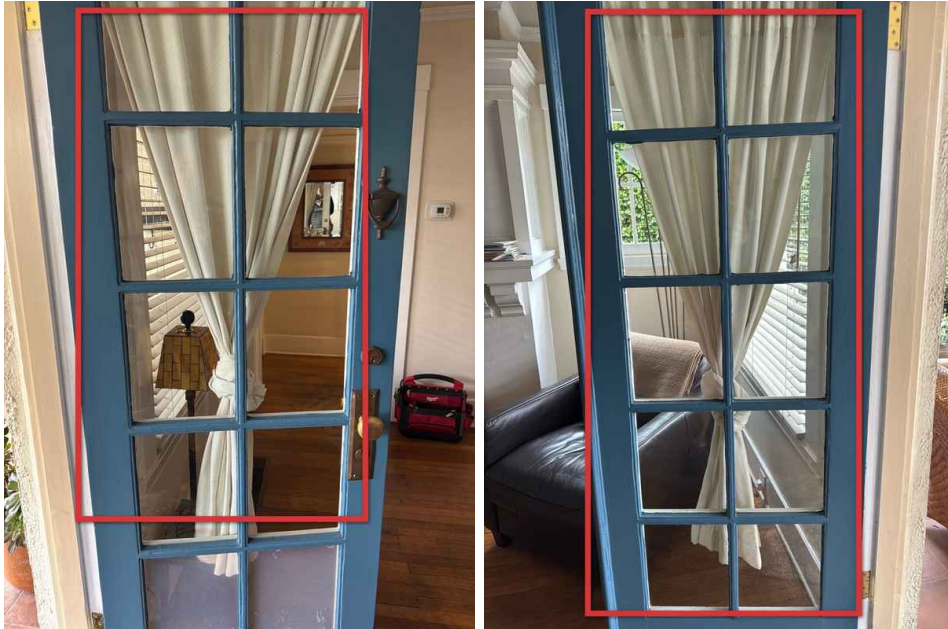
## 20.4.1 Door(s)

**SAFETY GLASS NOT OBSERVED**

Current practice calls for safety glass in doors, and any side lites or windows adjacent to doors. Recommend correction for occupants' safety.

Contact a qualified door repair/installation contractor.

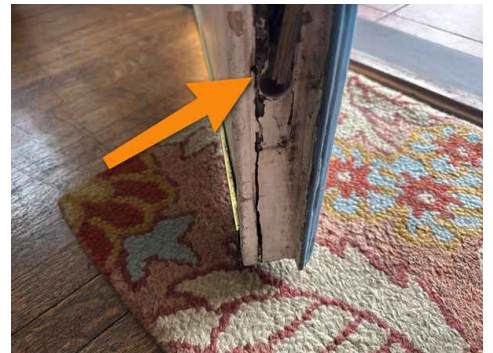
## 20.4.2 Door(s)

**LATCH DEFECT**

Door did not latch properly and should be adjusted or repaired.

Contact a qualified door repair/installation contractor.

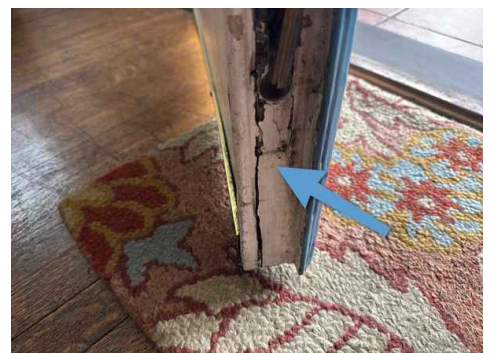
## 20.4.3 Door(s)

**MINOR DAMAGE**

Door had minor damage that did not affect its function.

Recommend monitoring.

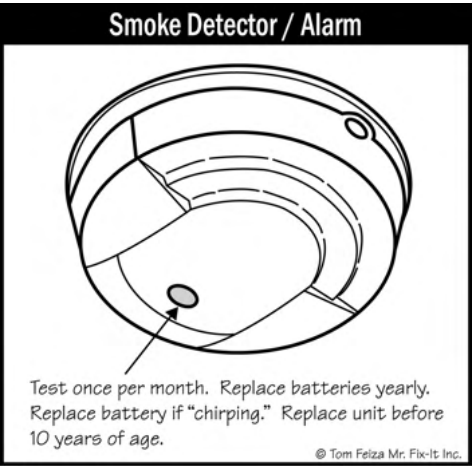
Current practice calls for a smoke alarm in every sleeping room. Recommend installation for occupants' safety.

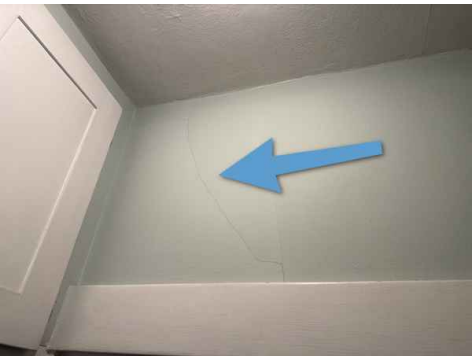
21.2.1 Walls & Ceiling

**CRACKS - TYPICAL**

Surface was cracked. Crack appeared typical of normal settling and not indicative of a larger problem.

Recommend monitoring.

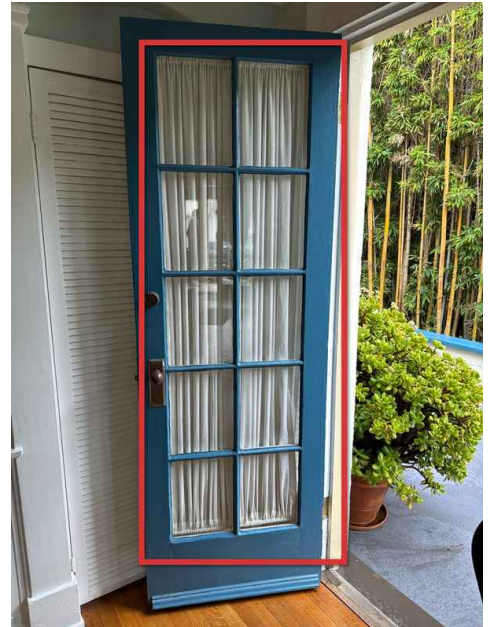
## 21.4.1 Door(s)

**SAFETY GLASS NOT OBSERVED**

Current practice calls for safety glass in doors, and any side lites or windows adjacent to doors. Recommend correction for occupants' safety.

Contact a qualified door repair/installation contractor.

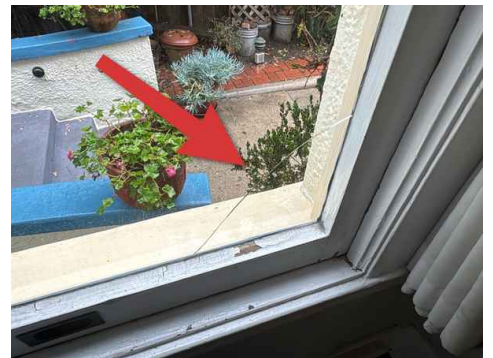
## 21.5.1 Windows

**GLASS DEFECT**

Window pane was cracked or damaged and should be replaced for occupants' safety.

Contact a qualified window repair/installation contractor.

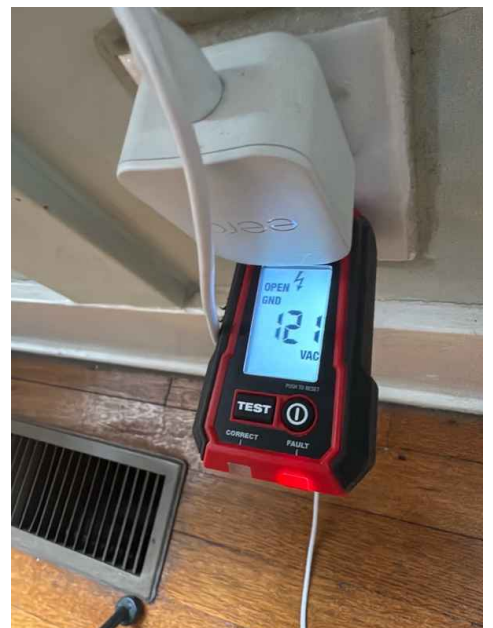
## 21.7.1 Electrical

Ungrounded receptacle observed. This represents a safety hazard and may result in damage to equipment. Recommend evaluation of the electrical system to see if outlet can be grounded.

Contact a qualified electrical contractor.

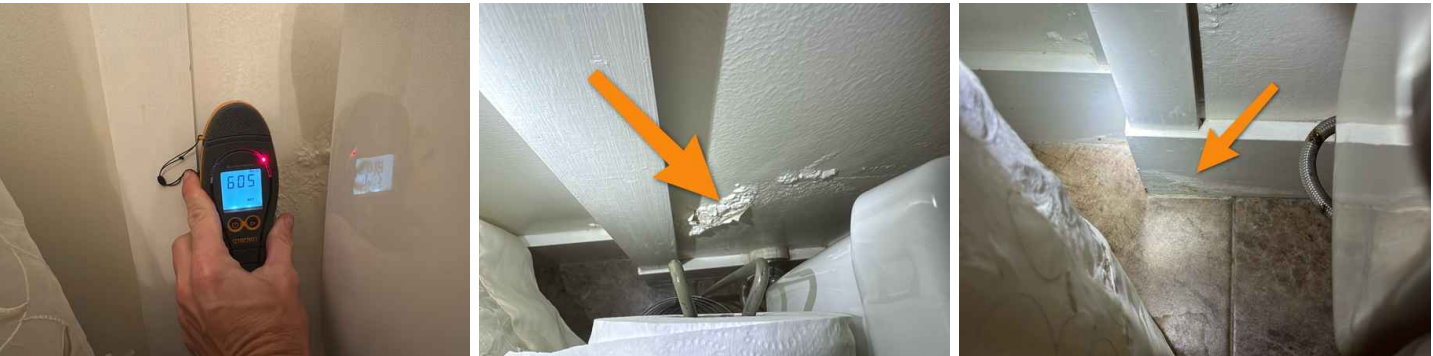
MOISTURE DETECTED

Excessive moisture was found with the use of a moisture meter. Recommend opening wall to determine the source of moisture and extent of the damage.

Contact a qualified general contractor.

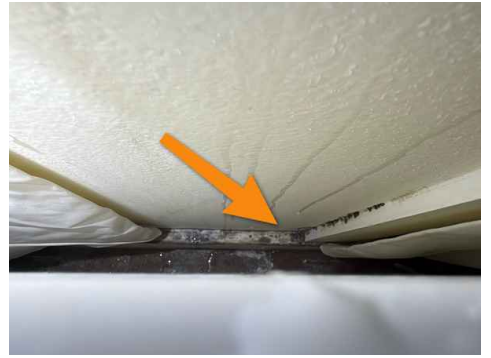
## 22.3.2 Walls &amp; Ceiling

An organic growth was observed, which is a sign of a moisture problem. Recommend removal of damaged material and monitoring for moisture intrusion. If condition continues or worsens, an environmental hazards contractor may be necessary to help determine the best course of action.

Contact a qualified environmental contractor

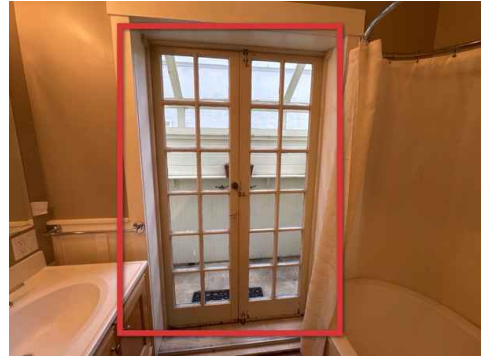
## 22.5.1 Door(s)

**SAFETY GLASS NOT OBSERVED**

Current practice calls for safety glass in doors, and any side lites or windows adjacent to doors. Recommend correction for occupants' safety.

Contact a qualified door repair/installation contractor.

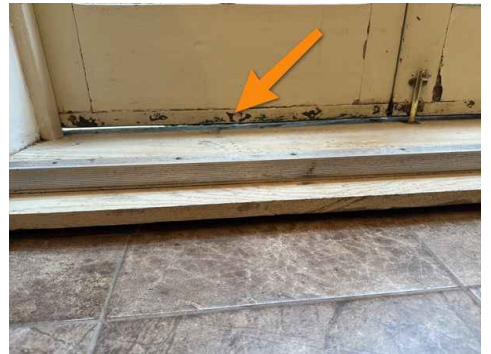
## 22.5.2 Door(s)

The exterior door had gaps around it that will let outside elements and possibly pests into the home, as well as any conditioned air out of the home. Recommend weather-stripping or improving door alignment.

Contact a qualified door repair/installation contractor.

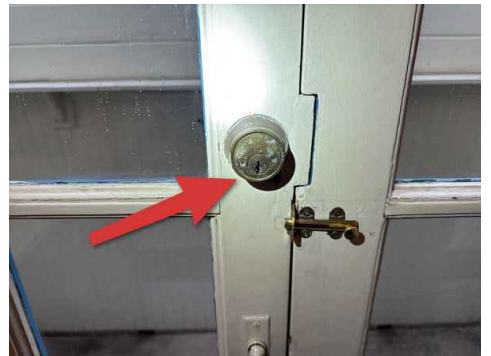
## 22.5.3 Door(s)

Door had a deadbolt operated by a key on both sides (dual cylinder). These are considered a danger, especially in case of a fire, and should be replaced with a lever-operated (single cylinder) deadbolt.

Contact a qualified door repair/installation contractor.

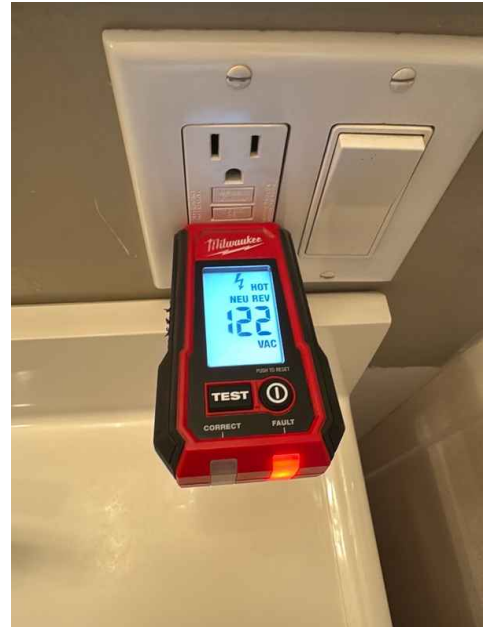
## 22.8.1 Electrical

**RECEPTACLE WIRING DEFECT**

Receptacle was wired incorrectly or not functional. Incorrect wiring of a receptacle could present a higher risk of shock or damage to equipment. Recommend correction.

Contact a qualified electrical contractor.

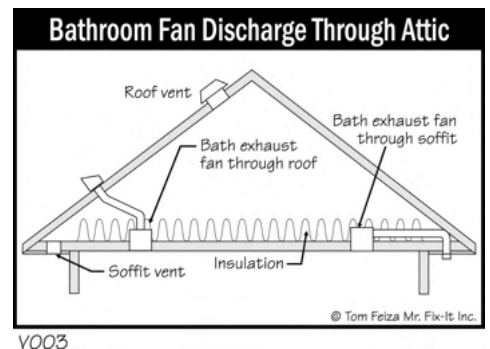
## 22.10.1 Ventilation

**RECOMMEND ADDING VENT FAN**

No ventilation fan was installed. Recommend adding to help remove moisture from the room. Though a window meets code, a fan is more effective and can be used in all seasons.

Contact a qualified general contractor.

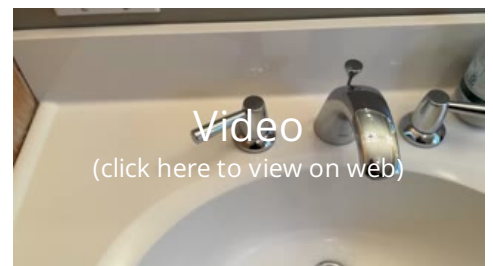
## 22.11.1 Sink

**FAUCET HANDLE DEFECT**

Sink faucet handle was **loose**, missing or could not be operated properly and should be repaired or replaced.

Contact a qualified plumbing contractor.

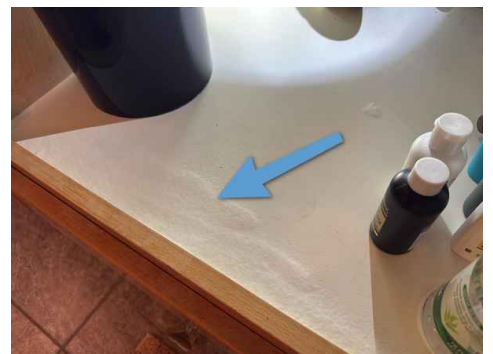
## 22.13.1 Cabinets

**PAST WATER DAMAGE UNDER SINK**

Cabinet was damaged or stained from a past water leak. No leak observed during inspection.

Recommend monitoring.

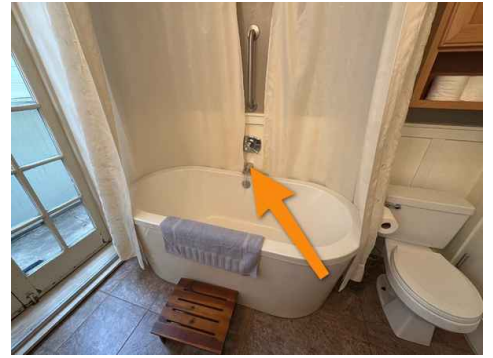
## 22.15.1 Tub / Shower Enclosure

Wood trim or paneling installed directly adjacent to a bathtub is prone to moisture exposure from regular bathing use. Over time, repeated splashing and steam can cause wood to absorb water, leading to deterioration such as swelling, rot, warping, and damage to finishes. These conditions can also promote mold growth and compromise the integrity of surrounding materials. A more water-resistant finish or material is recommended to prevent future damage.

Contact a qualified general contractor.

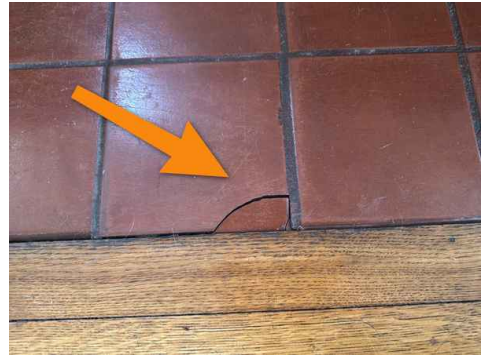
**TILE DEFECT**

Tile at fireplace was cracked, broken or missing. Damaged tile should be repaired or replaced.

Contact a qualified tile contractor

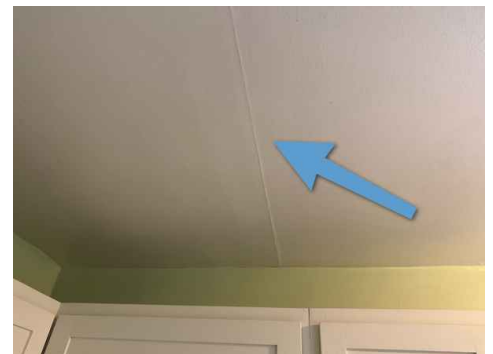
**CRACKS - TYPICAL**

Surface was cracked. Crack appeared typical of normal settling and not indicative of a larger problem.

Recommend monitoring.

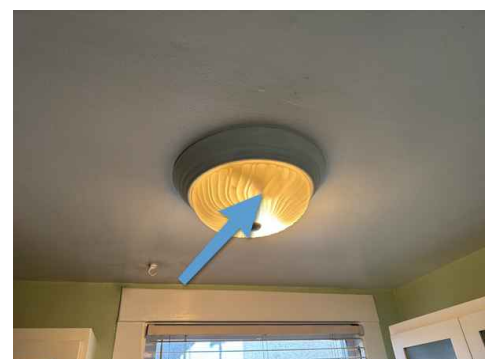
### 25.7.1 Lighting

**BULB OUT**

Light fixture had a bulb missing or burnt out. Recommend replacement of bulb and testing of fixture.

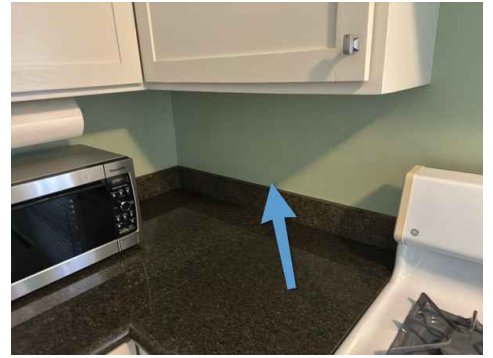
## 25.8.1 Electrical

Current practice calls for enough receptacles at kitchen counters such that no point on a counter is more than 24 inches from an receptacle. Recommend further evaluation by a qualified electrician.

Contact a qualified electrical contractor.

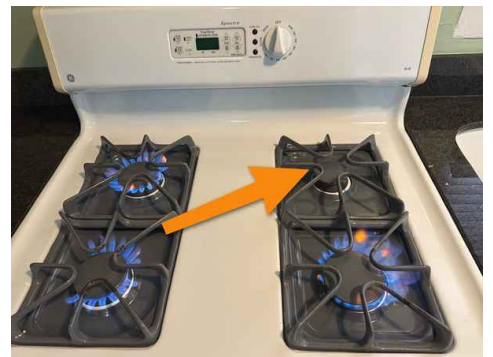
## 25.14.2 Cooking

**BURNER DID NOT LIGHT**

Stove burner did not light or heat up on its own. Appliance should be serviced or repaired.

Contact a qualified appliance repair professional.

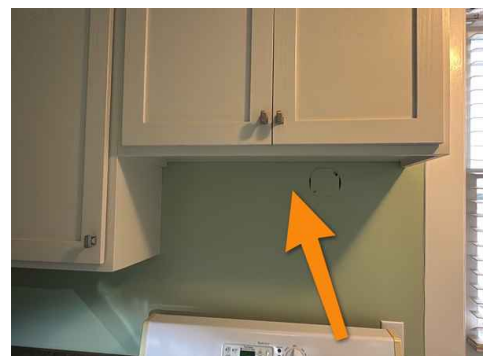
## 25.16.1 Ventilator

No vent was present. Current practice calls for powered ventilation in all kitchens to exhaust the moisture, heat and gas from the cooking appliance. In homes without an external vent present, a recirculating vent can be used.

Contact a qualified general contractor.
