STEADFAST HOME INSPECTION

## PROPERTY INSPECTION REPORT

118 Chapala St  
Santa Barbara, CA 93101

11/20/2025

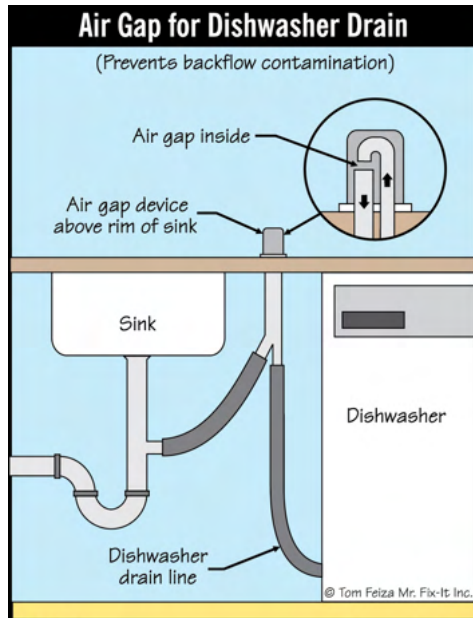
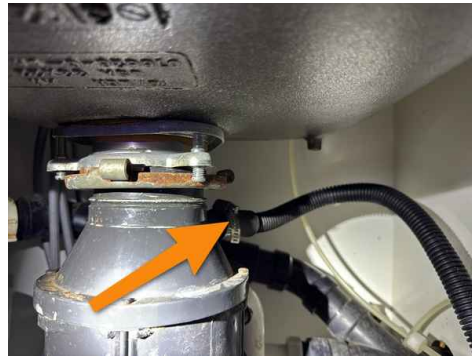
## 25.17.1 Dishwasher

Dishwasher did not have an air gap installed. A physical air gap helps protect the public water supply in case of a loss of pressure. Although required by the local building code, many people opt to go without. If this is the case, a high-loop of the dishwasher drain line under the counter is highly recommended (or some other means of backflow prevention).

Contact a qualified plumbing contractor.

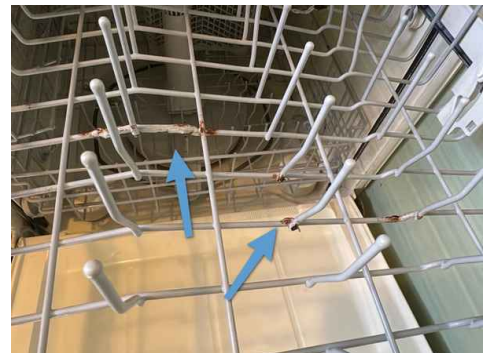
## 25.17.2 Dishwasher

**RUST INSIDE**

Dishwasher rack was rusted, which will affect the performance of the washer. Recommend repair or replacement of rack.

Contact a qualified appliance repair professional.

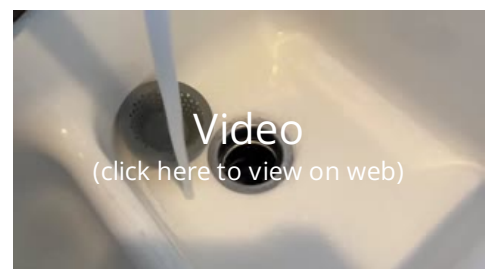
## 25.18.1 Disposal

Disposal operated, but was noisy, which may indicate a need for adjustment or repair.

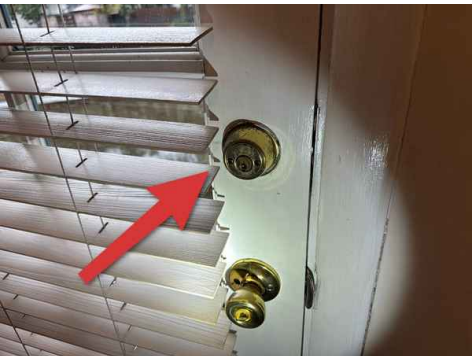
27.4.1 Door(s)

Door had a deadbolt operated by a key on both sides (dual cylinder). These are considered a danger, especially in case of a fire, and should be replaced with a lever-operated (single cylinder) deadbolt.

Contact a qualified door repair/installation contractor.

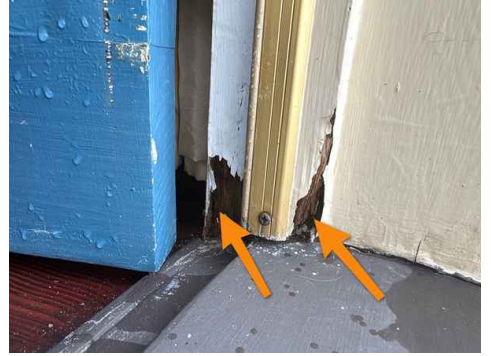
## 27.4.2 Door(s)

**WOOD DECAY**

Wood decay observed, which should be repaired or replaced to reduce chances of further decay or moisture intrusion.

Contact a qualified door repair/installation contractor.

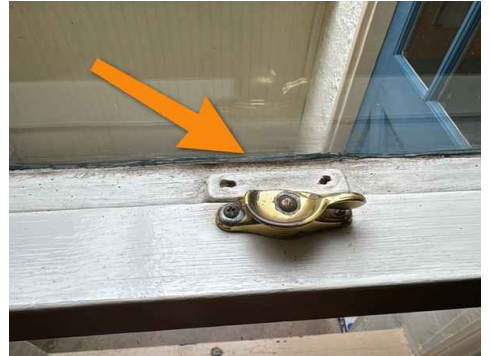
## 27.5.1 Windows

**LATCH DEFECT**

Window did not latch or lock properly and should be repaired for security purposes.

Contact a qualified window repair/installation contractor.

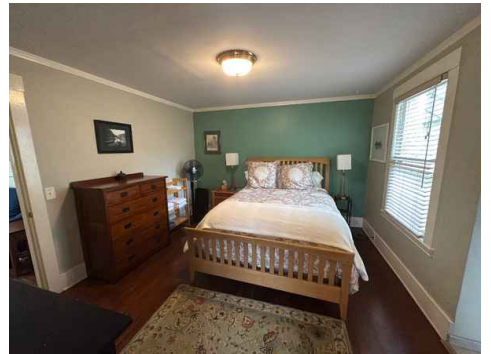
## 27.8.1 HVAC

Current practice calls for all habitable spaces to be heated by a permanently installed appliance capable of maintaining the room at a minimum of 68 degrees. Recommend further evaluation by a qualified HVAC contractor.

Contact a qualified HVAC professional.

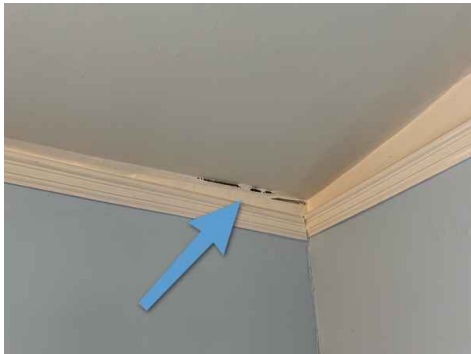
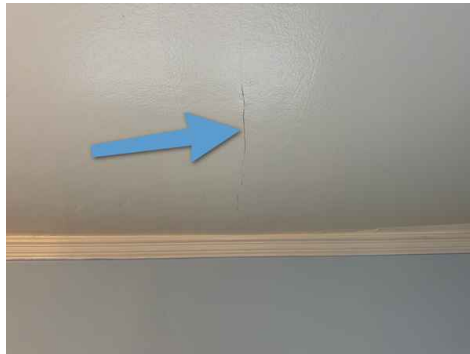
**CRACKS - TYPICAL**

Surface was cracked. Crack appeared typical of normal settling and not indicative of a larger problem.

Recommend monitoring.

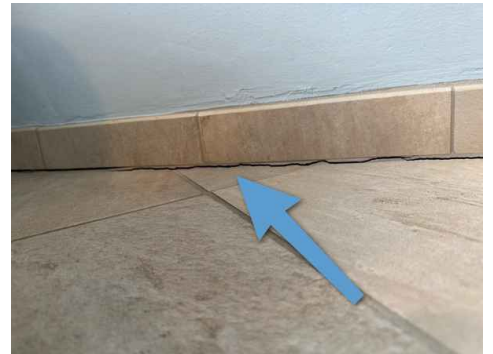
## 28.4.1 Floor

**GROUT DEFECT**

Grout was damaged or missing and should be repaired. Grout holds the tiles in place and helps keep water from penetrating between the tiles.

Contact a qualified tile contractor

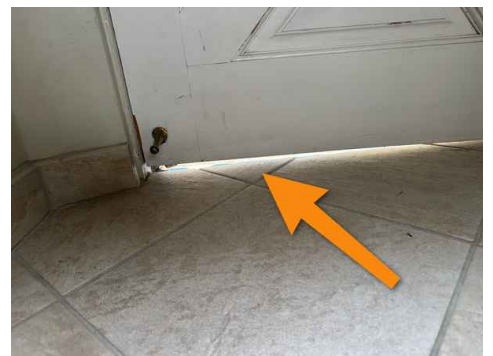
## 28.5.1 Door(s)

**GAP AT EXTERIOR DOOR**

The exterior door had gaps around it that will let outside elements and possibly pests into the home, as well as any conditioned air out of the home. Recommend weather-stripping or improving door alignment.

Contact a qualified door repair/installation contractor.

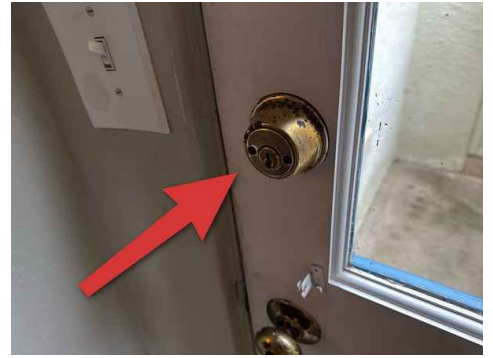
## 28.5.2 Door(s)

Door had a deadbolt operated by a key on both sides (dual cylinder). These are considered a danger, especially in case of a fire, and should be replaced with a lever-operated (single cylinder) deadbolt.

Contact a qualified door repair/installation contractor.

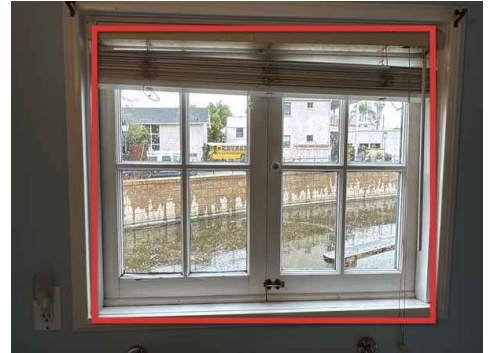
## 28.6.1 Windows

**SAFETY GLASS NOT OBSERVED IN BATHROOM**

Current practice calls for safety glass when used in and around showers and tubs (within 5 feet) when the bottom edge is less than 5 feet above the ground. Recommend correction for occupants' safety.

Safety glass (or tempered glass) can be identified by a marking etched into the glass. In certain cases, it is possible that safety glass is present, but the etching was not observed.

Contact a qualified window repair/installation contractor.

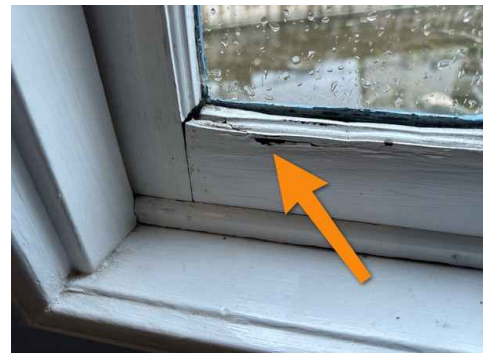
## 28.6.2 Windows

**WOOD DECAY**

Wood decay observed, which should be repaired or replaced to reduce chances of further decay or moisture intrusion.

Contact a qualified window repair/installation contractor.

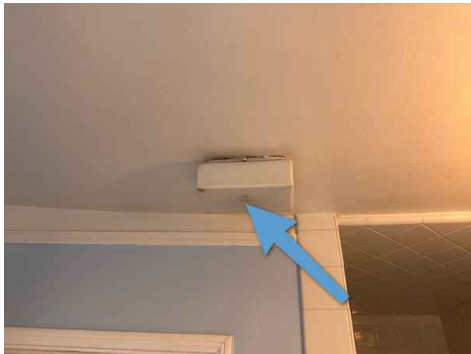
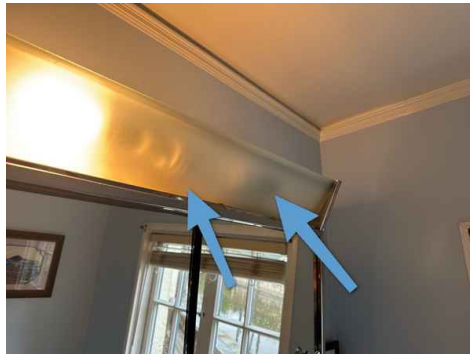
## 28.7.1 Lighting

**BULB OUT**

Light fixture had a bulb missing or burnt out. Recommend replacement of bulb and testing of fixture.

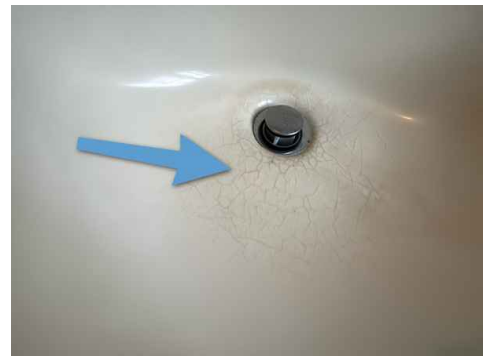
## 28.11.1 Sink

**SINK FINISH DAMAGED**

Sink finish was chipped or cracked. The finish is the waterproofing that protects the material underneath. Recommend repair or replacement.

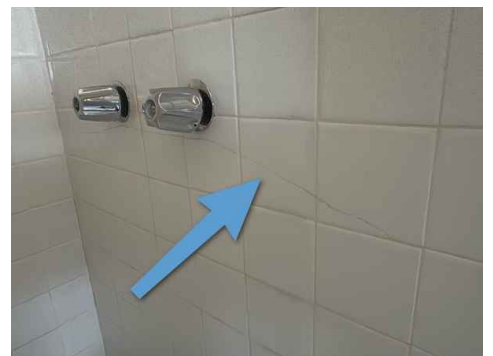
## 28.15.1 Tub / Shower Enclosure

**TILE DEFECT AT SHOWER OR SURROUND**

Tile was cracked or damaged at tub or shower surround. A small crack can be sealed and monitored. If crack worsens, tile should be replaced to help prevent water intrusion.

Recommend monitoring.

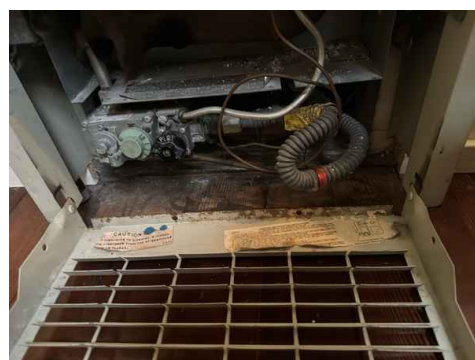
#### **GAS NOT ON**

Heating appliance could not be tested because the gas was not on. Recommend testing once gas service has been restored.

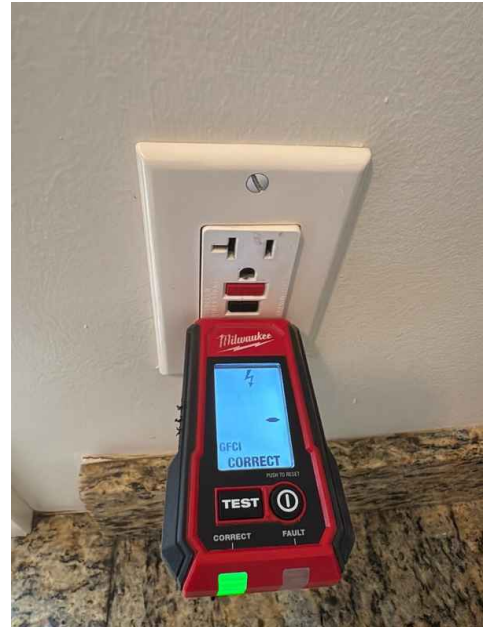
**GFI DEFECT**

GFI device was not functional. It did not trip when tested, would not reset after testing, or was mis-wired. GFI device should be repaired or replaced for occupants' safety.

Contact a qualified electrical contractor.

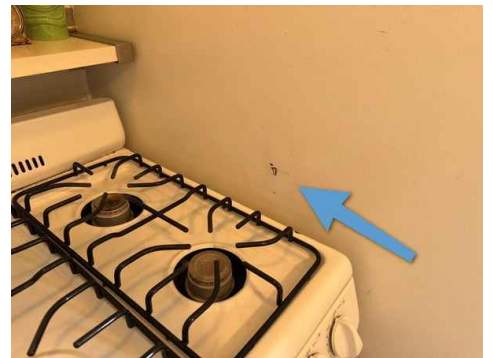
## 30.3.1 Walls &amp; Ceiling

**SURFACE DAMAGE**

Surface had a gap, dent or hole and should be repaired.

Contact a handyman or DIY project

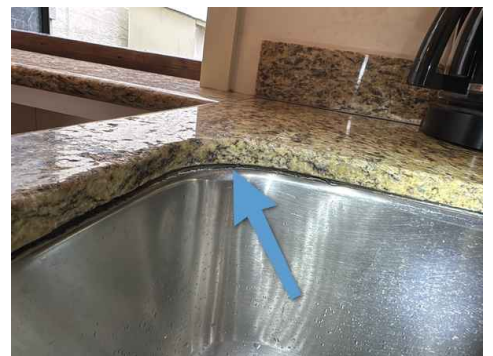
## 30.9.1 Sink

**CAULK DEFECT**

Caulk around the sink was damaged or missing. It should be repaired to help keep water from dripping into the cabinet below the sink and causing damage.

Contact a qualified countertop contractor.

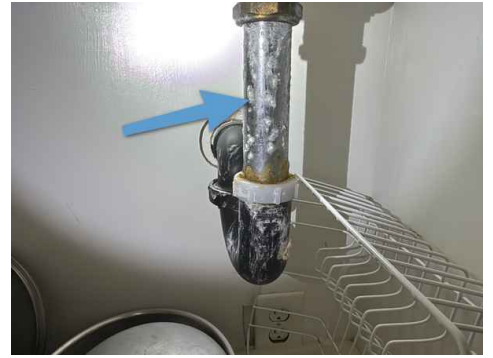
## 30.9.2 Sink

**CORROSION**

Sink plumbing had corrosion, which is a sign of a slow leak over time. Recommend cleaning or monitoring.

Recommend monitoring.

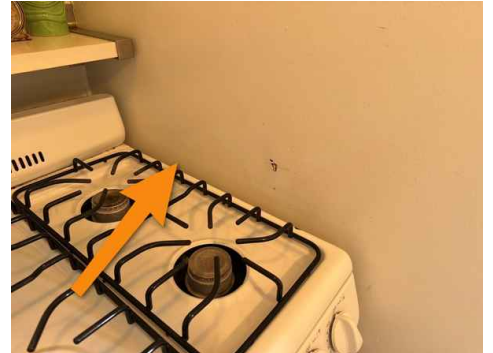
## 30.14.1 Cooking

**INADEQUATE CLEARANCE TO COMBUSTIBLES**

Generally, an electric range may not need clearance, but up to 6 inches may be preferred to help prevent damage to certain materials and a gas range should have 3-6 inches of clearance to any combustible materials.

Contact a qualified general contractor.

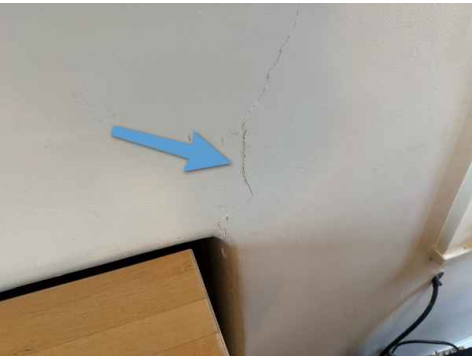
### CRACKS - TYPICAL

Surface was cracked. Crack appeared typical of normal settling and not indicative of a larger problem.

Recommendation  
Recommend monitoring.

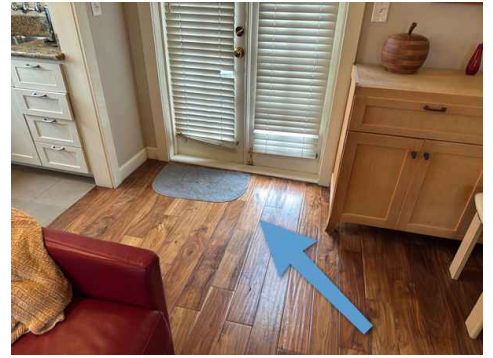
## 31.3.1 Floor

**FLOOR UNEVEN**

Floor had an area of unevenness that could be due to settling or imperfection of the installed flooring and subfloor. Unless paired with other signs of major damage, it is not likely to be a significant concern.

Recommend monitoring.

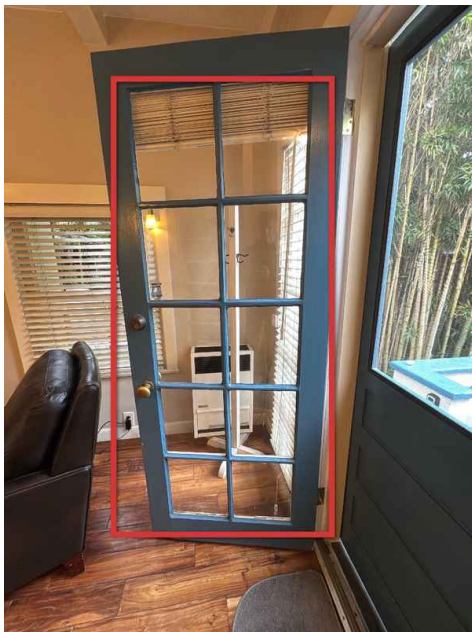
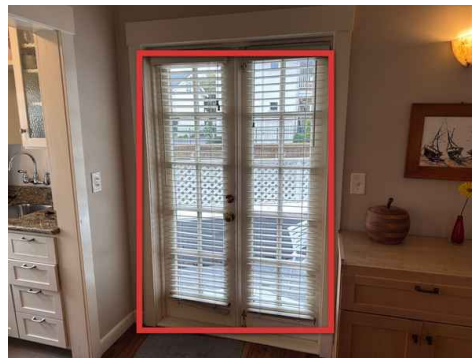
## 31.4.1 Door(s)

**SAFETY GLASS NOT OBSERVED**

Current practice calls for safety glass in doors, and any side lites or windows adjacent to doors. Recommend correction for occupants' safety.

Contact a qualified door repair/installation contractor.

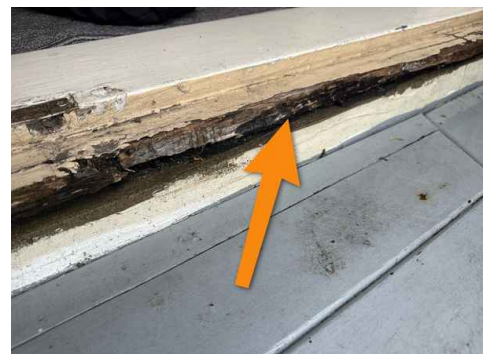
## 31.4.2 Door(s)

**WOOD DECAY**

Wood decay observed, which should be repaired or replaced to reduce chances of further decay or moisture intrusion.

Contact a qualified door repair/installation contractor.

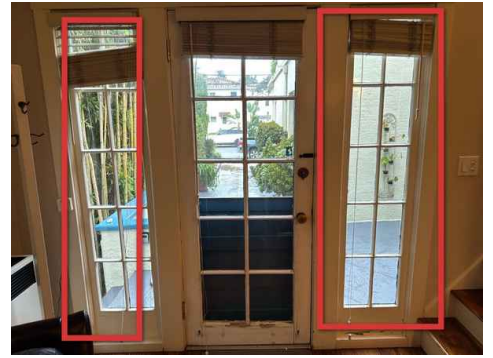
## 31.5.1 Windows

**SAFETY GLASS NOT OBSERVED**

Current practice calls for safety glass when windows are positioned within 18 inches of the floor, large enough to fall through or **adjacent to doors**. Recommend correction for occupants' safety.

Contact a qualified window repair/installation contractor.

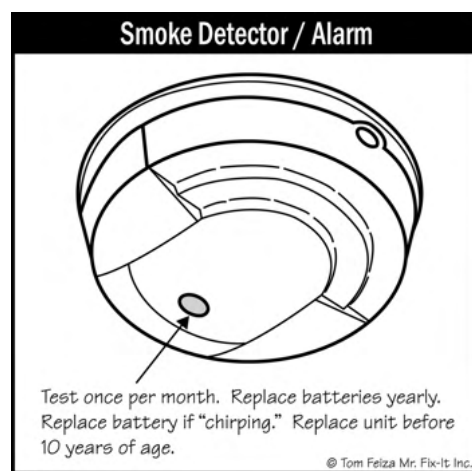
Current practice calls for a smoke alarm in every sleeping room. Recommend installation for occupants' safety.

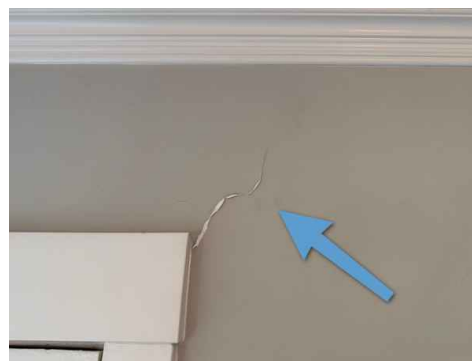
#### 32.2.1 Walls & Ceiling

#### **CRACKS - TYPICAL**

Surface was cracked. Crack appeared typical of normal settling and not indicative of a larger problem.

Recommend monitoring.

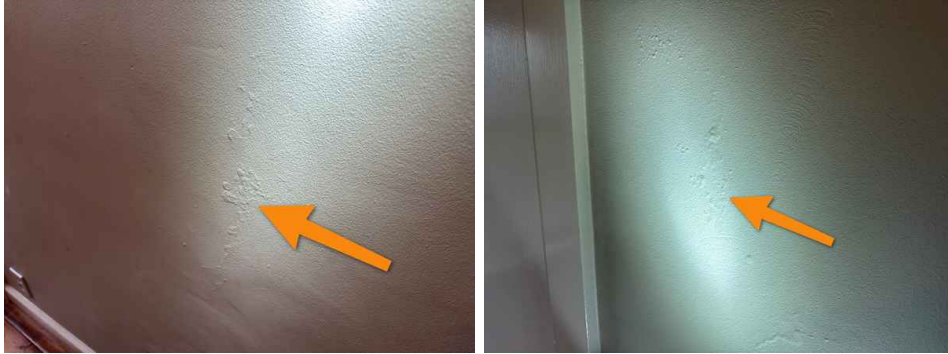
## 32.2.2 Walls &amp; Ceiling

**MOISTURE DAMAGE**

Surface had signs of moisture damage but was not currently wet. Recommend replacement of damaged material and monitoring the area. Damage may extend beyond what is visible.

Contact a qualified drywall contractor.

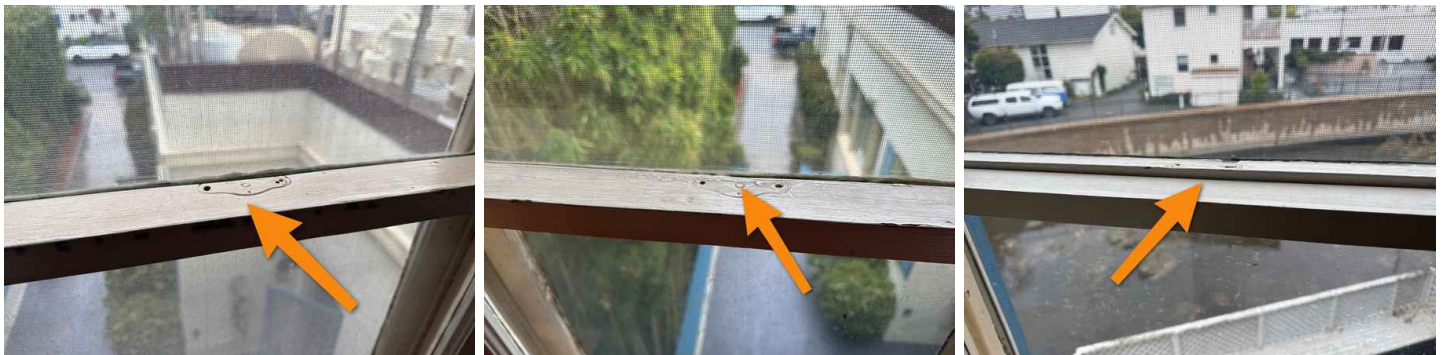
## 32.5.1 Windows

**LATCH DEFECT**

Window did not latch or lock properly and should be repaired for security purposes.

Contact a qualified window repair/installation contractor.

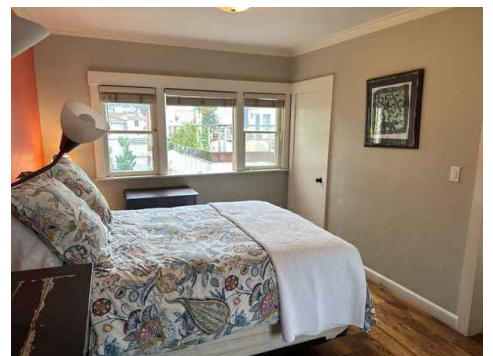
## 32.8.1 HVAC

**NO HEAT SOURCE IN ROOM**

Current practice calls for all habitable spaces to be heated by a permanently installed appliance capable of maintaining the room at a minimum of 68 degrees. Recommend further evaluation by a qualified HVAC contractor.

Contact a qualified HVAC professional.

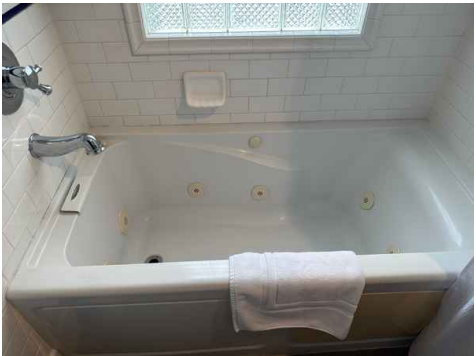
### SPA TUB NOT TESTED

The spa tub was not inspected, as the tub could not be safely filled to the proper level. Recommend further evaluation by a qualified plumber.

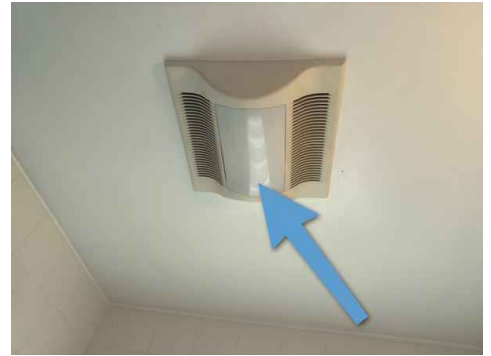
### 33.10.1 Ventilation

Fixture had a bulb missing or burnt out. Recommend replacement of bulb and testing of fixture.

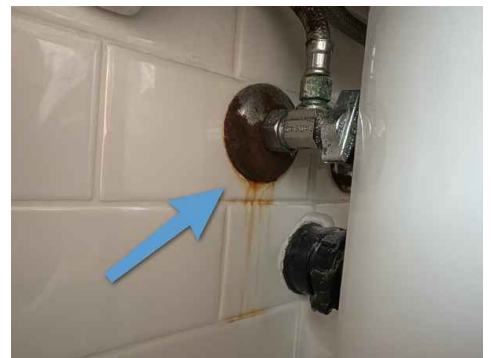
### 33.11.1 Sink

#### **CORROSION**

Sink plumbing had corrosion, which is a sign of a slow leak over time. Recommend cleaning or monitoring.

Recommend monitoring.

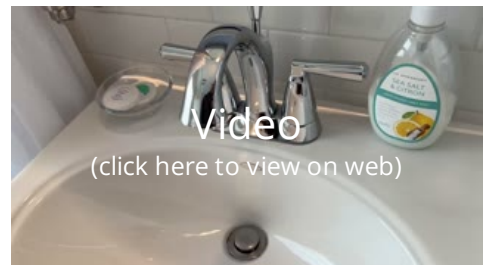
### 33.11.2 Sink

#### **FAUCET LOOSE**

Faucet was loose and should be secured. Loose faucets can lead to leaks or allow water intrusion under the counter.

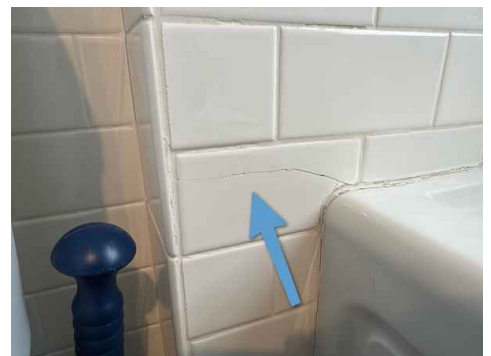
### 33.15.1 Tub / Shower Enclosure

#### **TILE DEFECT AT SHOWER OR SURROUND**

Tile was cracked or damaged at tub or shower surround. A small crack can be sealed and monitored. If crack worsens, tile should be replaced to help prevent water intrusion.

Recommend monitoring.

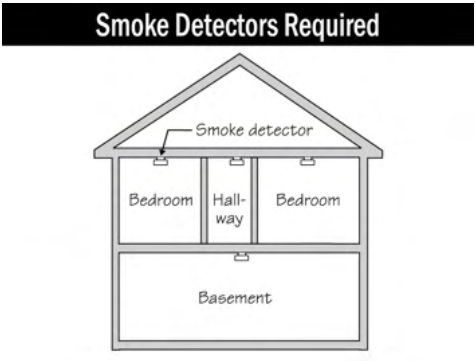
Current practice calls for a smoke alarm in each bedroom and one **outside any sleeping area**, with at least one on each level of the home. Recommend installation for occupants' safety.

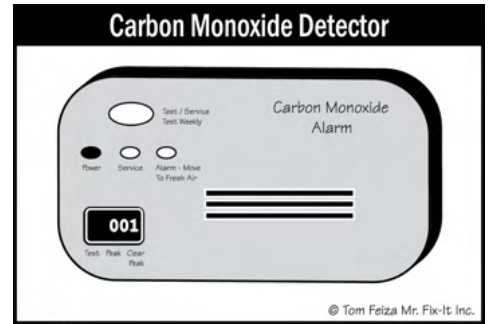
## 34.1.2 Safety

Recommend installation for occupants' safety.

Contact a handyman or DIY project

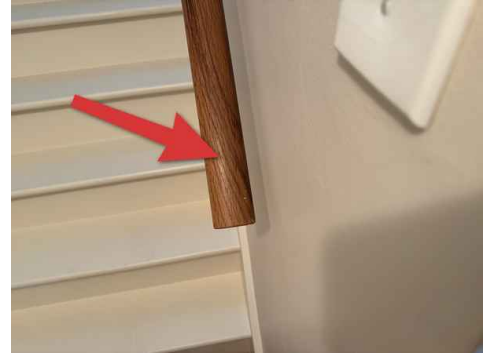
## 34.2.1 Stairway

The stair railing did not have a return to the wall at the end, which is considered a safety hazard. Because straps, clothing or especially firefighting equipment may get caught on the end of the railing, all handrails should have a return to the wall at their ends.

Contact a qualified general contractor.

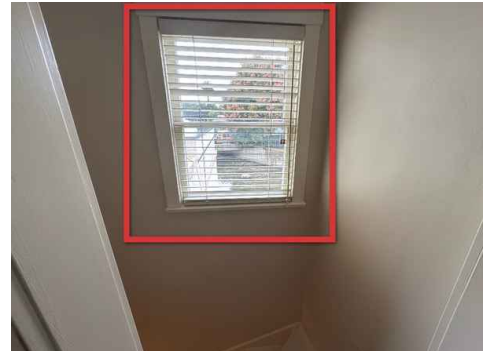
## 34.2.2 Stairway

**SAFETY GLASS NOT OBSERVED AT STAIRWAY**

Current practice calls for windows in stairways or adjacent landings to be made of safety glass if the window is within 60 inches of the top of the nearest stair tread. Recommend installation of safety glass for occupants' safety.

Contact a qualified window repair/installation contractor.

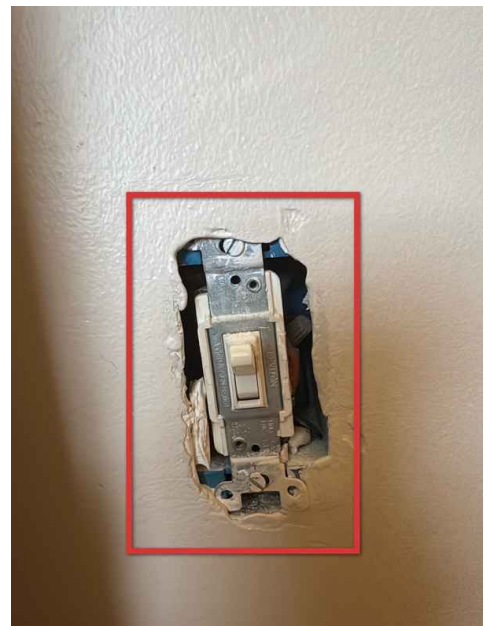
## 34.7.1 Lighting

**SWITCH COVER DEFECT**

Light switch cover plate was broken or missing. The cover prevents access to the live electrical conductors within. Cover should be installed.

Contact a handyman or DIY project

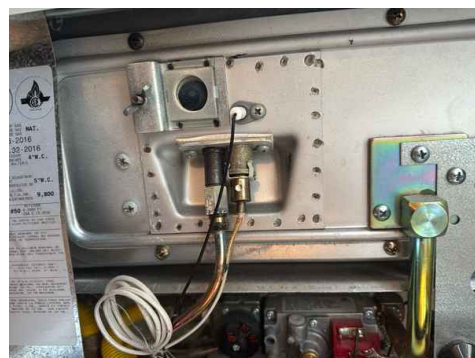
##### **PILOT NOT LIT**

Heater was not inspected because the pilot light was not lit. Without knowing why it had been extinguished, it should not be re-lit. Recommend testing appliance before use.

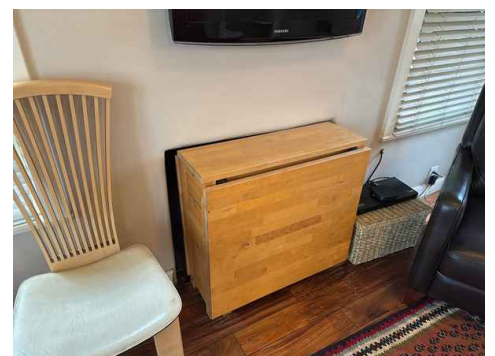
##### **OBSTRUCTED**

Fireplace or its components were not inspected due to occupant's belongings obstructing access.
