STEADFAST HOME INSPECTION

## PROPERTY INSPECTION REPORT

4676 Gerona Way  
Santa Barbara, CA 93110

09/10/2024

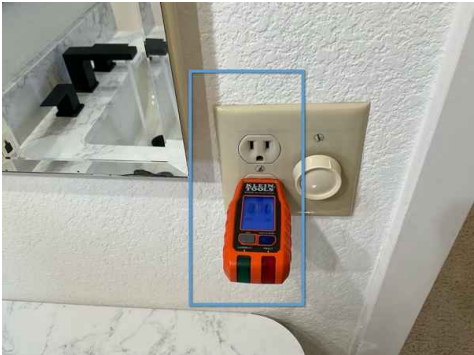
##### TRIPS IN PRIMARY BATHROOM

The receptacle in this area was GFI-protected by a device in a different room. This meets current standards for GFI protected, but if the receptacle trips and turns off, it must be reset in that room.

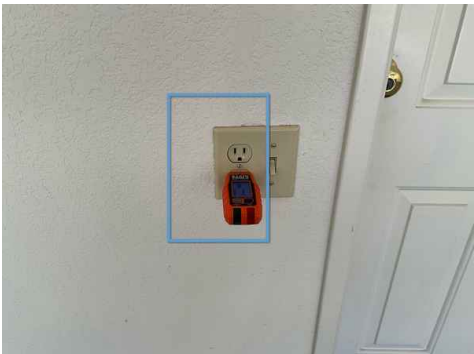
##### TRIPS IN PRIMARY BATHROOM

The receptacle in this area was GFI-protected by a device in a different room. This meets current standards for GFI protected, but if the receptacle trips and turns off, it must be reset in that room.
