**HomeTeam**<sup>®</sup>  
INSPECTION SERVICE

**886 N Meadowcroft Ave**  
**RE: Pittsburgh, PA 15216**  
**Inspection #: 527-072025-6406**

### *HOME INSPECTION REPORT*

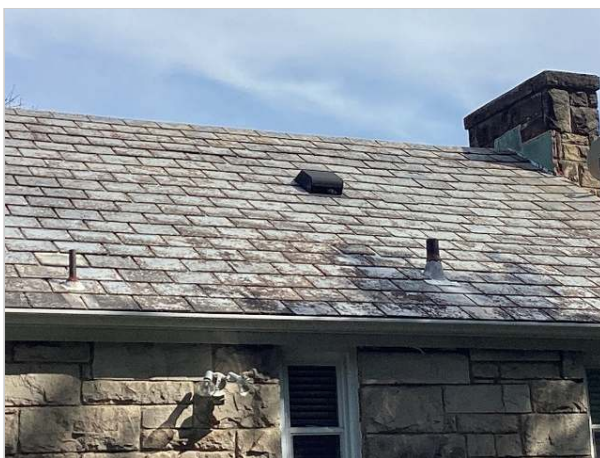
The roof was a gable design covered with slate. Observation of the roof surfaces, flashing, skylights and penetrations through the roof was performed from the ground level with the aid of binoculars. We will access the roof as long as it is dry, has a pitch that can be safely walked and accessible with the 16 foot ladder we carry. The age of the roof covering, as reported by the MLS sheet, was unknown. There was one layer of slate on the roof at the time of the inspection. These conditions indicate the roof slate were near the end of their useful life as they appear to be original to the home.

Original slate roof

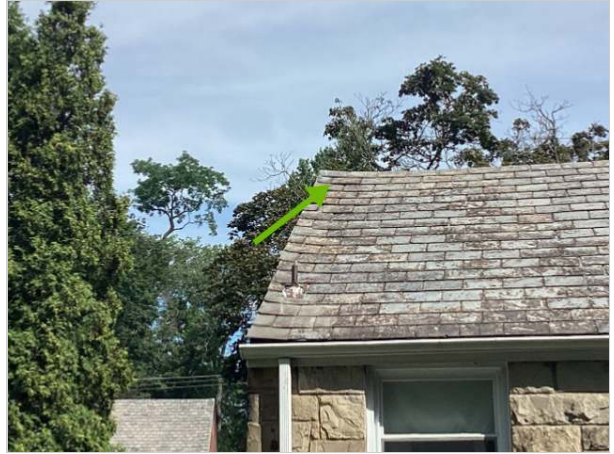
Rear

### ***NOTE: DAMAGED SLATE:***

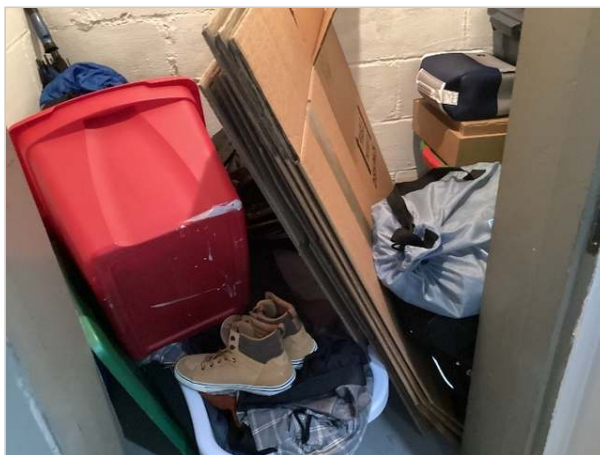
The basement was cluttered with many stored items and/or shelves at the time of inspection, therefore several areas were unable to be inspected.

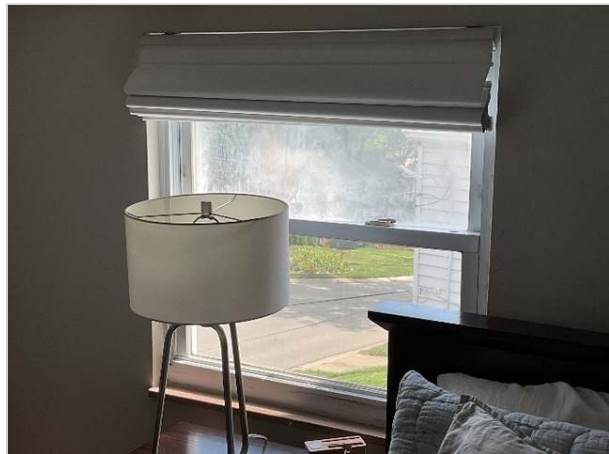
master bedroom

- Water marks with no surface damage was noted on the wall in the master bedroom.

Elevated levels of moisture with no surface damage was noted on the wall in the master bedroom. The moisture appeared to be the result of active leaks. Consult with a qualified contractor for evaluation and repairs as required.

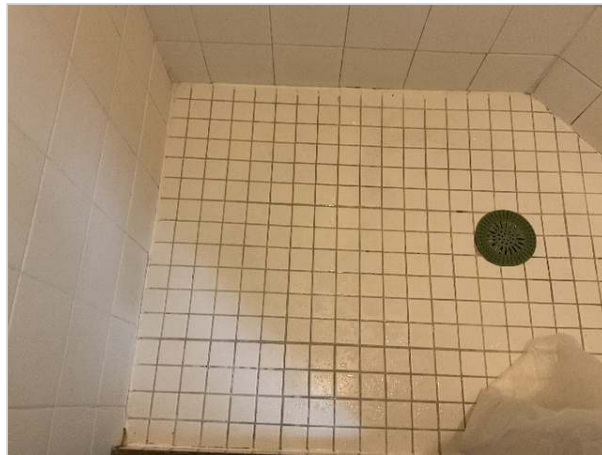
A walk-in shower was located in the master bath. The base of the shower was constructed of ceramic tile. While no leaks were noted at the time of the inspection, this type of shower is more prone to leaks than a standard tub or precast shower base. The waterproof membrane or shower pan, which is the primary water proofing material is installed beneath the finished floor and is not visible from the interior of the shower or the subfloor below. We cannot verify the integrity of the shower pan or concealed portions of the drain. Additionally, our test of the unit cannot simulate an actual shower and therefore is not a guarantee that the unit is free of leaks. The cosmetic condition of the tile or grout is not considered during the inspection. The absence or presence of cracks in the tile or joints is not an indication of a leak free unit.

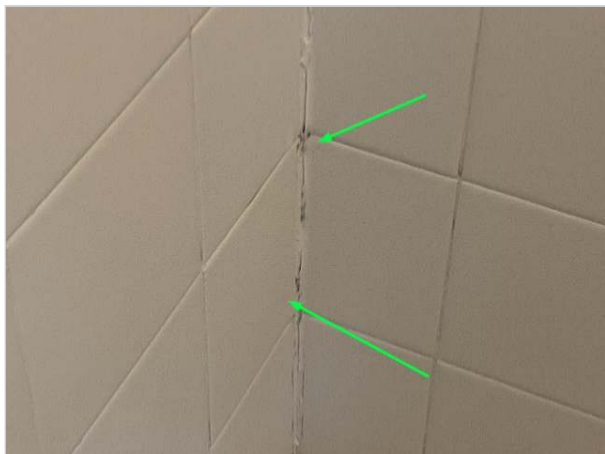
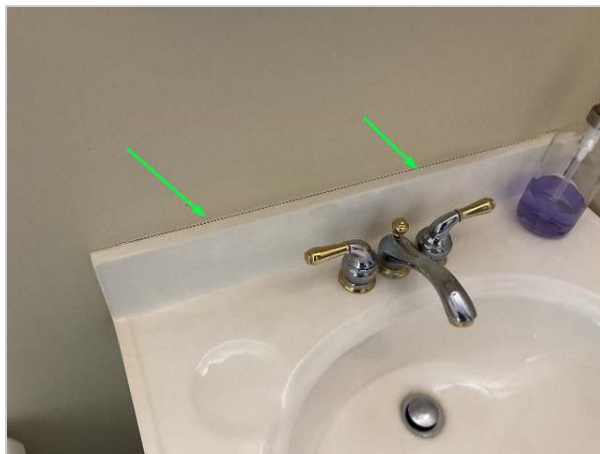
master

Failure to keep walls sealed can cause deterioration and extensive moisture damage including mold growth to the interior walls, which is not always visible at the time of the inspection. Some of the caulk and grout was missing from around the sink top and enclosure. These areas should be re-caulked and re-grouted to help prevent moisture

penetration.

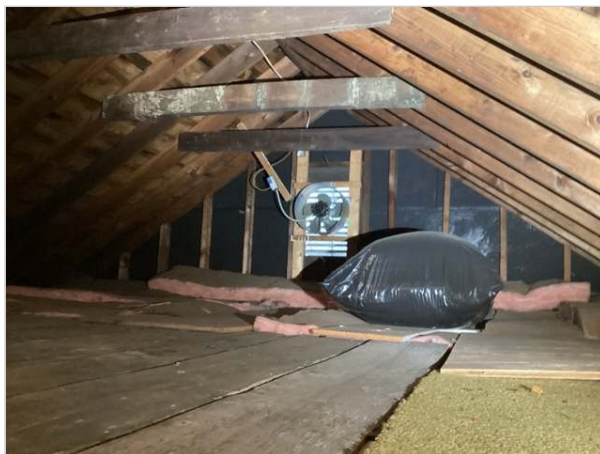
There was moisture visible in the attic space.
