# Home Inspection Report

**694 Valleyview Rd, Pittsburgh, PA 15243**

251103-01

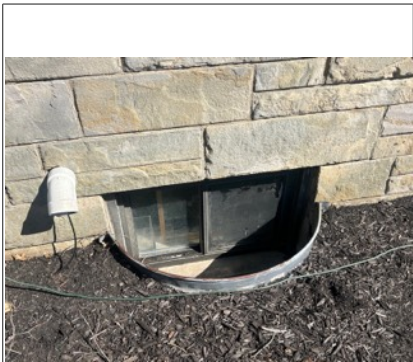
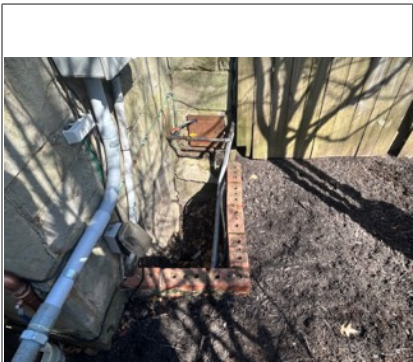
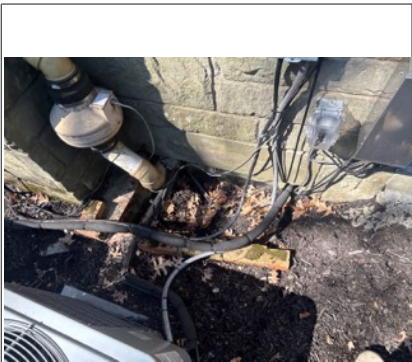
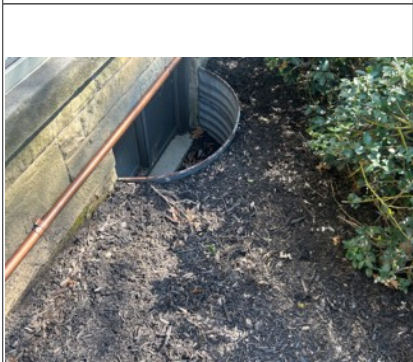
At the time of inspection, bowing was observed at brick window well. Recommend monitoring. If further movement occurs, rebuilding the window well may be necessary.

At the time of inspection, failure of the brick window well near the radon mitigation system was observed. Recommend having a mason rebuild window. Due to the failure of the window well, dirt and mulch buildup was observed at basement window.

At the time of inspection, low grading was observed near foundation. Recommend adding additional dirt to divert surface water away from the foundation and re-mulch in areas to prevent water from ponding near foundation. This will help prevent moisture infiltration.

Comments Recommend installing window well covers. This will help prevent moisture buildup in heavy rains and prevent moisture infiltration.

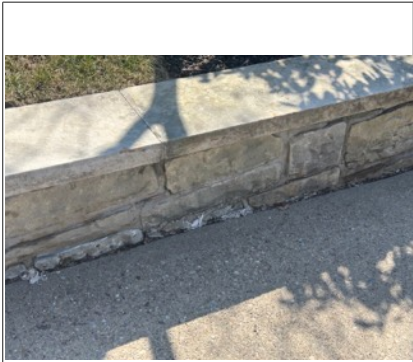
At the time of inspection, stone deterioration was observed at retaining wall. When removing snow buildup from the driveway, recommend not piling the snow near the wall as it can absorb into the stone, then freeze, deteriorating the face of the stone.

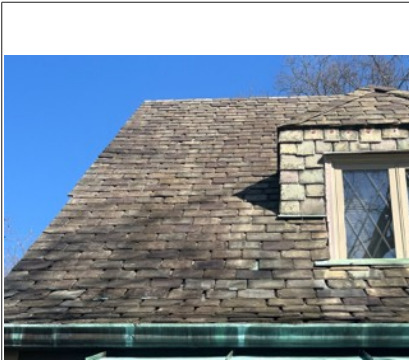
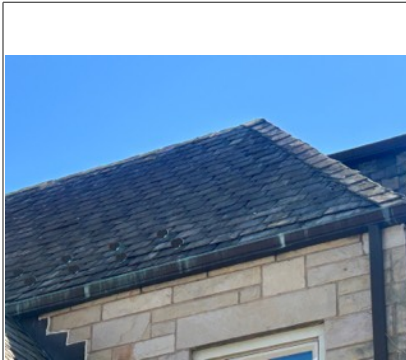
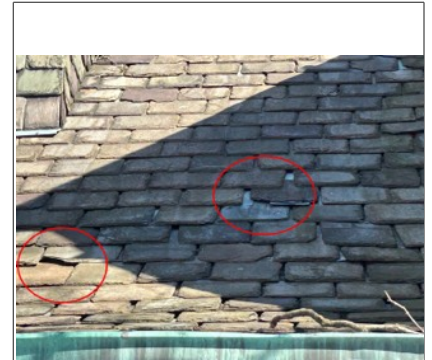
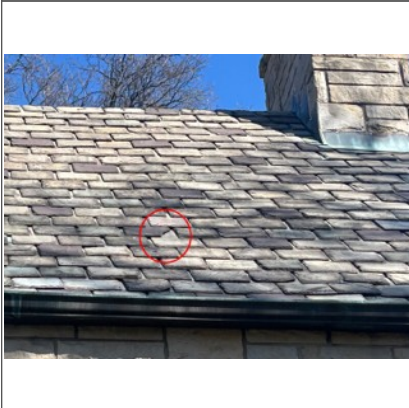
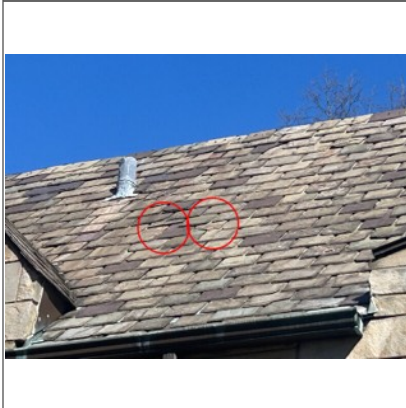
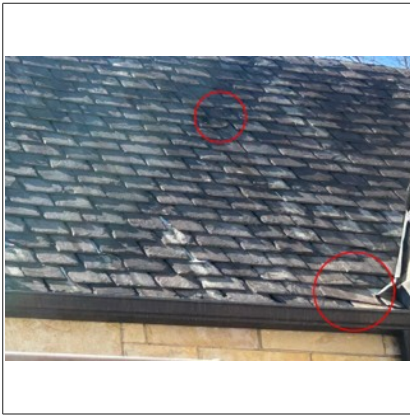
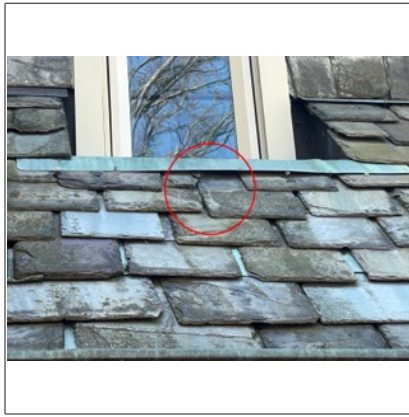
**Comments** At the time of the inspection, overall condition of the slate tiles were good. However, loose and broken tiles were observed throughout the roof. Recommend having a licensed slate roofer evaluate and make the necessary repairs to prevent potential water infiltration points.

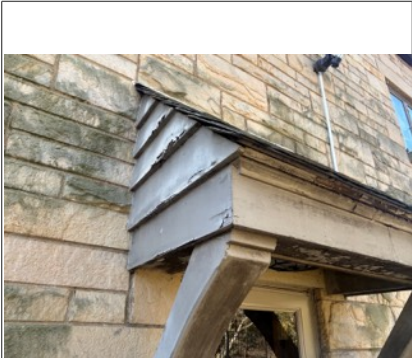
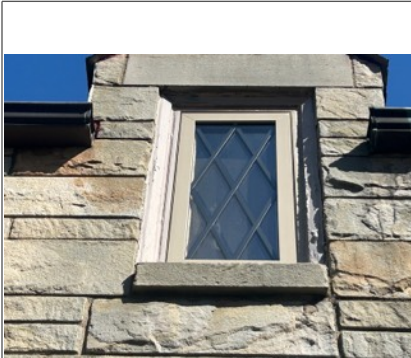
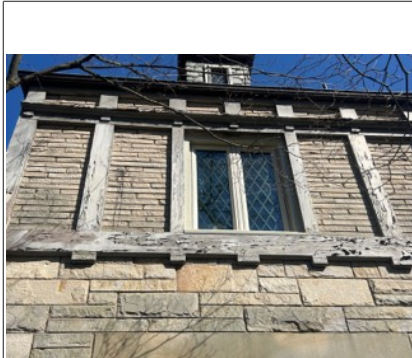
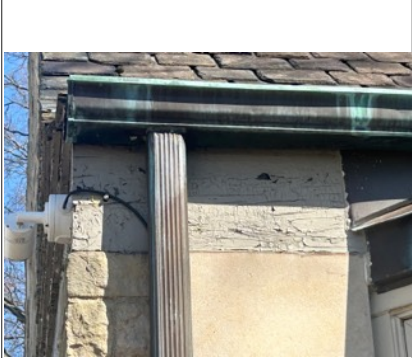
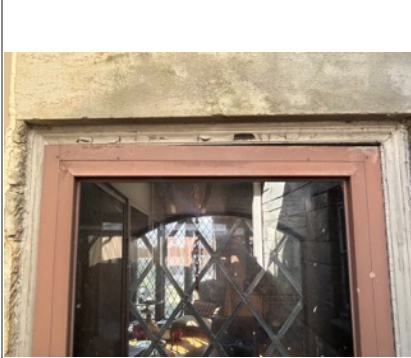
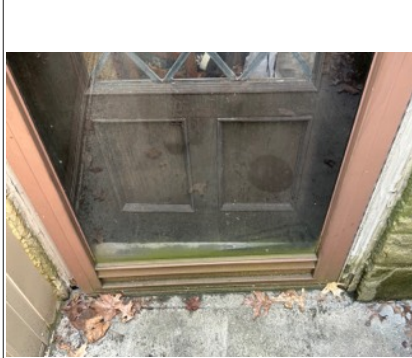
Comments cont. sanding, priming and painting to protect the trim from the exterior elements.

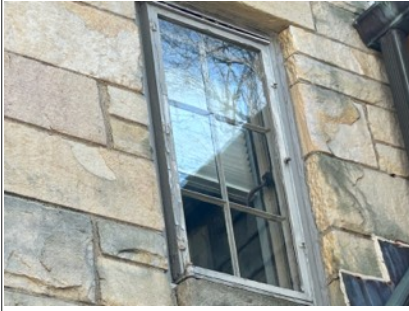
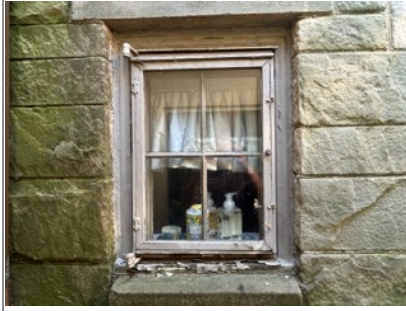
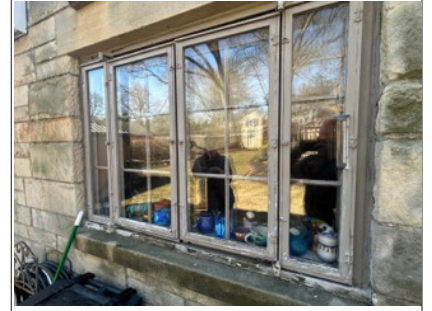
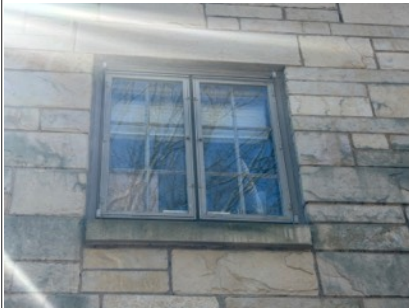
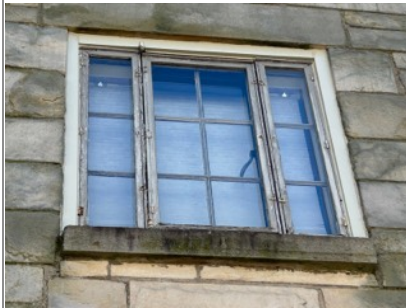
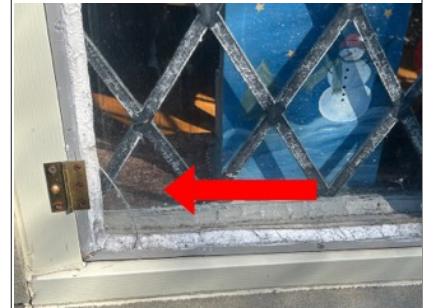
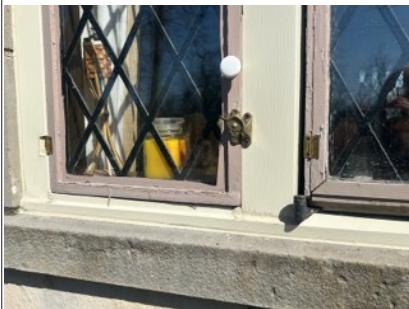
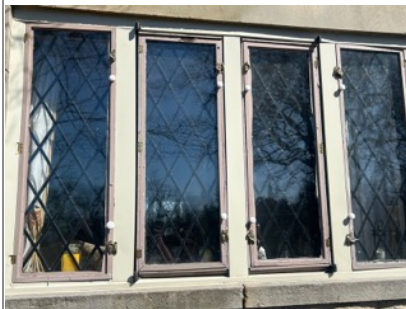
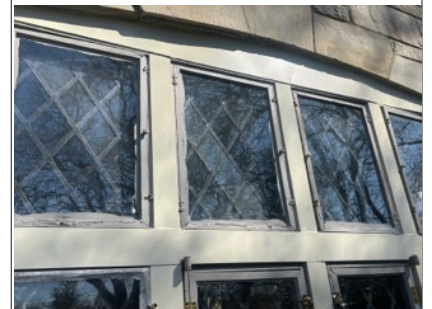
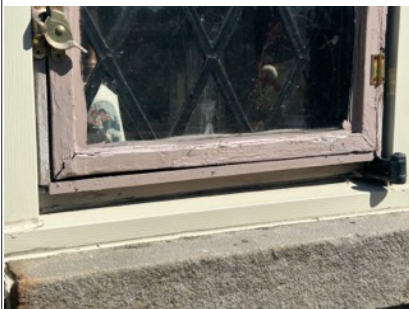
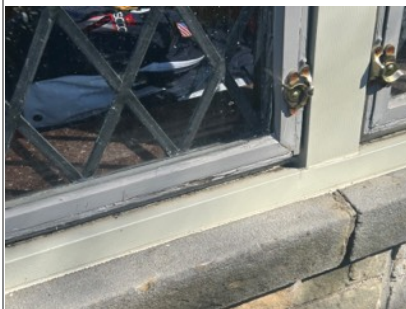
At the time of inspection, cracked glass was observed at storm window. The storm windows are to help with energy efficiency because the original windows are single pane glass windows. If deemed necessary, recommend replacing glass at the storm window to resolve this issue.

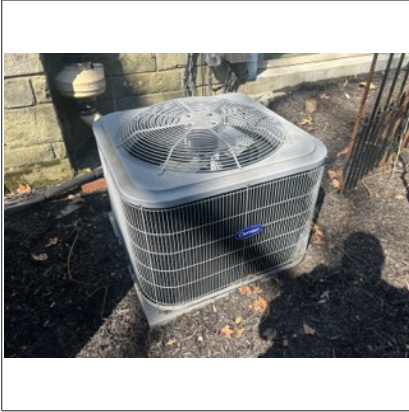
**Comments** At the time of inspection, AC unit was 3 years old with a typical life expectancy of 18 to 25 years.

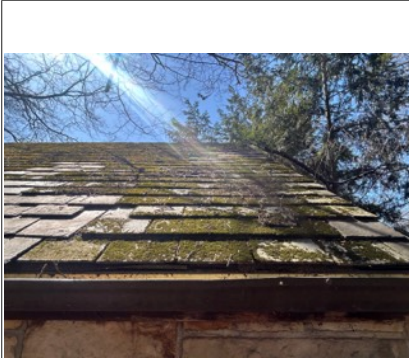
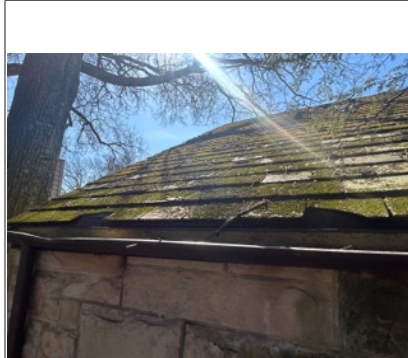
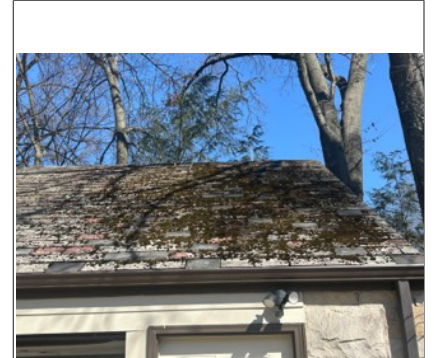
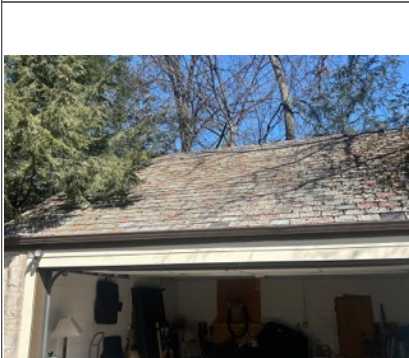
**Material** ☐ Same as house  
Type:Slate  
Approx. age: 50+ Years  
**Comments** At the time of inspection, moss build up and broken tiles were observed. Over time, moss buildup can further damage slate tiles. Recommend having the slate cleaned and having a slate roofer make the necessary repairs at damaged tiles to prevent potential water infiltration.

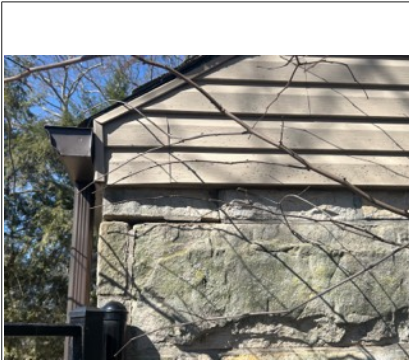
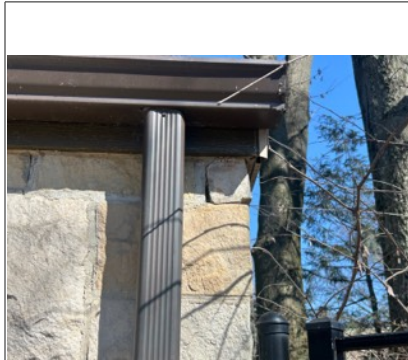
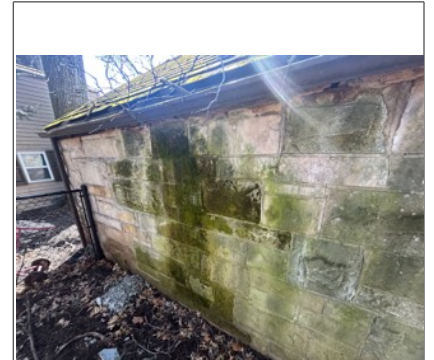
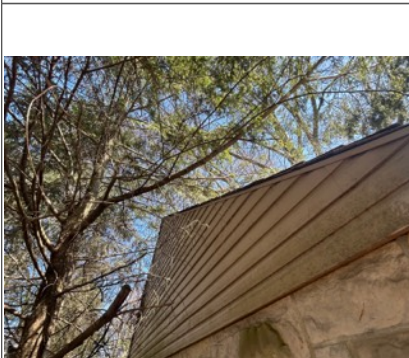
Recommend trimming back tree branches from the garage as this can cause damage to the slate roof.

**Comments** At the time of inspection, damaged wood trim was observed at the fascia. It appears water is entering behind the gutter into missing drip edge. Recommend installing a drip edge to properly divert water into the gutters and replace fascia board.

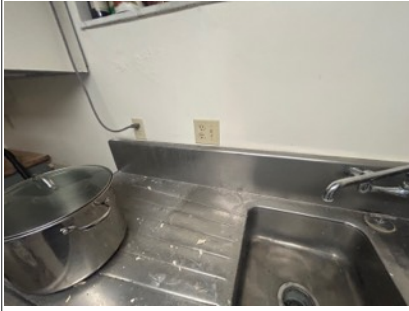
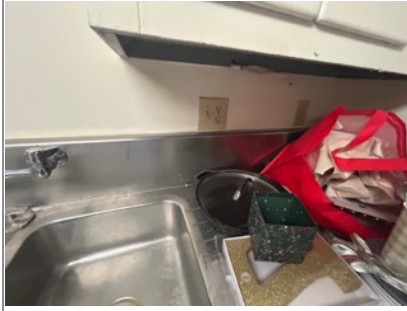
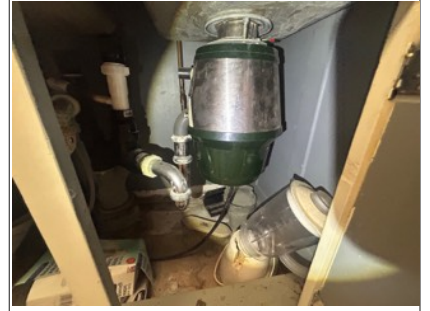
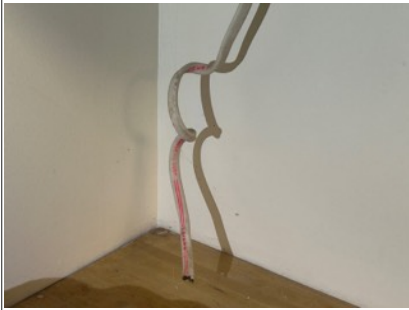
**Comments** At the time of inspection, missing GFCI receptacles were observed at kitchen sink. Recommend installing GFCI protected receptacles to prevent potential safety hazard.

At the time of inspection, garbage disposal did not operate. Recommend repair/replacement.

At the time of inspection, loose wiring was observed. Recommend installing junction box with cover plate to prevent potential safety hazard.

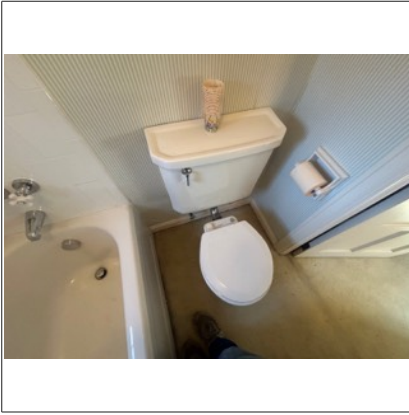
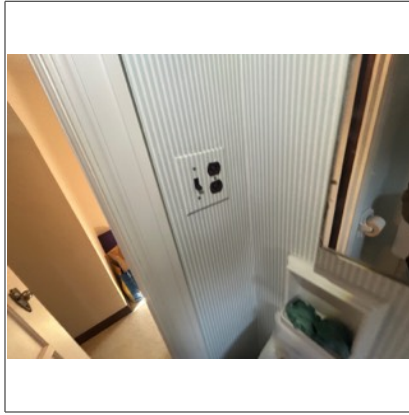
**Open ground/Reverse polarity** ☒ Yes ☐ No ☒ Potential Safety Hazard  
**Exhaust fan** ☐ Yes ☒ No Operable: ☐ Yes ☐ No  
**Comments** At the time of inspection, cold water faucet would not turn on. Recommend having a plumber evaluate and make the necessary repairs to resolve this issue.

At the time of inspection, water at tub/shower would not turn on. Recommend having plumber evaluate and make the necessary repairs to resolve this issue.

At the time of inspection, cracking was observed at shower surround. Recommend caulking with a tub/tile caulking to protect grout and prevent potential leaking.

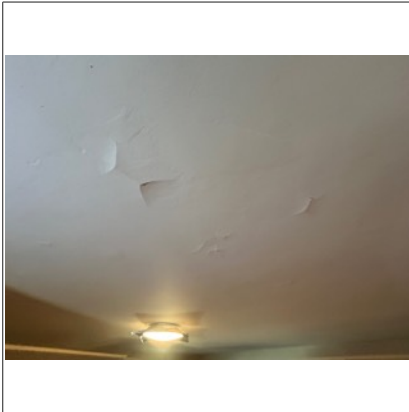
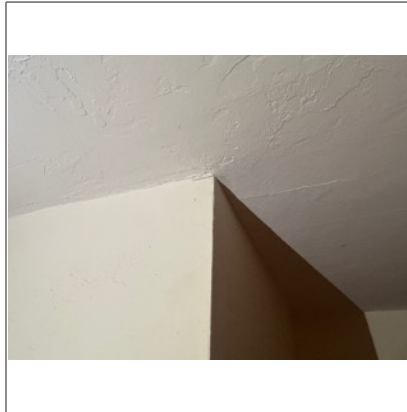
At the time of inspection, typical cracking was observed. If deemed necessary, recommend cosmetic repair and repainting.

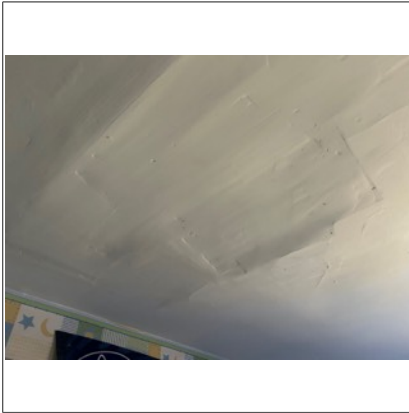
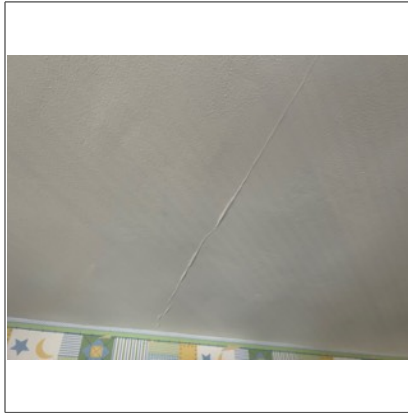
At the time of inspection, typical cracking was observed. If deemed necessary, recommend cosmetic repair and repainting.

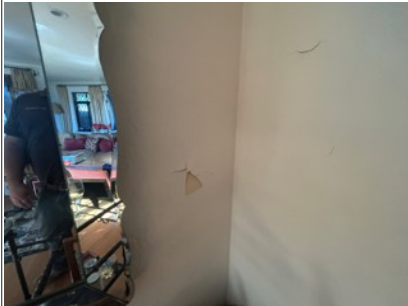
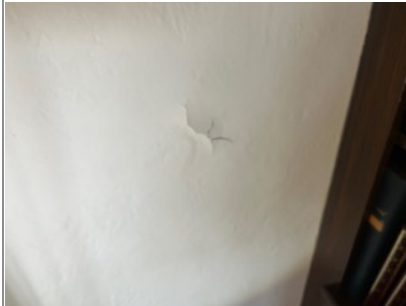
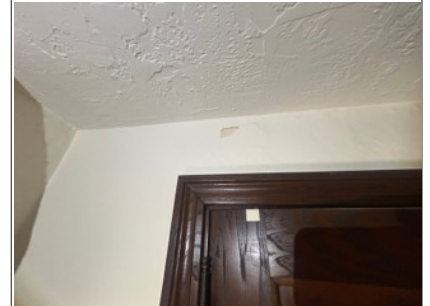
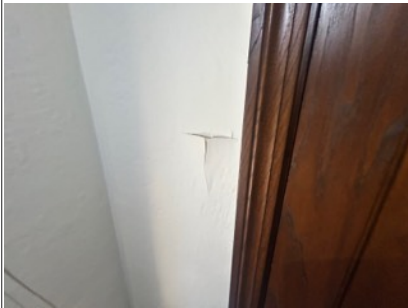
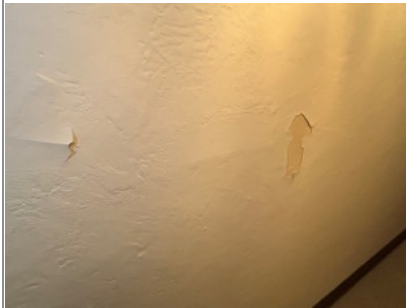
**Comments** At the time inspection, peeling paint was observed. If deemed necessary, recommend scraping loose paint, making any surface repair then repainting for cosmetic purposes.

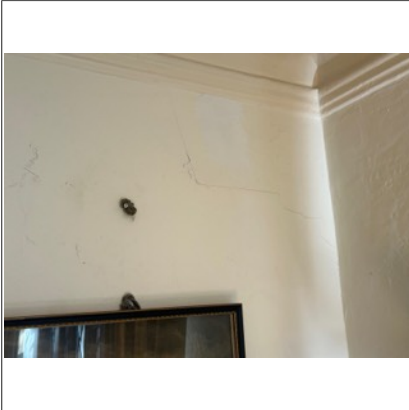
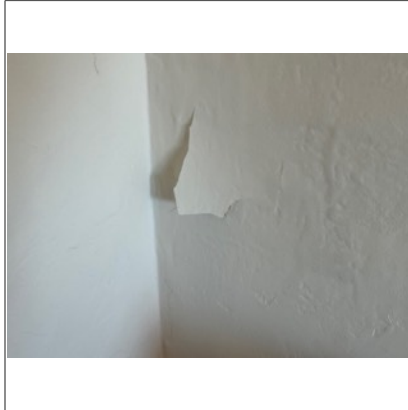
At the time inspection, peeling paint was observed. If deemed necessary, recommend scraping loose paint, making any surface repairs, then repainting for cosmetic purposes.

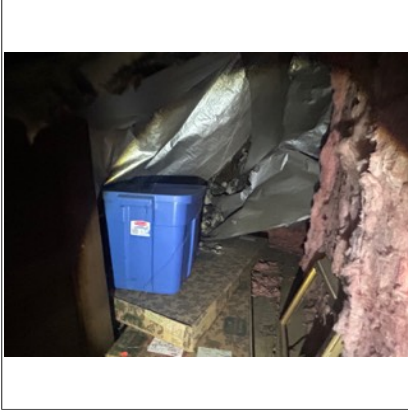
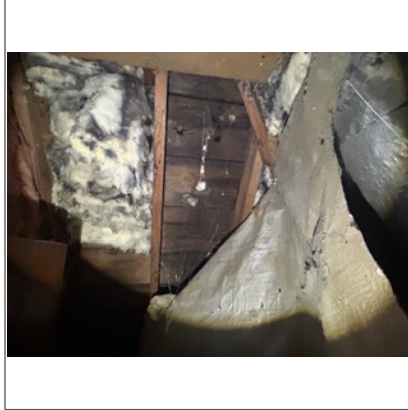
**Comments** At the time of inspection, loose and displaced insulation was observed in attic. Recommend resealing and adding additional insulation for energy efficiency purposes.

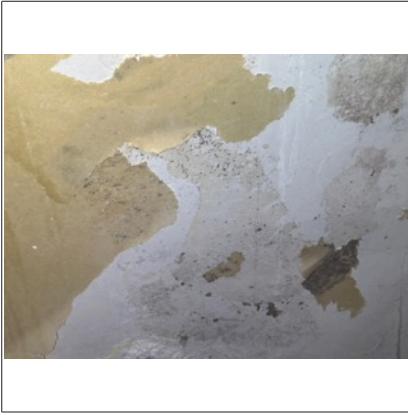
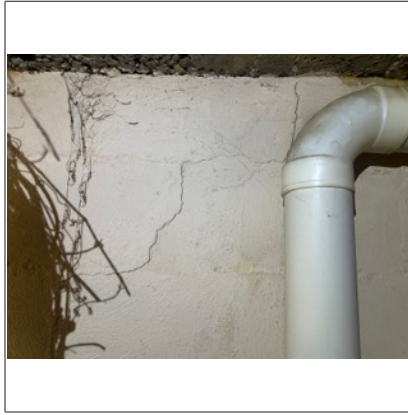
**Comments** At the time of inspection, efflorescence and mold like sporing was observed at foundation. Efflorescence is a chemical reaction when moisture comes in contact with the foundation. During inspection, newer drainage was observed at the exterior. Recommend having mold like sporing treated for removal.

At the time of inspection, cracking was observed by foundation. This is caused by limited settling. No repairs are necessary at this time.

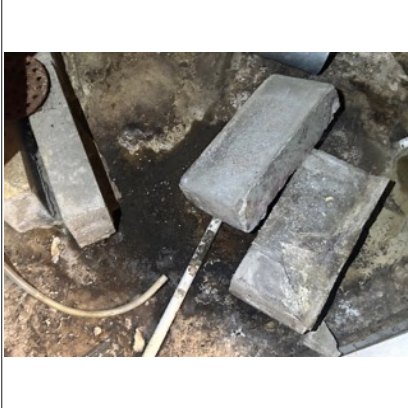
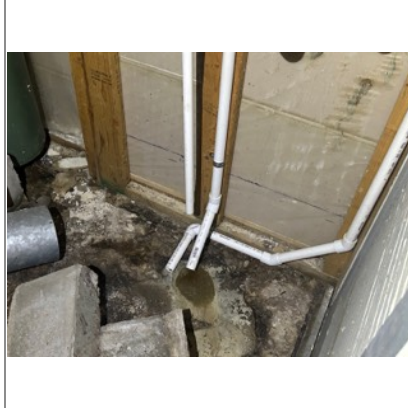
At the time of inspection, dirt and possible mold sporing was observed at concrete floor in furnace closet. Recommend deep cleaning and treating for mold like sporing then extending drain lines to the floor drain to prevent it from reoccurring.

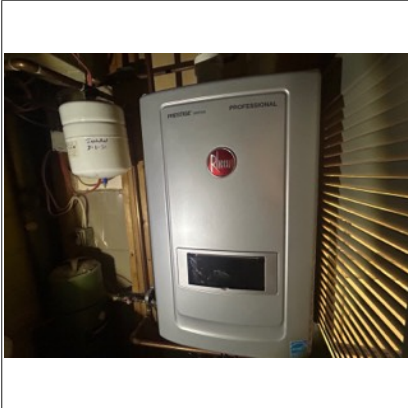
**Comments** At the time of inspection, tankless water heater was working as intended. The current age is 5 years old with the typical life expectancy of 15 to 20 years.

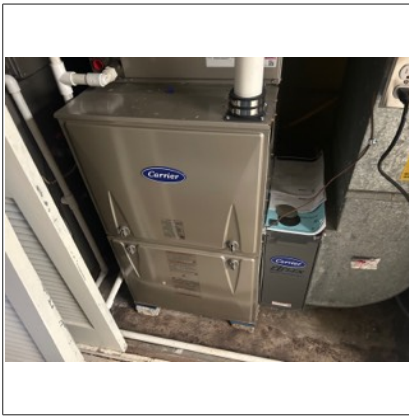
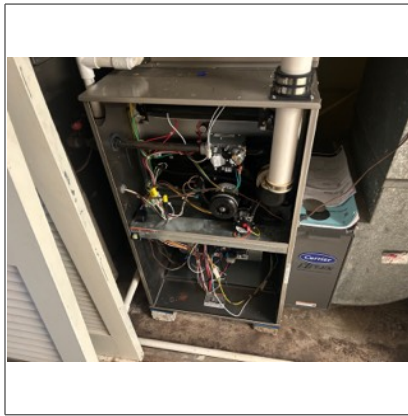
**Comments** At the time of inspection, furnace was 3 years old with a typical life expectancy of 18 to 25 years.

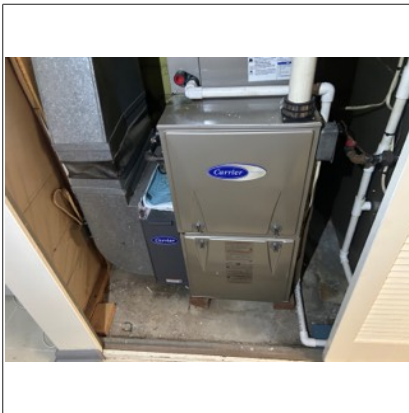
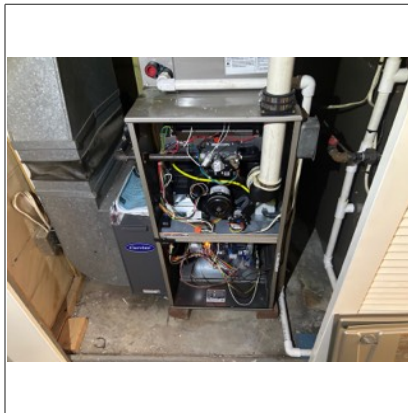
**Comments** At the time of inspection, furnace was 5 years old with a typical life expectancy of 18 to 25 years.

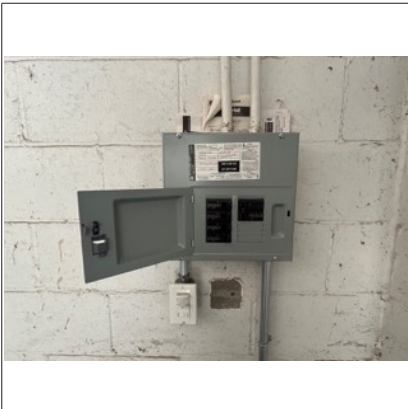
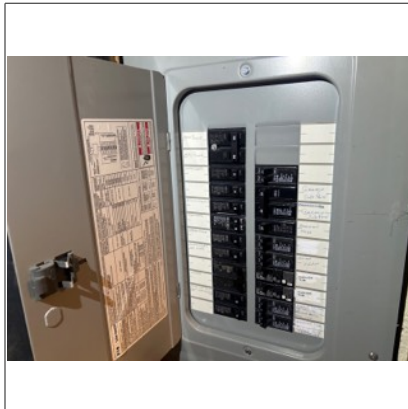
☐ None apparent  
**Location(s)** Location 1:Garage  
 Location 2:Basement  
**Branch wire** ☒ Copper ☐ Aluminum  
**Condition** ☒ Satisfactory ☐ Marginal ☐ Poor  
**Comments** At the time of inspection, sub panels were in satisfactory condition.  
**Photos**
