**337 Snowberry Cir**

**RE: Venetia, PA 15367**

**Inspection #: 527-072026-6967**

### *HOME INSPECTION REPORT*

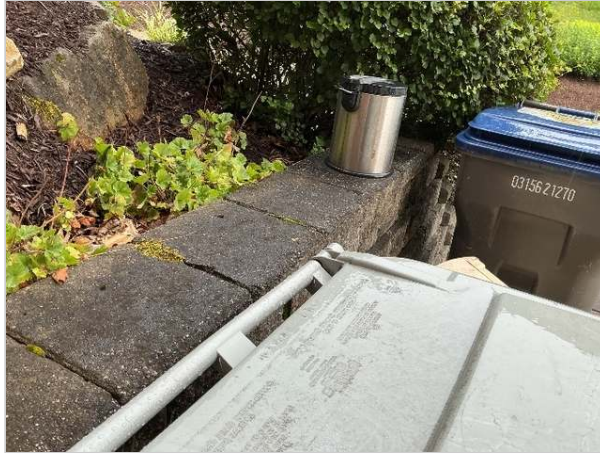
There was one retaining wall constructed of a manufactured interlocking stone system. The wall was in good condition. There were no material defects observed in the wall. We do not inspect or comment on retaining walls that are detached from the main structure of the home unless the walls function has an impact on the structure.

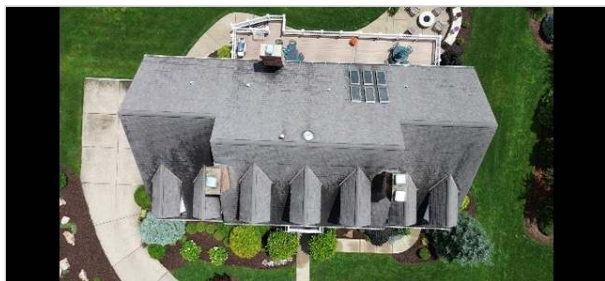
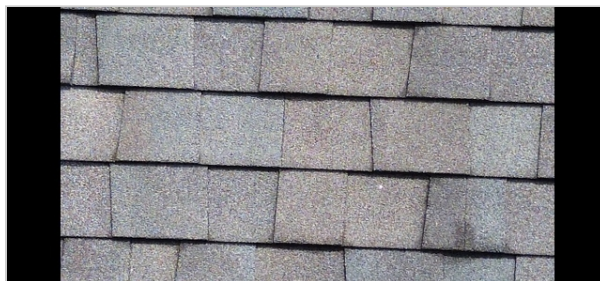
### NOTE: LOOSE FLASHING:

Loose flashing was noted on the front of the roof. Loose flashing could be a leak source. We cannot always determine if active leaks exist. Consult with a qualified roofer for further evaluation and repair.

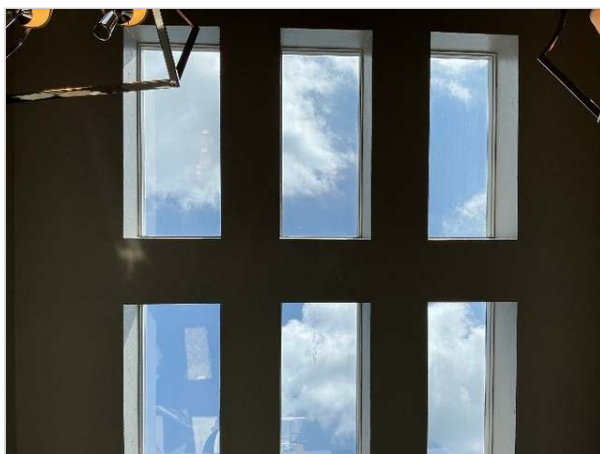
There were several skylights installed. Skylights are considered roof penetrations and require water tight installation. Our ability to verify that the skylight is water tight is limited to our visual inspection. In order to ensure the unit remains water tight, we will not attempt to open units that contain this feature. Skylight lens' are made of either plexiglas, lexan or glass. It is not always possible to identify the lens material. Plexiglas and lexan skylight lens' often develop hairline cracks as the lens material ages. This is usually a cosmetic condition and does not affect the performance of the skylight. In this case hairline cracks were not observed. The skylight lens was clear. Skylights are usually double pane. Depending upon the angle of the sun and the frosting of the glass we cannot always determine if the thermal seal is intact. There were no visual defects observed on the skylights.

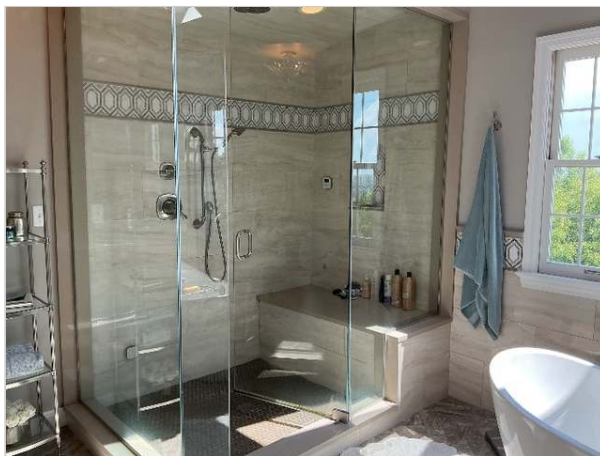
***INFORMATIONAL NOTE: WALK-IN SHOWER:***

A walk-in shower was located in the master bath. The base of the shower was constructed of ceramic tile. While no leaks were noted at the time of the inspection, this type of shower is more prone to leaks than a standard tub or precast shower base. The waterproof membrane or shower pan, which is the primary water proofing material is installed beneath the finished floor and is not visible from the interior of the shower or the subfloor below. We cannot verify the integrity of the shower pan or concealed portions of the drain. Additionally, our test of the unit cannot simulate an actual shower and therefore is not a guarantee that the unit is free of leaks. The cosmetic condition of the tile or grout is not considered during the inspection. The absence or presence of cracks in the tile or joints is not an indication of a leak free unit.

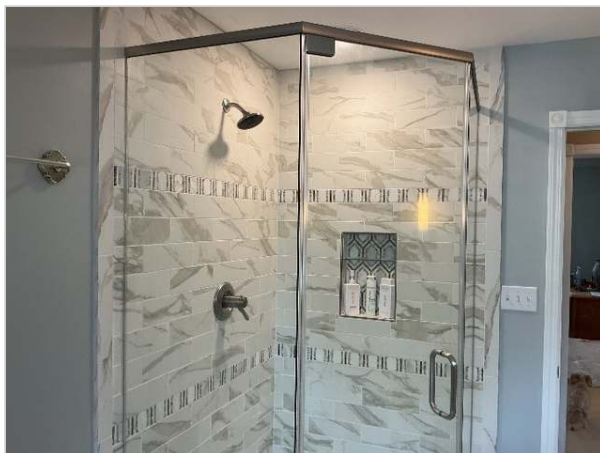
***INFORMATIONAL NOTE: WALK-IN SHOWER:***

A walk-in shower was located in the second floor bath. The base of the shower was constructed of ceramic tile. While no leaks were noted at the time of the inspection, this type of shower is more prone to leaks than a standard tub or precast shower base. The waterproof membrane or shower pan, which is the primary water proofing material is installed beneath the finished floor and is not visible from the interior of the shower or the subfloor below. We cannot verify the integrity of the shower pan or concealed portions of the drain. Additionally, our test of the unit cannot simulate an actual shower and therefore is not a guarantee that the unit is free of leaks. The cosmetic condition of the tile or grout is not

considered during the inspection. The absence or presence of cracks in the tile or joints is not an indication of a leak free unit.
