**244 E Jefferson St**

**RE: Pittsburgh, PA 15212**

**Inspection #: 527-062026-6907**

### *HOME INSPECTION REPORT*

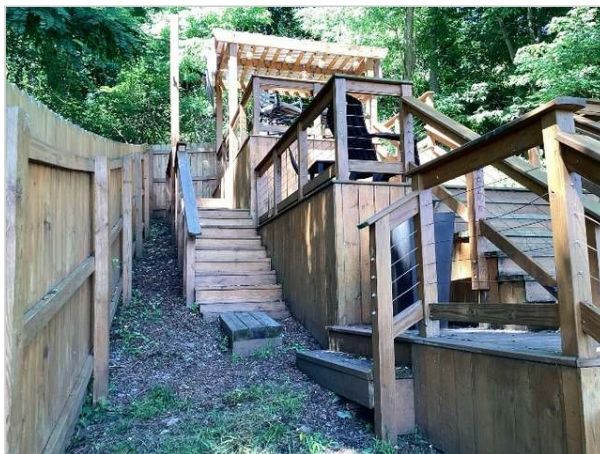
**SAFETY NOTE: DECK RAIL BALUSTERS:**

The balusters on the deck rail were installed horizontally rather than vertically. Generally accepted construction techniques provide for balusters to be installed vertically and spaced no greater than four inches apart. Larger baluster spacing can be a safety concern, and horizontally mounted balusters permit climbing. Local codes may require modification and / or installation of additional balusters. Consult with a general contractor for cost estimates for additional balusters.

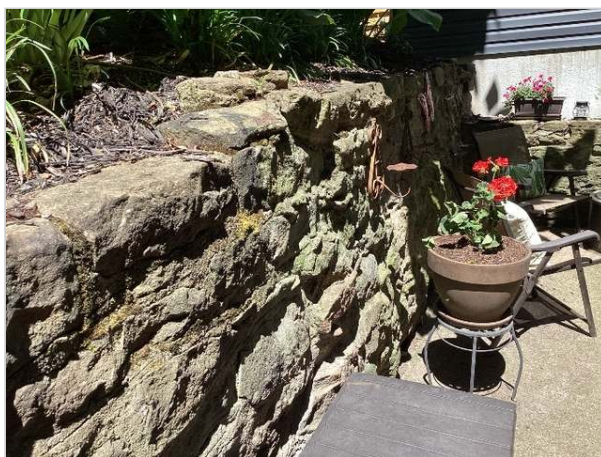
### NOTE: MISSING MORTAR:

Missing mortar was noted on the rear retaining wall of the home. There were no loose bricks noted. Small amounts of missing mortar are usually inconsequential. Extensive amounts of missing mortar can permit water intrusion. Consult with a qualified masonry contractor for repair estimates.
