**1012 Biltmore Ave**

**RE: Pittsburgh, PA 15216**

**Inspection #: 527-042026-6791**

### HOME INSPECTION REPORT

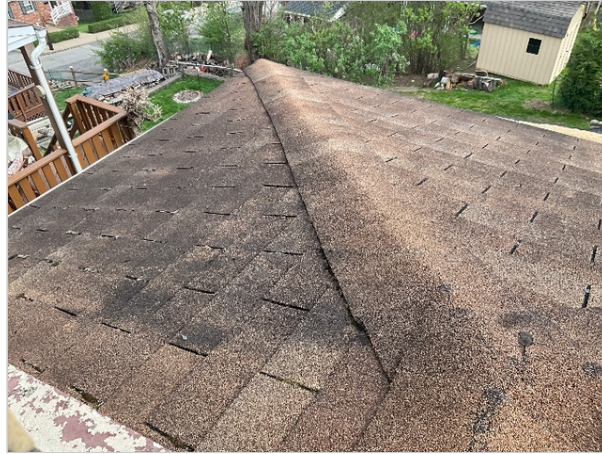
**NOTE: ROOF SHINGLES:**

Three shingles were damaged on the front of the roof at the time of the inspection. While this condition is not necessarily an indication of a leak, repairs should be made. Consult with a qualified roofer for repair.

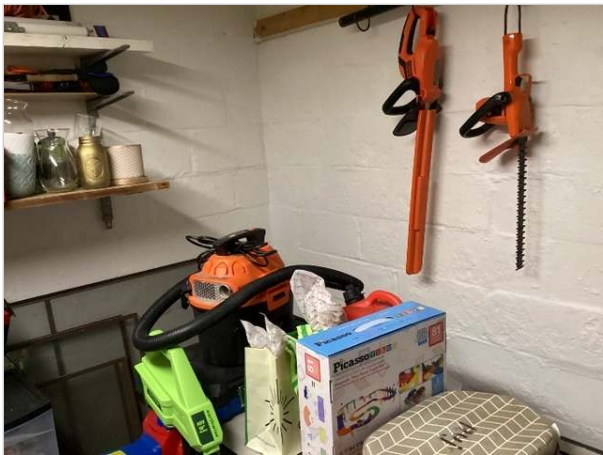
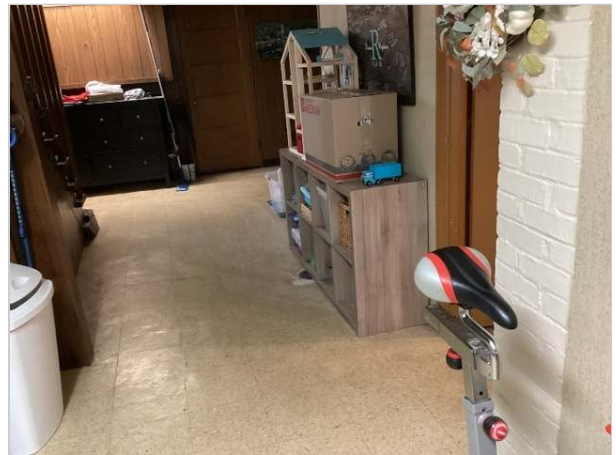
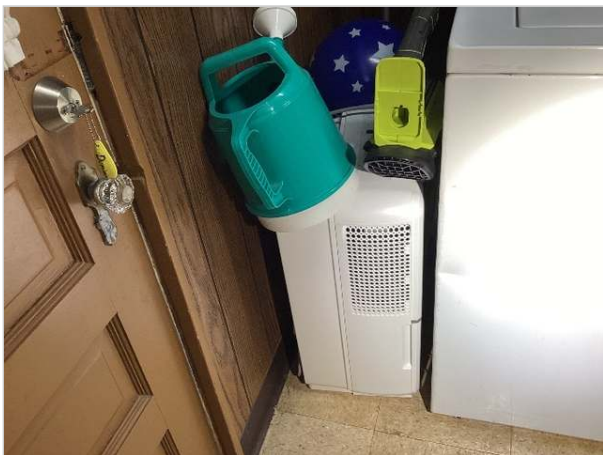
**INFORMATIONAL NOTE: BASEMENT STORED ITEMS:**

The basement was cluttered with many stored items and/or shelves at the time of inspection, therefore several areas were unable to be inspected.

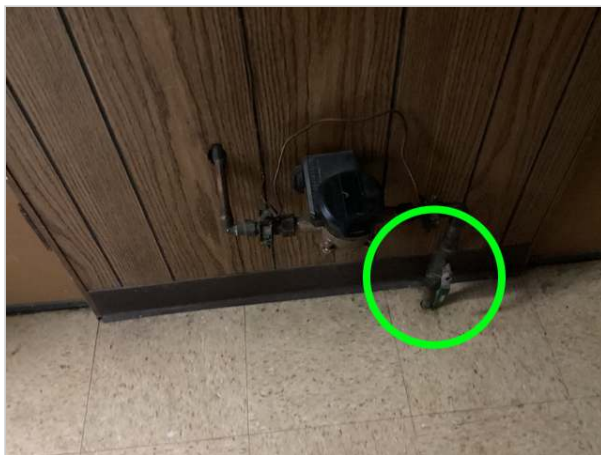
Shut off

The water meter was located in the basement. The main water shutoff valve for the home was located adjacent to the water service entry point in the basement. Water shutoff valves are visually inspected only. No attempt is made to operate the main or any other water supply shutoff valves during the inspection. These valves are infrequently used and could leak after being operated. The only exception to this policy is made when the main water supply valve is off upon arrival at the inspection. Since it is the buyers right to have all utilities operable for the home inspection, we will attempt to turn the main water valve on for the inspection. The HomeTeam is not responsible for leaks caused by operating the valve.
