HomeTeam[®]

257 Lincoln Dr

Inspection #: 527-052026-6875

HOME INSPECTION REPORT

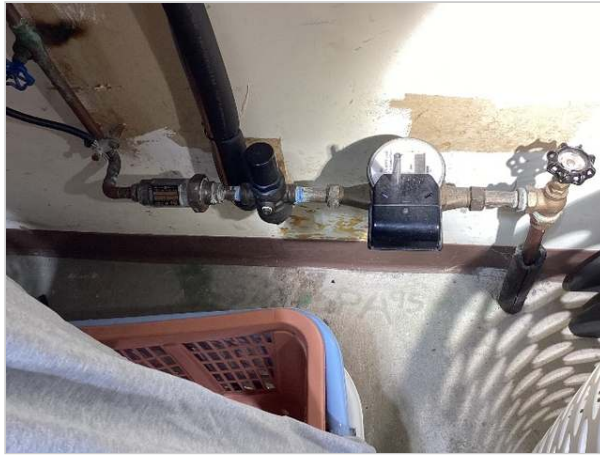
PLUMBING

The visible water supply lines throughout the home were copper pipe. The water was supplied by a public water supply. Water valves are not tested as part of the home inspection. Water valves that have not been operated for an extended period of time often leak after being operated. We would not be able to repair a leaking valve during the home inspection. The visible waste lines consisted of ABS plastic pipe. The functional drainage of the drain waste lines appeared to be adequate at the time of the inspection. The home was connected to a public sewer system. The under-floor drain lines are considered underground utilities and are specifically excluded from the inspection. The lines are not visible or accessible and their condition cannot be verified during a visual home inspection. Simply running water into plumbing fixtures or floor drains will not verify the condition of the waste line infrastructure under the home. Consult with a qualified plumber for a video camera inspection of the sewer laterals if there is any concern as to the condition of the waste lines under the home. A video scan is the only way to confirm the condition of the drain system. Our inspection of the plumbing system is a functional inspection only. We make no attempt to validate that the plumbing system complies with any codes. Additionally, we cannot validate the workmanship of the plumbing system to be up to standard. We are generalists and do not claim to know everything about any trade. Any concern about the quality or adequacy of the plumbing system should be referred to a qualified, reputable plumber. All plumbing fixtures not permanently attached to a household appliance were operated and inspected for visible leaks. Water flow throughout the home was average. Water pressure was tested at the utility tub and found to be 70 to 80 pounds per square inch. There were no material defects observed in the visible portions of the plumbing system.

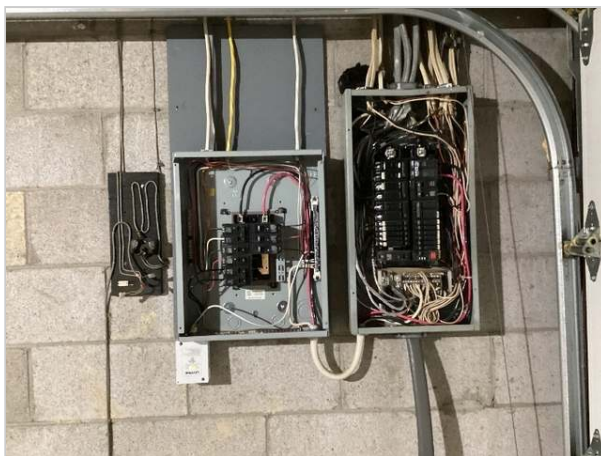
ELECTRIC SERVICE

The underground electric service wire entered the home on the right front wall. The electric meter was located on the exterior wall. The service entrance cable consisted of stranded aluminum rated for 100 amps. The service wire entered a General Electric service panel, located on the garage wall with a 100 amp and 120/240 volt rated capacity. The main service disconnect switch was located in the main panel. The branch circuits within the panel were copper. These branch circuits and the circuit breaker to which they were attached appeared to be appropriately matched. The internal components of the service panel, i.e. main lugs, bus bars, etc were in good condition. The visible house wiring consisted primarily of the Romex type and appeared to be in good condition. An electric service grounding system was installed. Service grounding requirements have changed many times over the years. The grounding system for a 30-year-old electric service is different from that of a 10-year-old service. The inspection does not attempt to verify that the grounding system or any other part of the electric service complies with current codes.

An electric service sub-panel was located in the garage, and was manufactured by Murray. The service disconnect switch for this panel was located in the main panel, and was rated at 60 amps. The branch circuits within the panel were copper. These branch circuits and the circuit breaker to which they were attached appeared to be appropriately matched. The visible wiring consisted primarily of the Romex type and appeared to be in good condition.

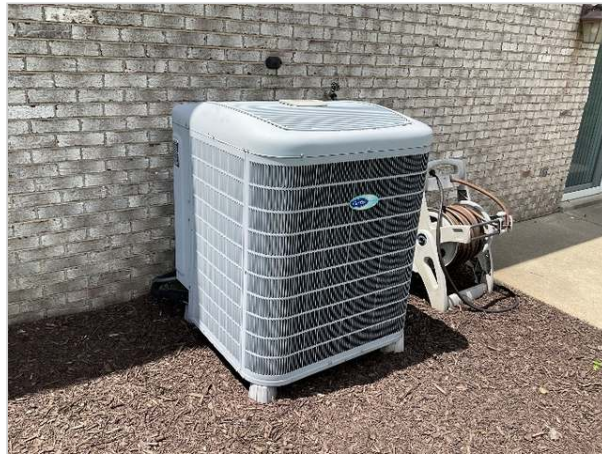
AIR CONDITIONING

The electric outdoor air conditioner condensing unit was a Carrier, Model Number 25VNA036A300 and Serial Number 0215E14175. The unit is located in the back of the home. This unit is approximately 11 years old. Periodic preventive maintenance is recommended to keep this unit in good working condition. The forced air cooling system was tested and found to be functional. The home inspection does not include a heat-gain analysis, cooling design or adequacy evaluation, energy efficiency assessment, installation compliance check or refrigerant evaluation.
