## **HomeTeam<sup>®</sup>** INSPECTION SERVICE

**1281 Washington Rd  
RE: Pittsburgh, PA 15228  
Inspection #: 527-062026-6954**

### *HOME INSPECTION REPORT*

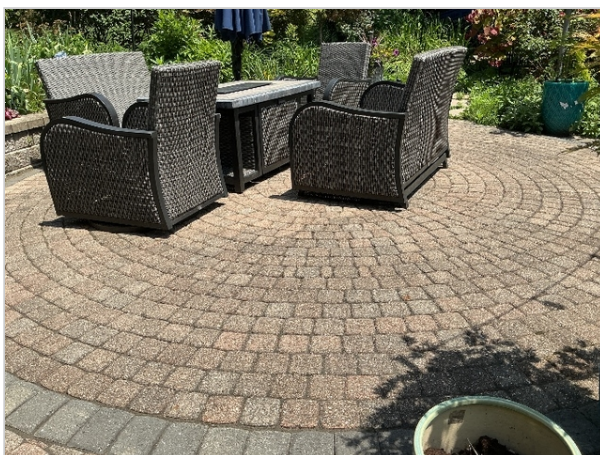
There was a brick and Block located in the back of the home. There were no material defects observed to the patio.

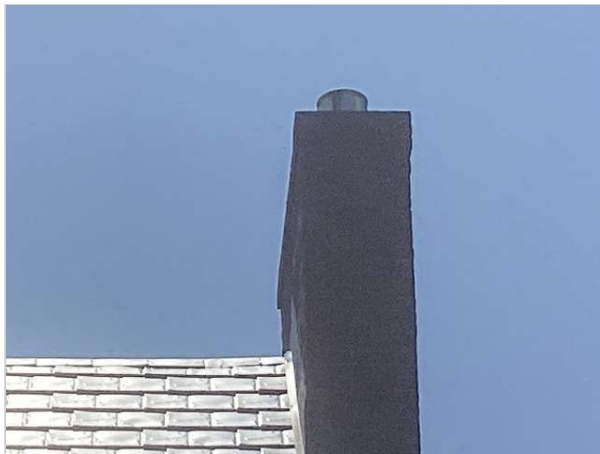
**NOTE: RAIN HAT:**

The rain hat on top of the chimney is missing. Repairs should be made by a qualified roofer.

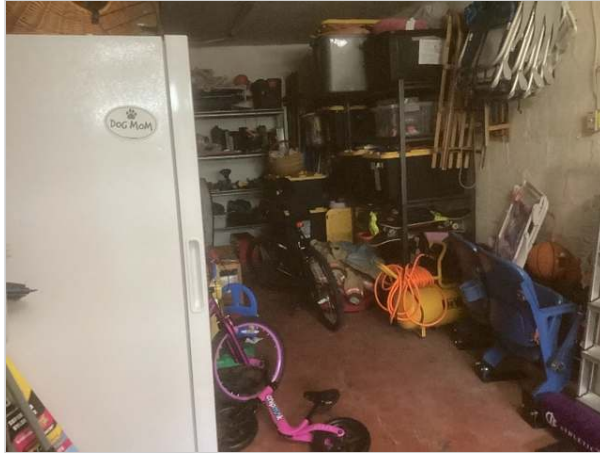
The garage was cluttered with many stored items and/or shelves at the time of inspection, therefore several areas were unable to be inspected.

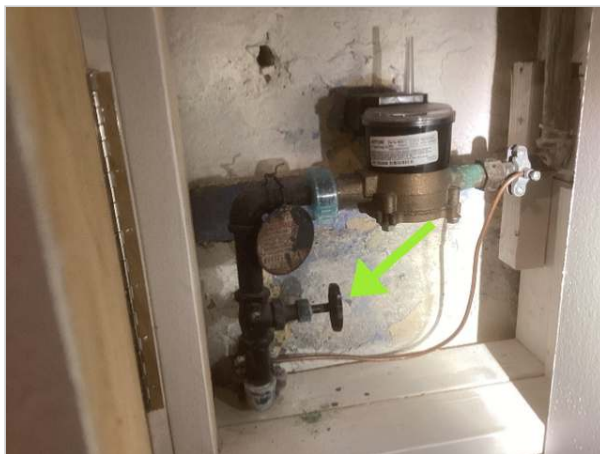
Shut off

The water meter was located in the basement. The main water shutoff valve for the home was located adjacent to the water service entry point in the basement. Water shutoff valves are visually inspected only. No attempt is made to operate the main or any other water supply shutoff valves during the inspection. These valves are infrequently used and could leak after being operated. The only exception to this policy is made when the main water supply valve is off upon arrival at the inspection. Since it is the buyers right to have all utilities operable for the home inspection, we will attempt to turn the main water valve on for the inspection. The HomeTeam is not responsible for leaks caused by operating the valve.

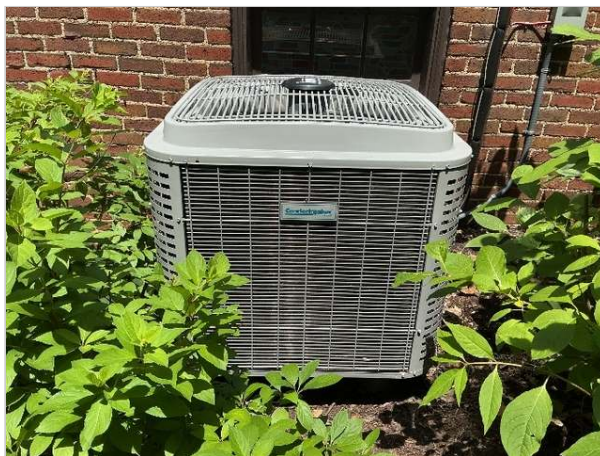
**NOTE: A/C LINE SET INSULATION:**

The insulation on the exterior air conditioning line set is damaged. This could affect the efficiency of the system and should be replaced.
