**1140 Franklin St**

**RE: White Oak, PA 15131**

**Inspection #: 527-072025-6431**

### *HOME INSPECTION REPORT*

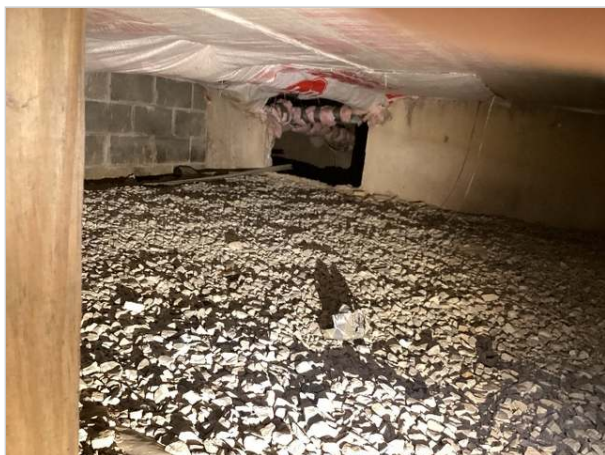
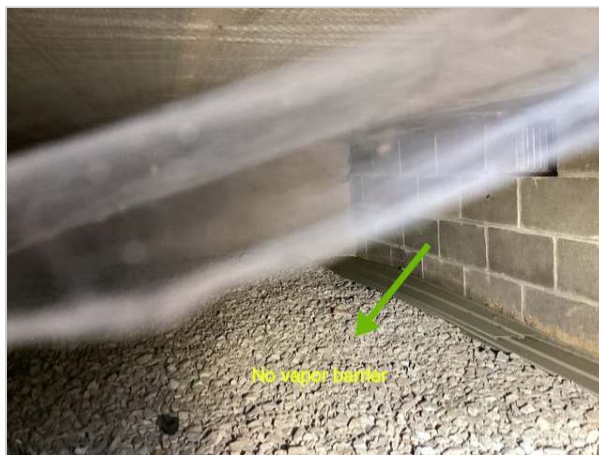
The crawl space was accessible at the time of the inspection. We will not enter any confined area which does not have at least 24-inches of unobstructed vertical clearance and at least 30-inches of unobstructed horizontal clearance. The crawl space opening / access is located on the exterior. The visible area of the crawl space was dry at the time of the inspection. Because of its configuration, it was not possible to inspect all areas of the crawl space. The crawl space is ventilated and a vapor retarder is not installed. A vapor retarder is not required in the crawl space if the floor is finished. The living space above the crawl space is insulated. There were no material defects noted in the crawl space.

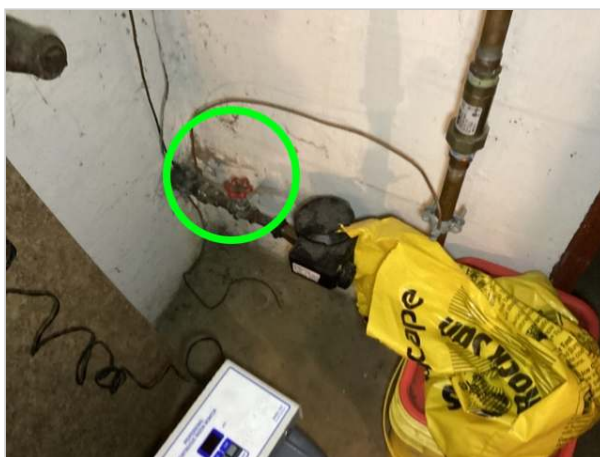
Shut off

The water meter was located in the basement. The main water shutoff valve for the home was located adjacent to the water service entry point in the basement. Water shutoff valves are visually inspected only. No attempt is made to operate the main or any other water supply shutoff valves during the inspection. These valves are infrequently used and could leak after being operated. The only exception to this policy is made when the main water supply valve is off upon arrival at the inspection. Since it is the buyers right to have all utilities operable for the home inspection, we will attempt to turn the main water valve on for the inspection. The HomeTeam is not responsible for leaks caused by operating the valve.

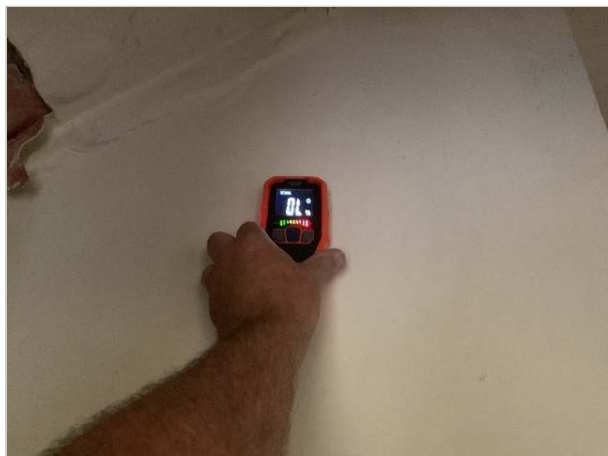
### *NOTE: CRACKED / BUBBLING PAINT:*

Cracked or bubbling paint was noted on the walls and ceilings in the bedrooms. This condition did not appear to be caused by water. There was no evidence of an active leak at the time of the inspection. Any damaged areas should be scraped, repaired, leveled and primed prior to applying a finish coat of paint.

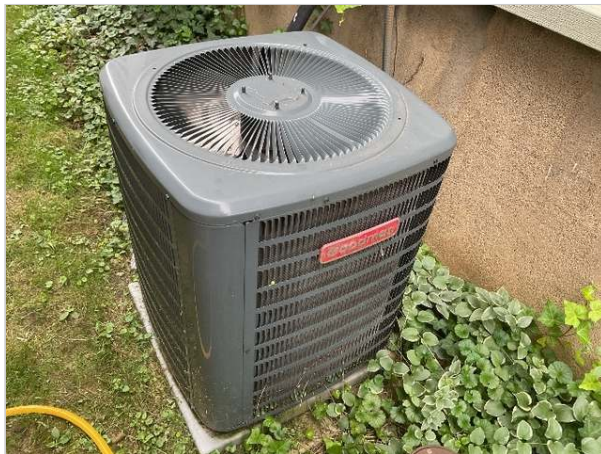
The electric outdoor air conditioner condensing unit was a Goodman, Model Number GSX130301LB and Serial Number 1903115263. The unit is located on the left side of the home. This unit is approximately 6 years old. Periodic preventive maintenance is recommended to keep this unit in good working condition. The forced air cooling system was tested and found to be functional. The home inspection does not include a heat-gain analysis, cooling design or adequacy evaluation, energy efficiency assessment, installation compliance check or refrigerant evaluation.

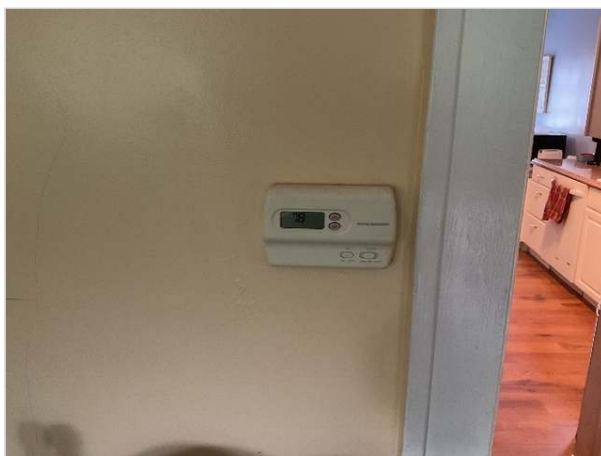
The control for the heating and air conditioning system was a 24 volt thermostat located on the living room wall of the home. The thermostat was manufactured by White Rodgers and was found to be in working order.
