Property Inspection Report

1393 Washington Road, Pittsburgh, PA

DATE OF INSPECTION: 2/18/2026

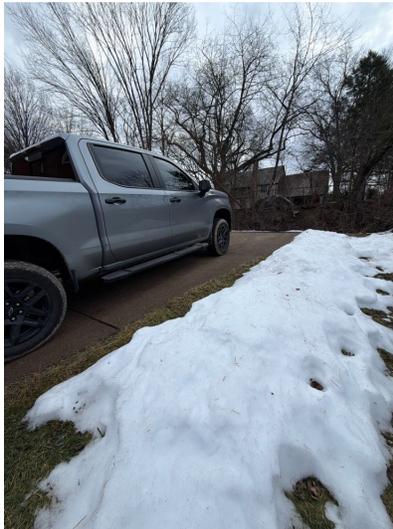
- The driveway is made of concrete.
- The driveway is steep and could be problematic for some vehicles, and should be used with caution.

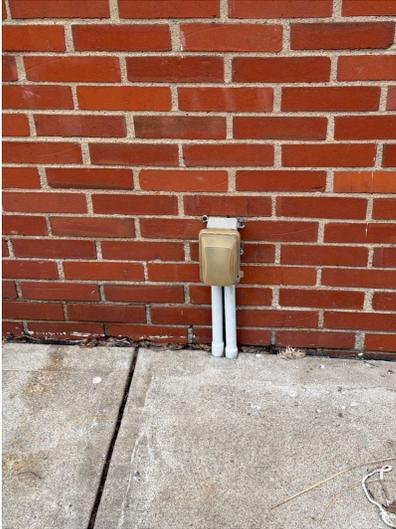
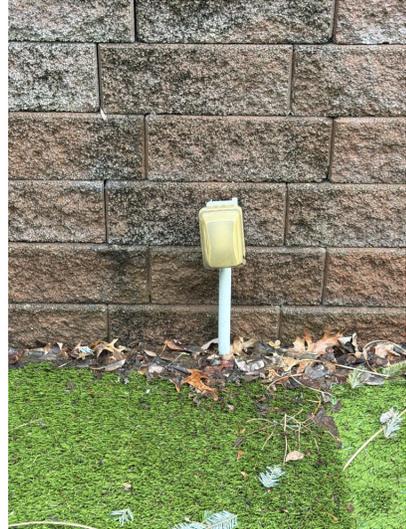
- Several ground-fault protected outlets at the rear of the house does not trip on test, and should be serviced.

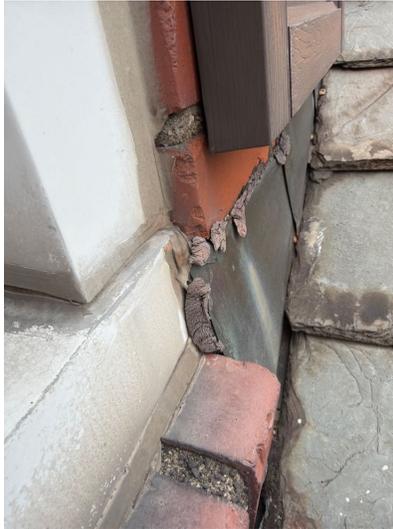
- The flashings need sealed or serviced in areas which should be repaired by a roofing contractor.

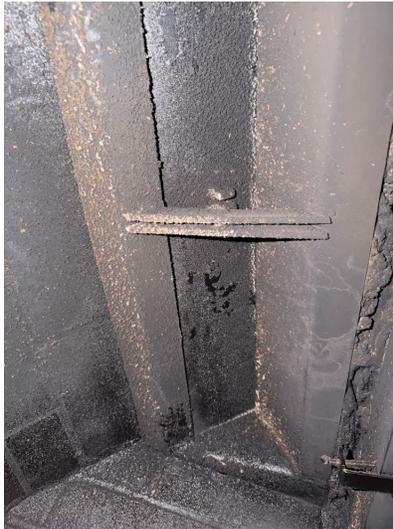
- The damper handle is missing and should be replaced.

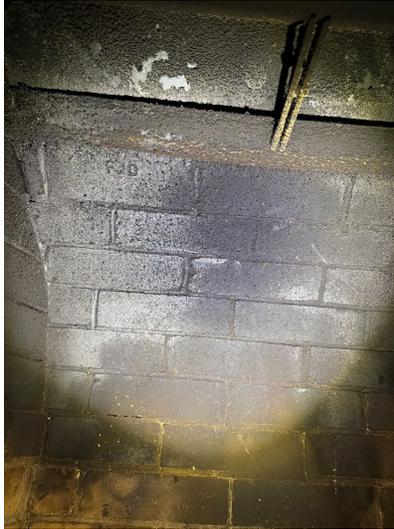
7. Fireplace

- Fireplace is very dirty and should be cleaned and serviced by a chimney sweep prior to use. You should have a chimney sweep evaluate this chimney and determine what is needed to be done, according to how you plan to use this chimney.

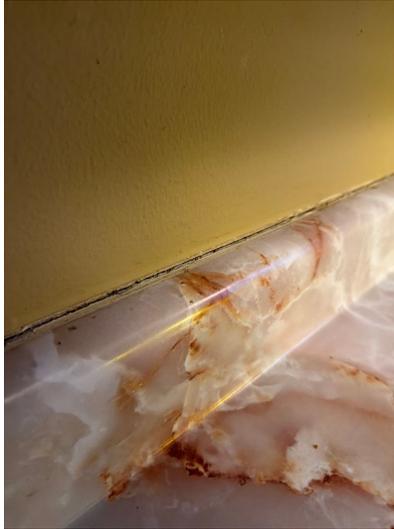
- An open seam between the sink and the counter top needs to be caulked or sealed to help prevent moisture penetration.

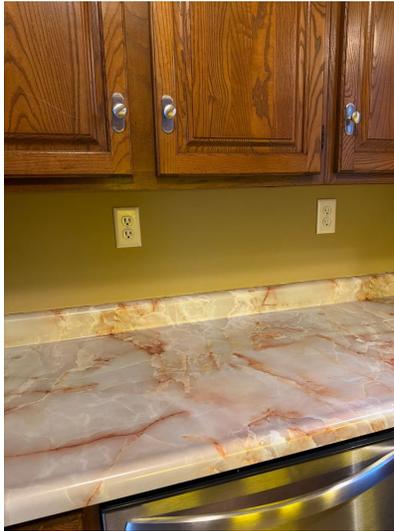
- Several counter top outlets should be upgraded to have ground fault protection.

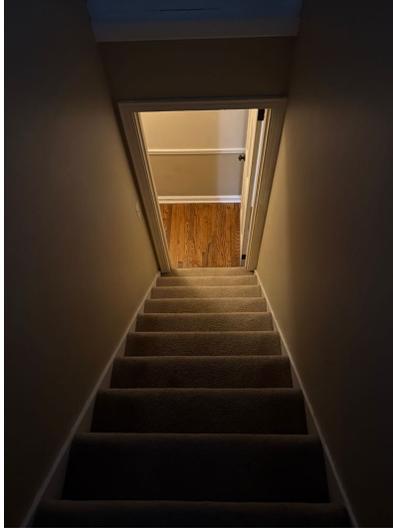
- There is no handrail on the stairs, which is an essential safety feature that should be added by a contractor.

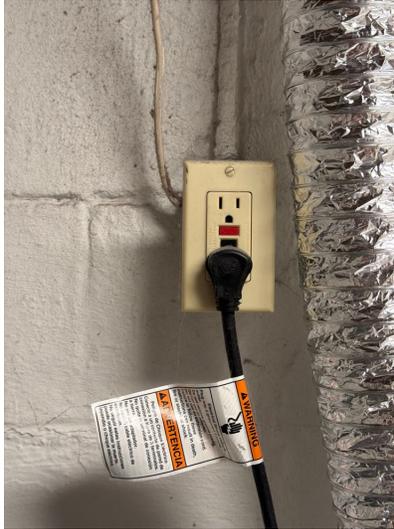
- A **GFCI** outlet did not trip on test, an electrician should evaluate and make repairs.

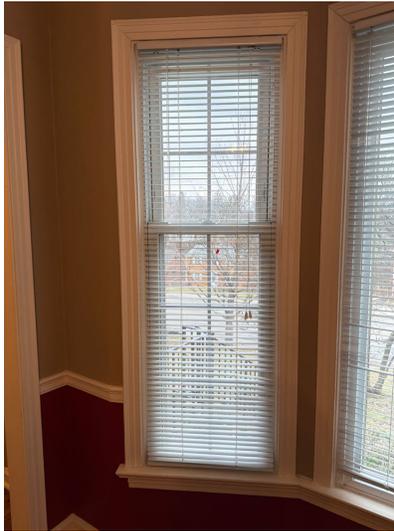
- The windows in this room are dual glazed.
- The window on the left side does not stay open, which is a safety hazard, and should be repaired or replaced by a contractor.

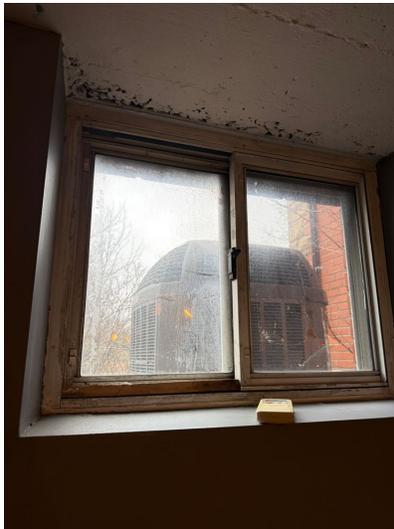
- The windows in this room are single glazed.
- The lock on the front window does not engage, and should be repaired by a contractor.

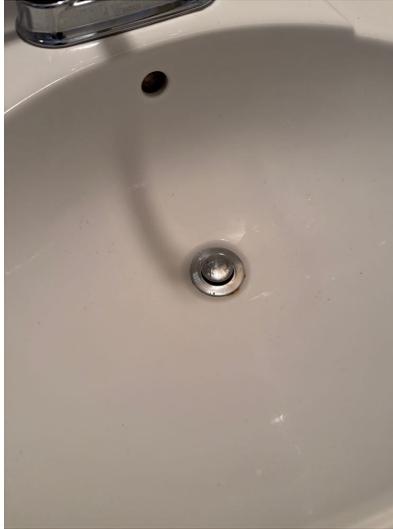
- The mechanical sink stopper does not function properly and should be repaired or replaced by a plumber.

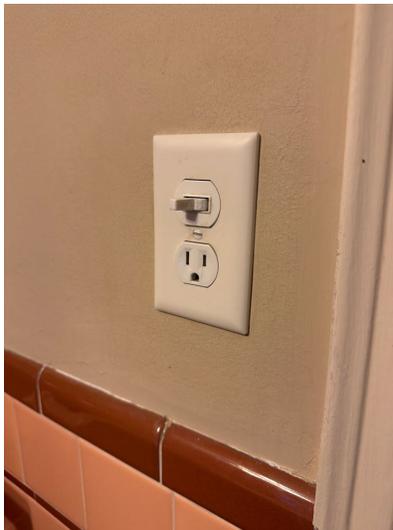
- The outlets in the bathroom are not ground fault protected and should be updated by an electrician.

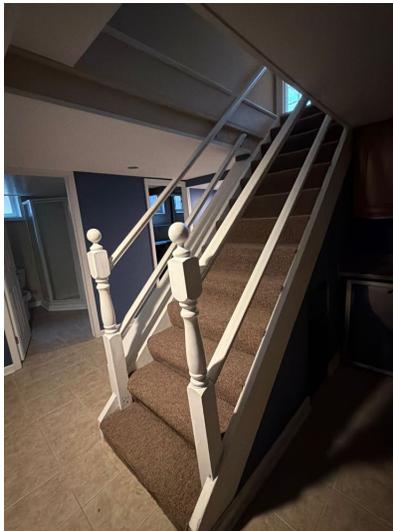
3. Basement Stair Rails

- The guardrails do not conform to current standards. They should be a minimum of thirty-six inches high with pickets no more than four inches apart, and appropriate precautions should be taken to safeguard children and the elderly.

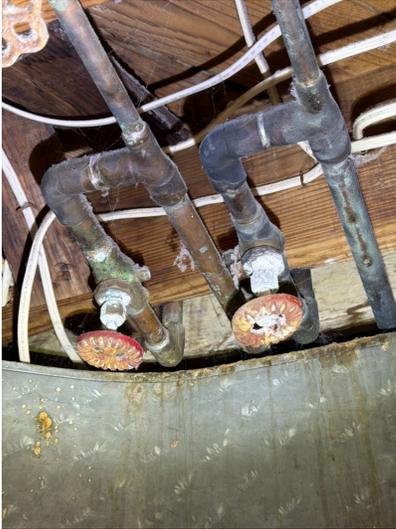
- There are valves in basement that are significantly corroded. Although not leaking now, these corroded pipes should be replaced by a plumber.

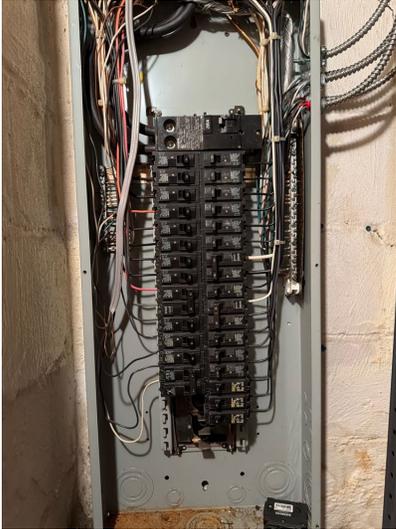
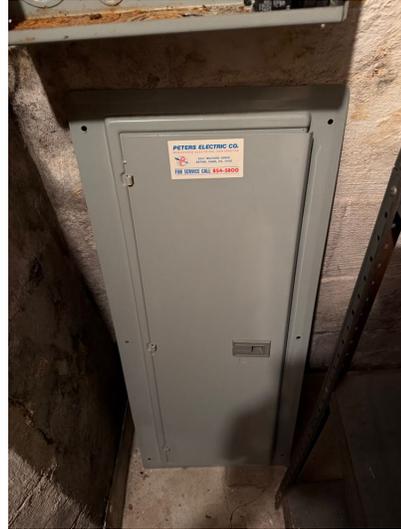
4. Main Panel

- The main electrical panel is not an original installation and has no inspection sticker on it. This panel should be inspected by an electrical inspector.

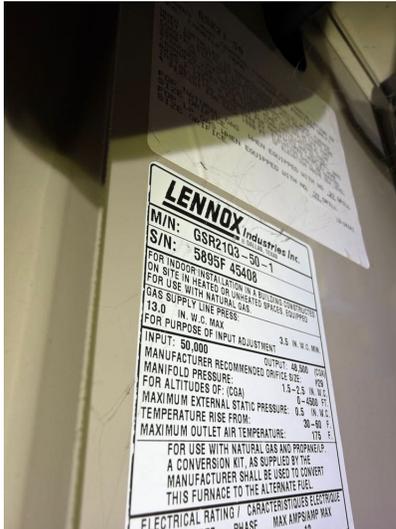
- The furnace is functional. However, it is beyond the commonly accepted design life of twenty years, and will need to be monitored more closely for evidence of metal fatigue. Future repairs or replacement should be expected and budgeted for.

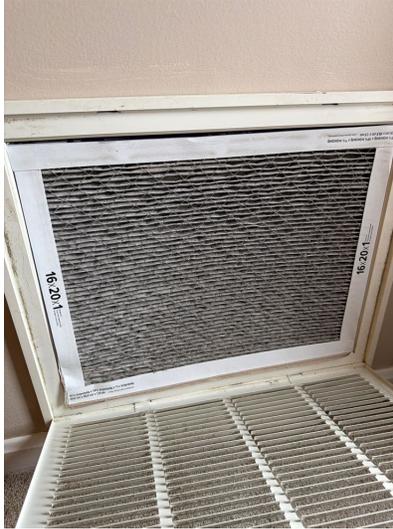
- The filter is dirty and should be changed now and every 3 months. If filters are not changed regularly, the evaporator coil and the ducts can become contaminated, and can be expensive to clean. A dirty filter can also cause premature aging and stress on the heat exchanger.

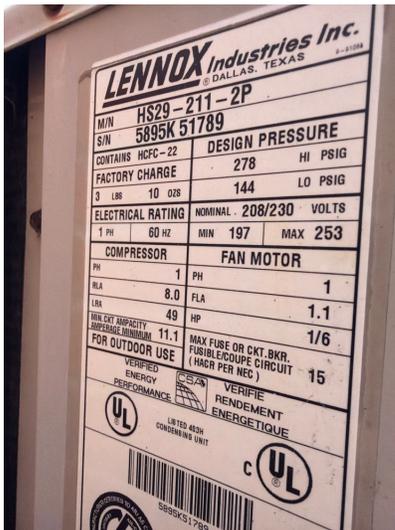
8. Condensing Coil

- The condensing coil is beyond its designed life and should be monitored in the future. You should expect that repairs or replacements will be in the close future.

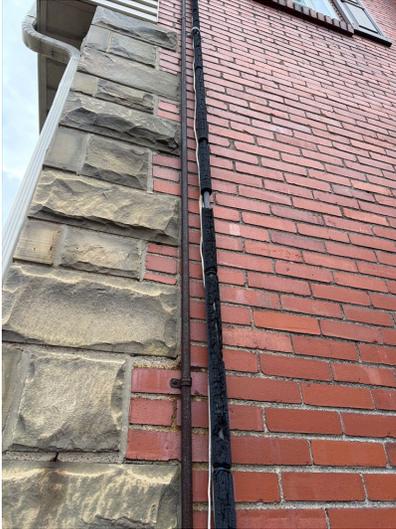
9. Refrigerant Lines

- Insulation is missing from the refrigerant lines, which will allow condensation to form and drip as well as lessen the efficiency of the system, and should be installed.
