**1240 Hillsdale Ave**

**RE: Pittsburgh, PA 15216**

**Inspection #: 527-082025-6463**

### *HOME INSPECTION REPORT*

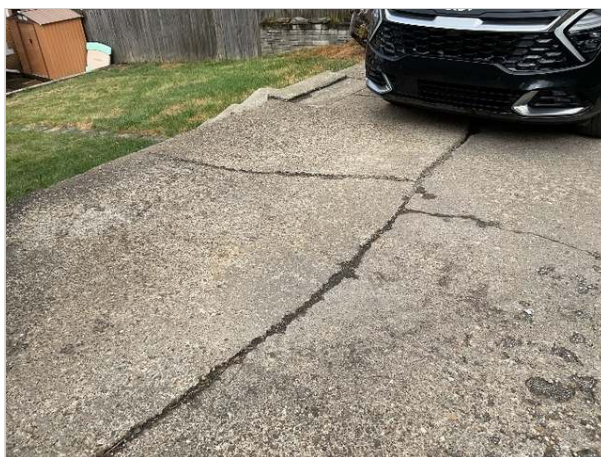
There was a concrete driveway in the back of the home which led to the off street parking. There were minor cracks and spalling noted on the driveway. Surface defects in driveways develop and progress with age and are considered normal as long as they do not create a safety hazard. There were no material defects observed in the driveway.

### *SAFETY NOTE: TRIP HAZARDS:*

There were several trip hazards found on the driveway. The hazards can be repaired using a suitable or similar surfacing material to "feather" the out-of-level condition to make a smooth transition.

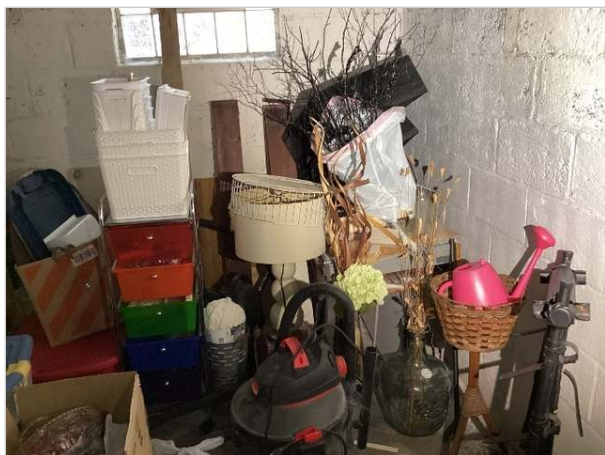
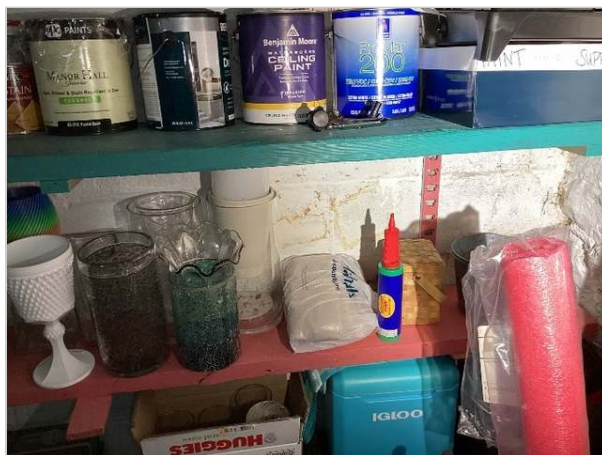
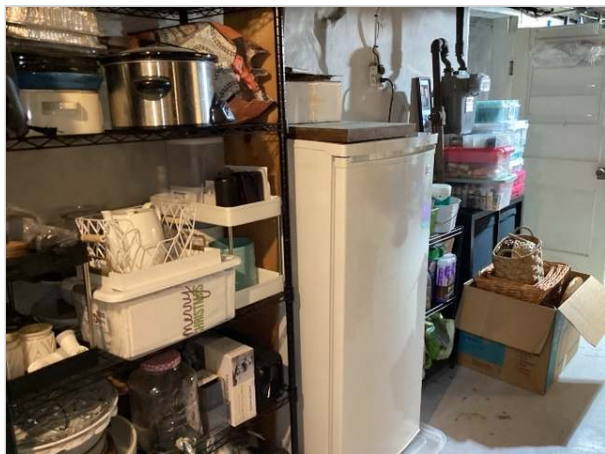
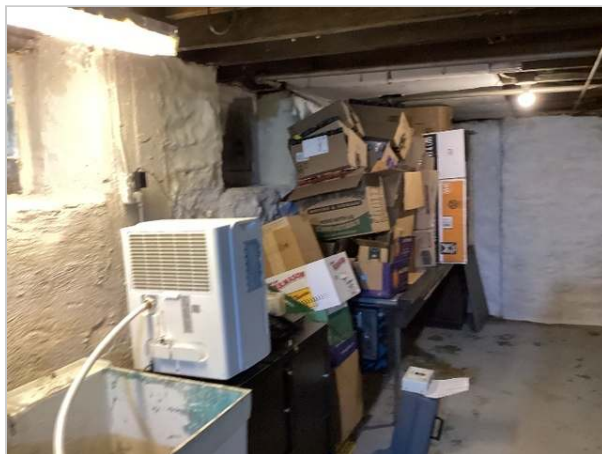
**INFORMATIONAL NOTE: BASEMENT STORED ITEMS:**

The basement was cluttered with many stored items and/or shelves at the time of inspection, therefore several areas were unable to be inspected.

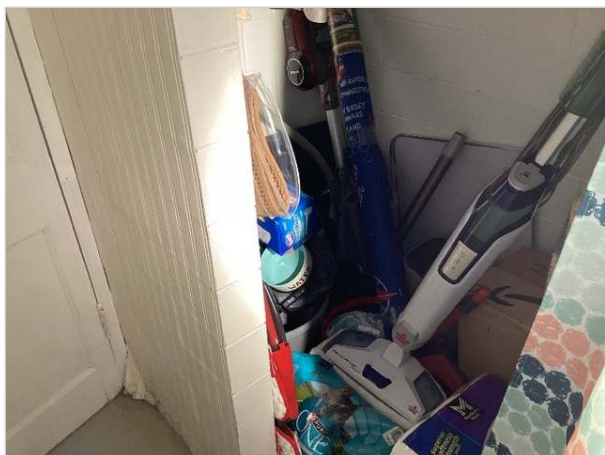
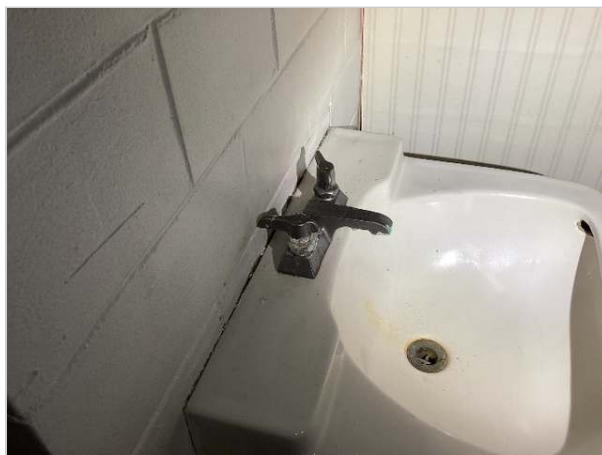
**INFORMATIONAL NOTE: PLUMBING NOT TESTED:**

The basement bath plumbing was not tested because the room was filled with items. The laboratory did not have a water supply. The affected plumbing should be evaluated by a qualified plumber and tested.

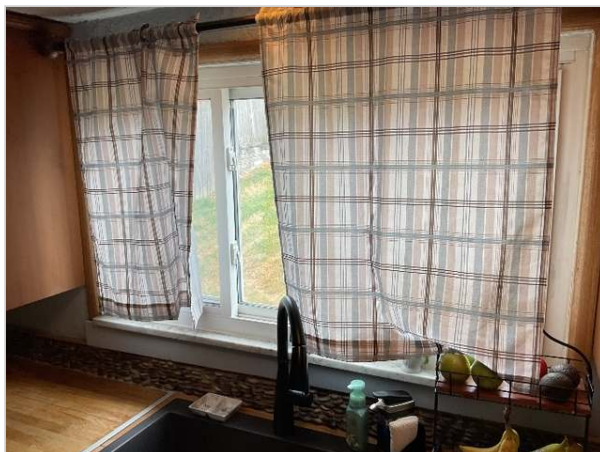
**SAFETY NOTE: WINDOW LOCKS:**

1 window would not lock. The windows was located in the kitchen For personal security all windows should properly lock.
