310 Cola St

RE: Pittsburgh, PA 15203

Inspection #: 527-032026-6753

HOME INSPECTION REPORT

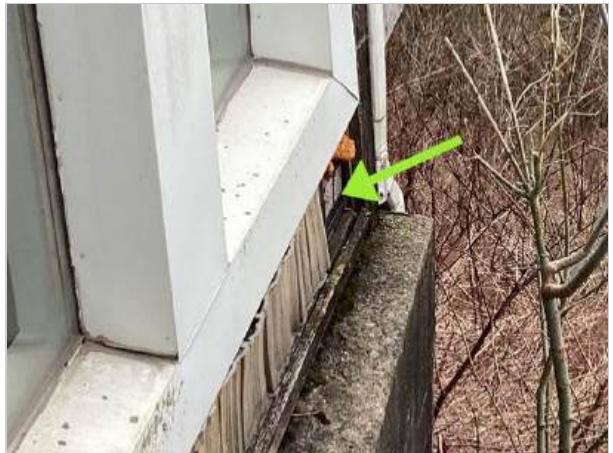
Right rear

Missing siding was noted on several areas of the home. Consult with a qualified contractor for replacement.

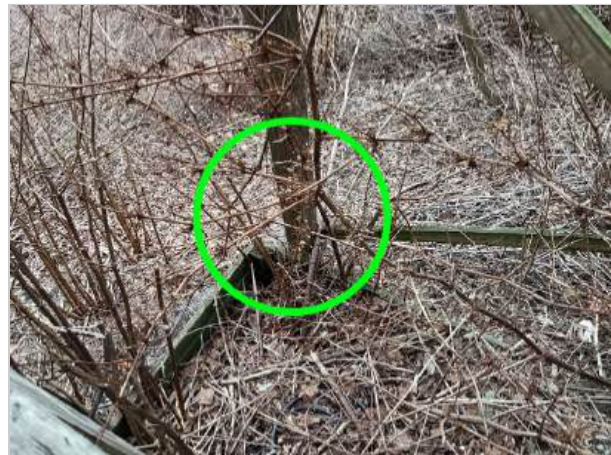
Mounted in earth

Earth mounted post with retaining wall at base

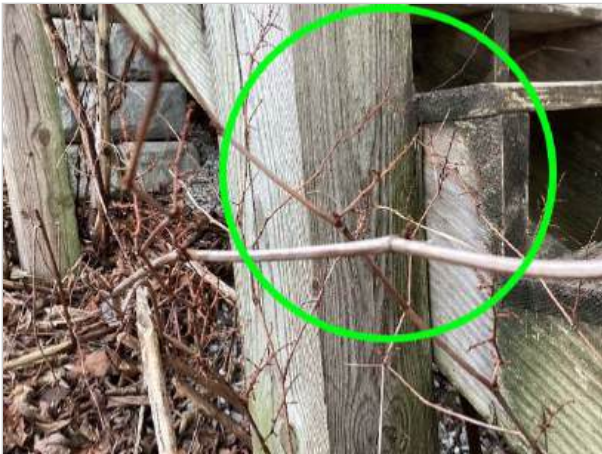
The ledger board and posts for the deck are nailed to the main structure of the home rather than bolted. Generally accepted deck construction techniques require the deck to be bolted to the main structure of the home at regular intervals. Consult with a qualified contractor to anchor the deck to the home with bolts.

No bolts

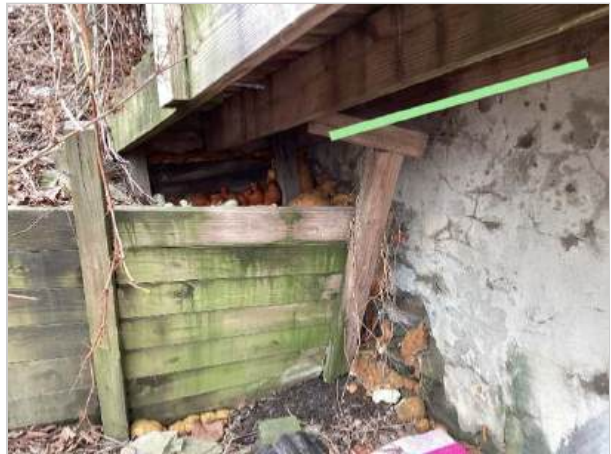
No evidence of bolts on front of ledger

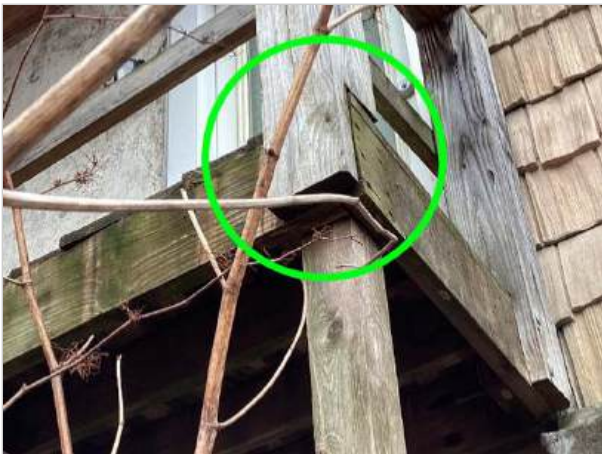
No bolts

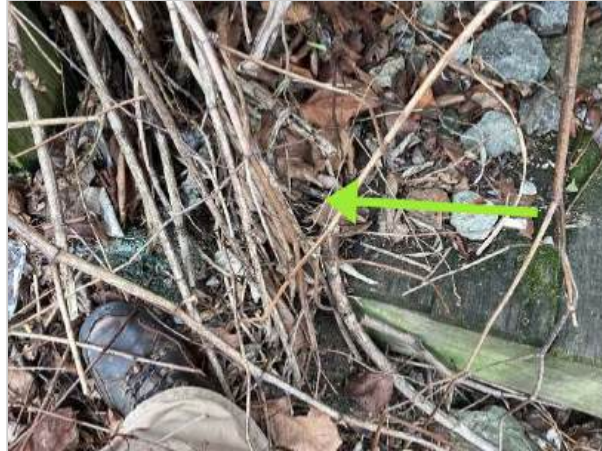
The landscaping on the right side is in direct contact with the wood framing. This condition can cause water to penetrate into the wood and other absorbent materials in the home, causing wood rot and/ or insect intrusion. The landscaping should be pulled back or the grade adjusted so that there is no earth-to-wood contact.

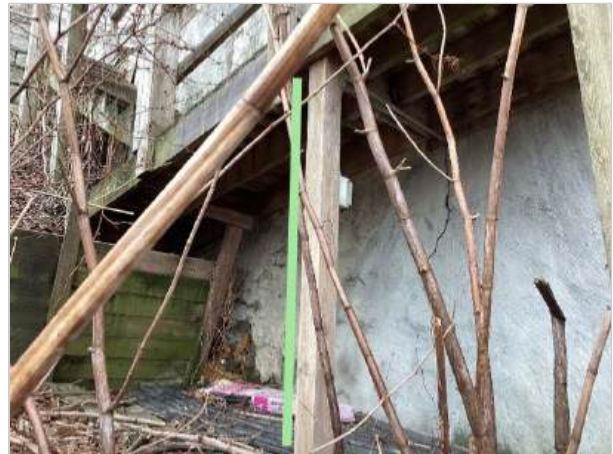
The vertical support posts on the lower right deck have several deficiencies. The post are not mounted on concrete piers with a bottom saddle to prevent rot. The front post has a retaining wall leaning on it's base. One post is detached and falling. The post is an important structural component and should be repaired. Consult with a qualified contractor for recommendations.

Not plumb

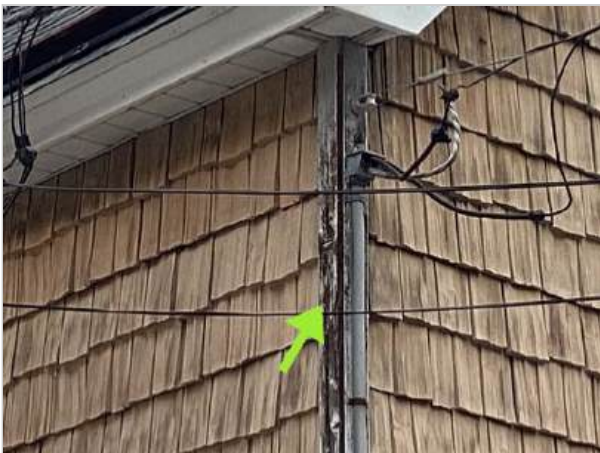
Rotted wood was noted on the wood fascia . The areas should be repaired and sealed by a qualified contractor.

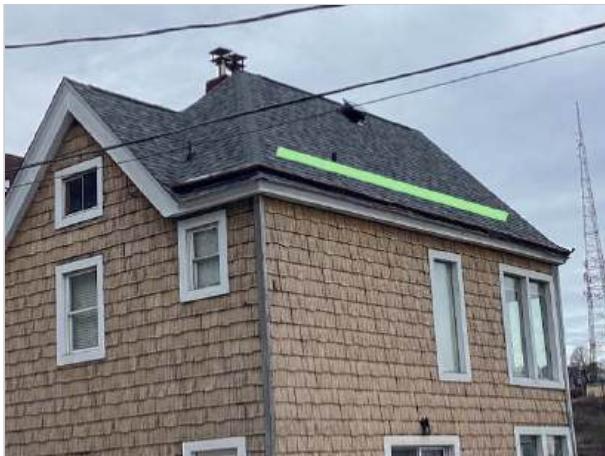
Damaged gutters were noted on the right. Gutters and downspouts help facilitate proper drainage of roof water away from the foundation of the home. Consult with a qualified, reputable contractor to install proper roof drainage.

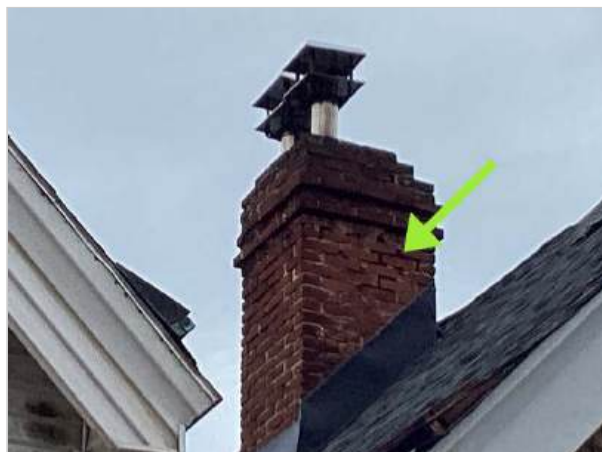
There were cracks on the top cap(s) of the chimney and repairs should be made to prevent further deterioration. Consult with a qualified masonry contractor for repair.

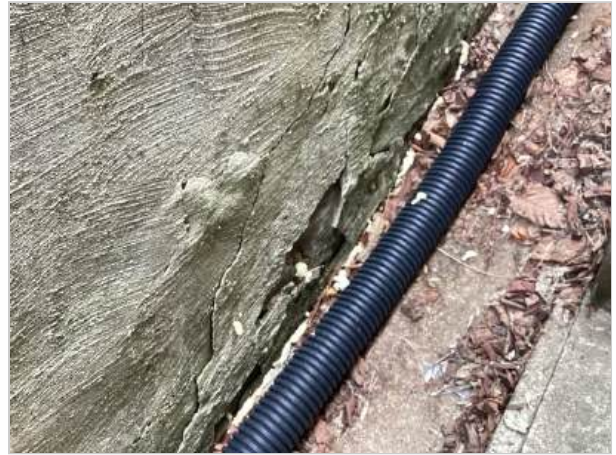
Left side

One or more cracks were noted on the foundation walls. The cracks were located on the right and left. The cracks appear to have been caused by settlement. There was no evidence of active movement at the time of the inspection. Corrective action did appear to be necessary. All cracks should be monitored for significant changes in characteristic. Consult with a contractor if the cracks change significantly or you desire another opinion on this condition.

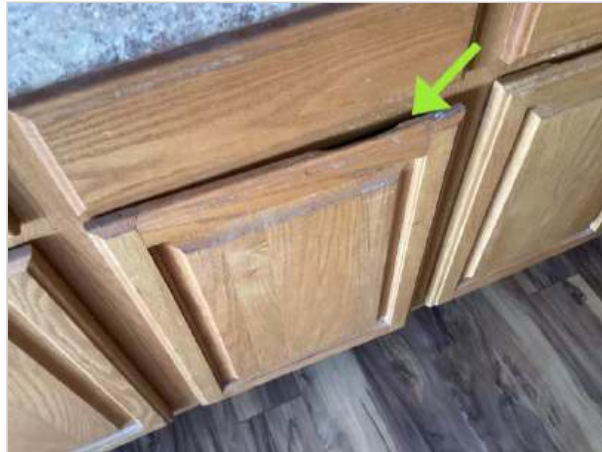
One or more of the kitchen cabinet door hinges are in need of adjustment. These adjustments are usually relatively simple and only require the tightening of screws or alignment of a variable adjustment hinge.

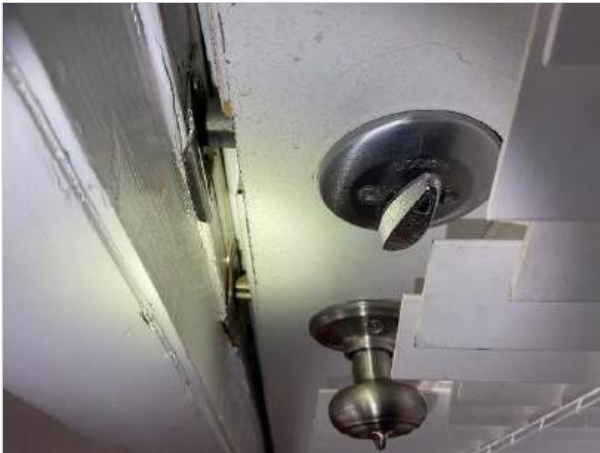
The basement man door could not be opened because the door is damaged. Consult with a qualified contractor for repair.

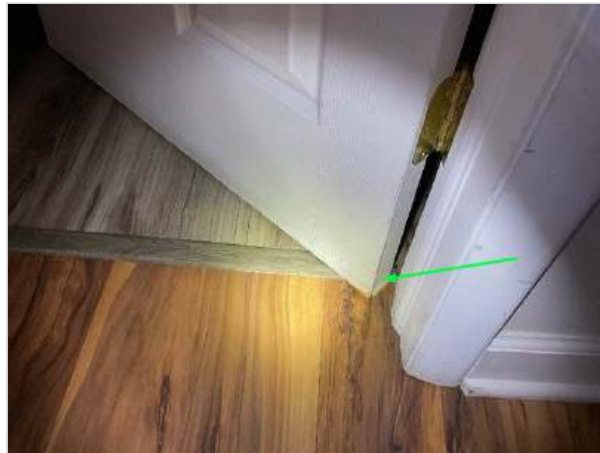
The cladding on the door located in basement bath is delaminated. The door will not close. Repair should be made by a qualified contractor.

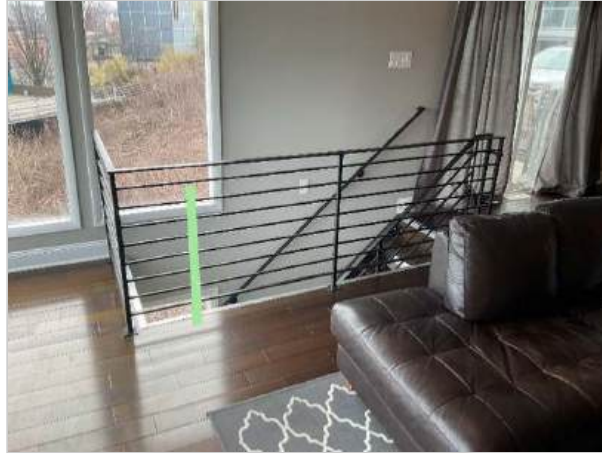
The balusters on the first floor handrail were installed horizontally. Local codes may require the installation of additional balusters. Consult with a general contractor for cost estimates for additional balusters.

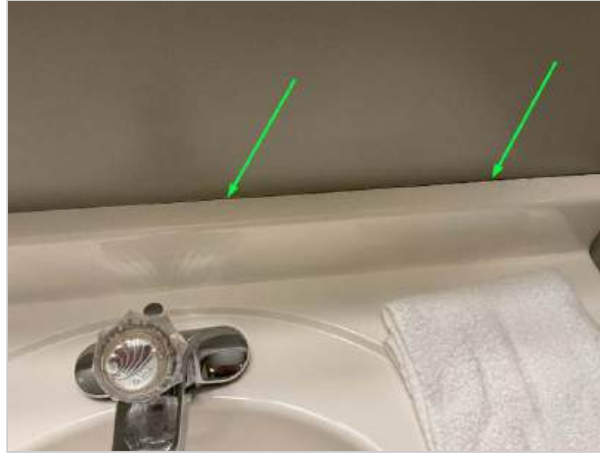
Failure to keep walls sealed can cause deterioration and extensive moisture damage including mold growth to the interior walls, which is not always visible at the time of the inspection. Some of the caulk was missing from around the sink top . These areas should be re-caulked to help prevent moisture penetration.

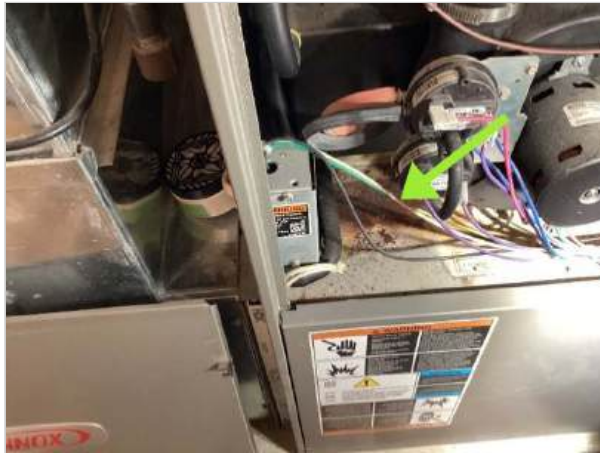
Evidence of water was noted inside the furnace compartment. The condition is most likely caused by a condensate leak in the furnace and/or air conditioning condensate drain lines. The water can also be caused by a leaking humidifier if one is installed. Water inside the furnace compartment can damage the furnace cabinet or other operational components and should be repaired. The furnace compartment was dry at the time of the inspection. Consult with a qualified heating contractor to determine the source of the water and correct the issue. Please also note that due to the seasonal use of heating and air conditioning systems, wet and dry conditions can change based on whether the inspection is performed during the heating or cooling season. The observation at the time of the inspection can be limited to seasonal conditions.

Rust

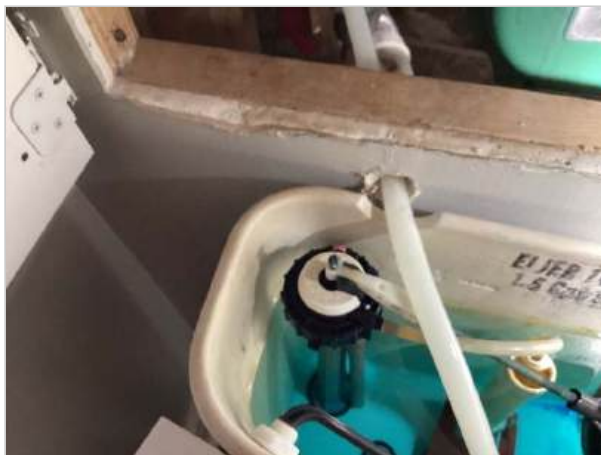
The condensate pump did not appear to be directed to a proper drain. Efforts should be made to ensure the condensation is directed into a proper drain.

Drains to toilet tank

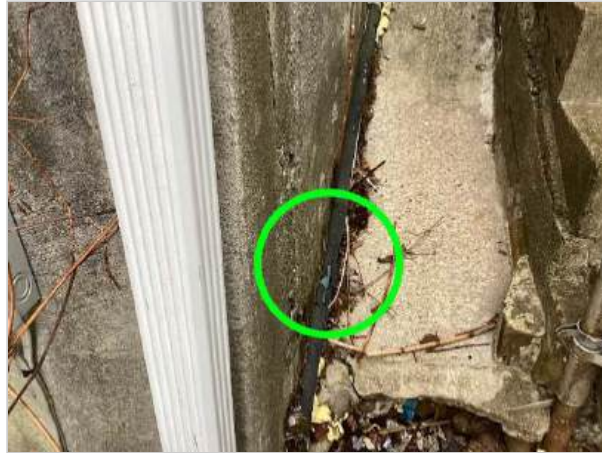
NOTE: A/C LINE SET INSULATION:

The insulation on the exterior air conditioning line set is damaged. This could affect the efficiency of the system and should be replaced.

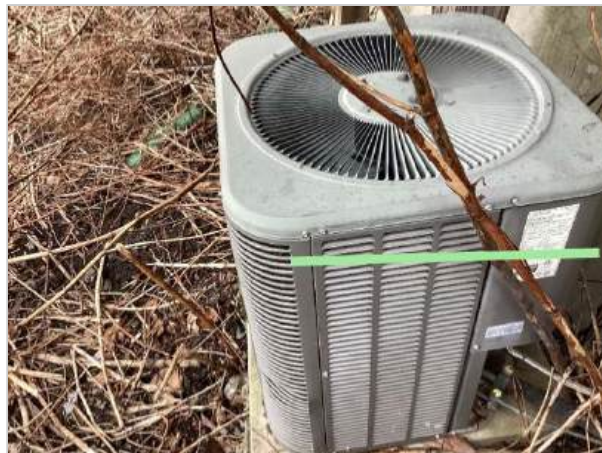
NOTE: UNLEVEL AC:

The air conditioning condensing unit is not installed level. An uneven installation can impact the unit's operational efficiency and may cause premature wear on internal components such as the compressor. A qualified HVAC contractor should evaluate and correct the installation to ensure the unit is properly leveled and operating as intended.

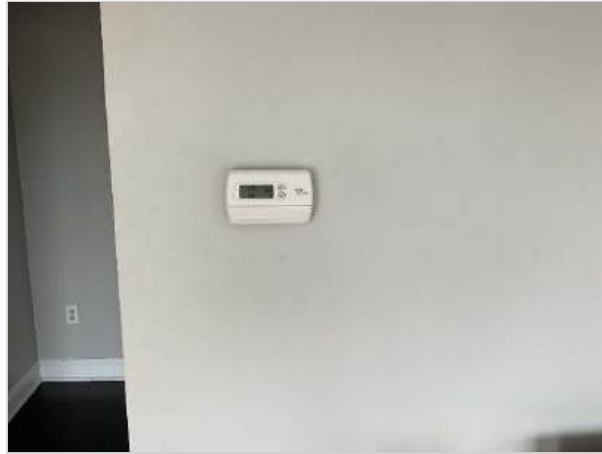
CONTROLS

The control for the heating and air conditioning system was a 24 volt thermostat located on the bedroom wall of the home. The thermostat was manufactured by White Rodgers and was found to be in working order.
