2516 Highland Cir

RE: Bethel Park, PA 15102

Inspection #: 527-032026-6736

HOME INSPECTION REPORT

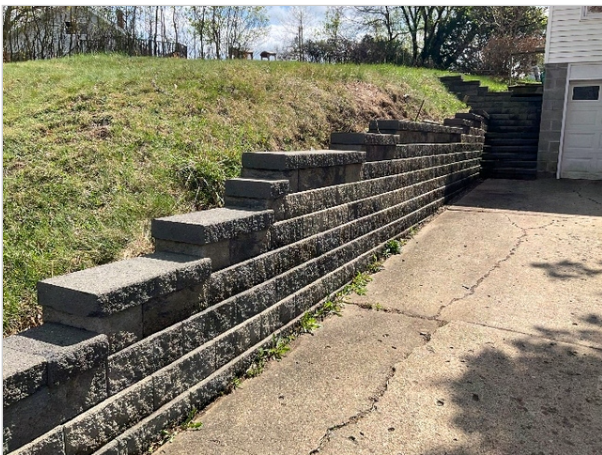
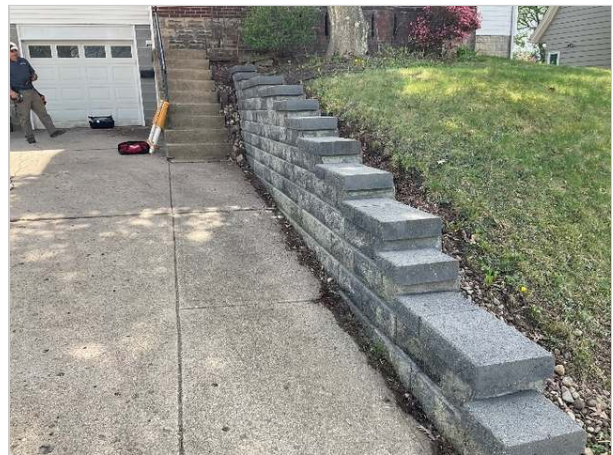
There is no barrier installed along the front retaining wall. The absence of a proper rail or barrier constitutes a fall

hazard and should be corrected. Consult with a qualified contractor for installation of a proper barrier.

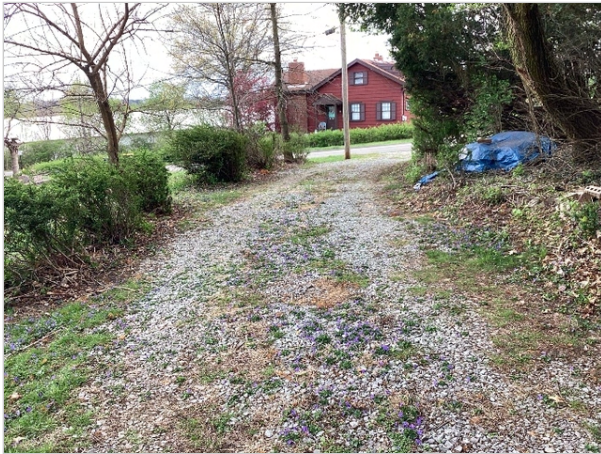
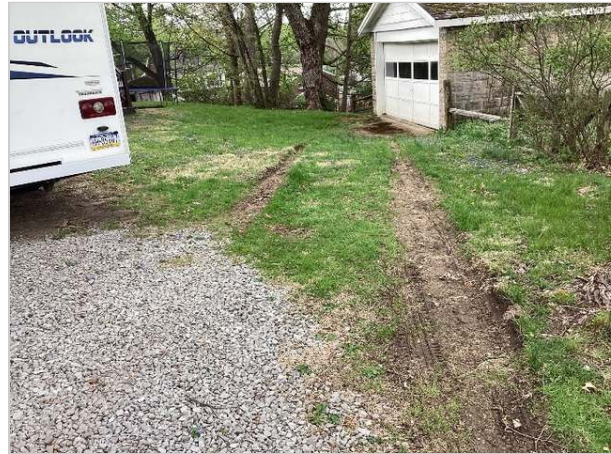
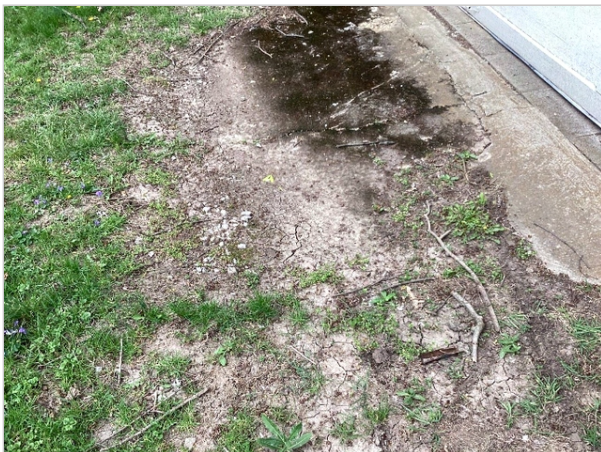
DRIVEWAY REAR

There was an unpaved driveway in the back of the home which led to the detached garage. There were notable deterioration and trip hazards noted on the driveway. Surface defects in driveways develop and progress with age and are considered normal as long as they do not create a safety hazard. There were no material defects observed in the driveway.

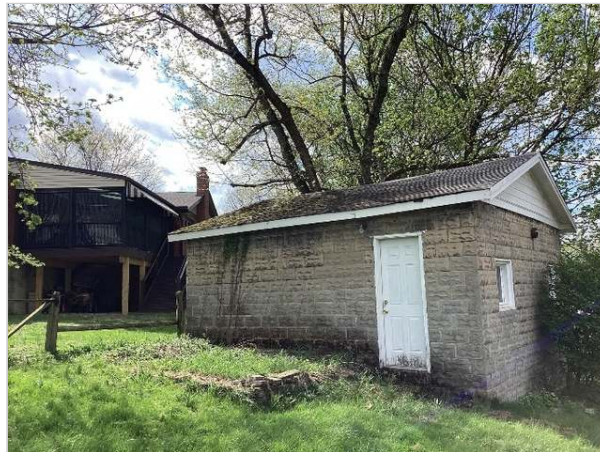
Missing gutters and downspouts were noted on garage. Gutters and downspouts help facilitate proper drainage of roof water away from the foundation of the home. Consult with a qualified, reputable contractor to install proper roof drainage.

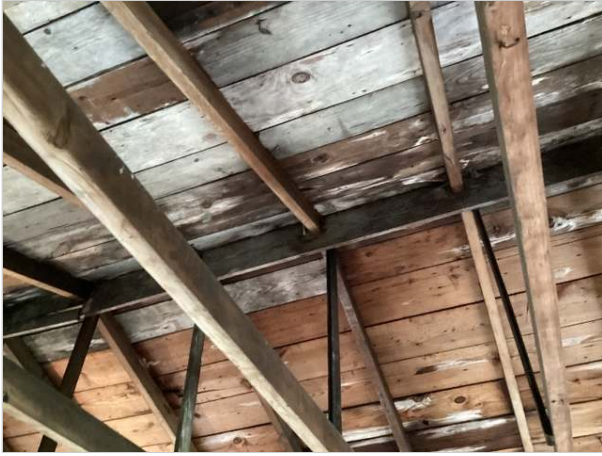
The roof deck as viewed from the garage is water marked. The cause of condition appears to be the result of active leaks. Repairs to the affected areas are required. Consult with a qualified contractor for repair.

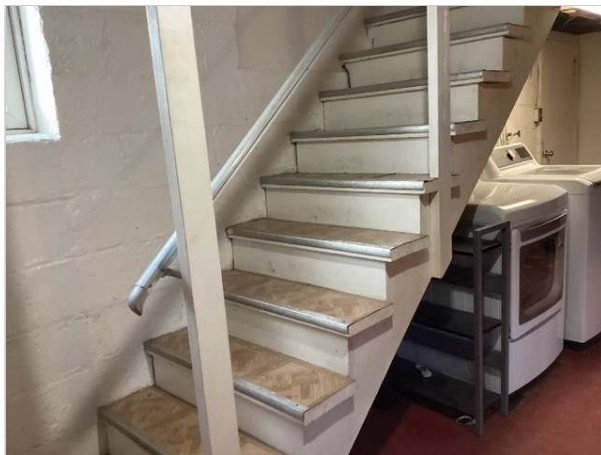
The balusters on the basement rail were installed horizontally rather than vertically. Generally accepted construction techniques provide for balusters to be installed vertically and spaced no greater than four inches apart. Larger baluster spacing can be a safety concern, and horizontally mounted balusters permit climbing. Local codes may require modification and / or installation of additional balusters. Consult with a general contractor for cost estimates for additional balusters.

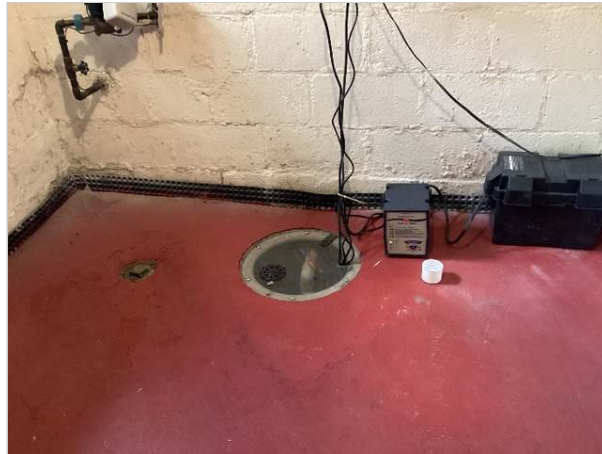
The sump pump is not properly wired. The pump should be connected to a permanently wired, grounded outlet that is located close to the sump. Consult with a qualified electrician for installation.

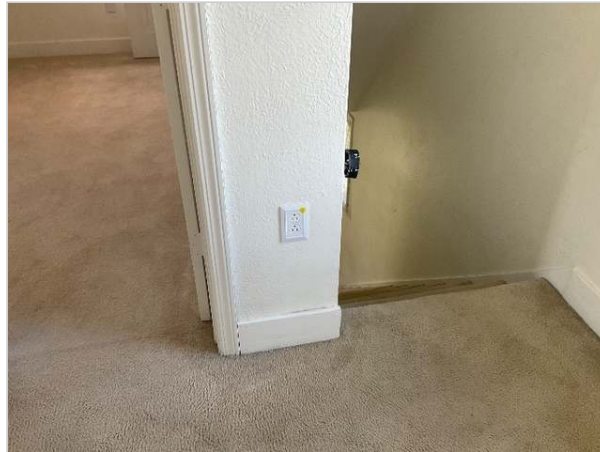
There were one or more receptacles in the home where the presence of hot and neutral wires were reversed. This is a safety concern and should be repaired by a licensed electrician. The outlets that tested with this condition were marked with a "YELLOW" dot for easy identification. The affected outlets were located in the hallway. Please note that we only test outlets that are visible and readily accessible at the time of the inspection.

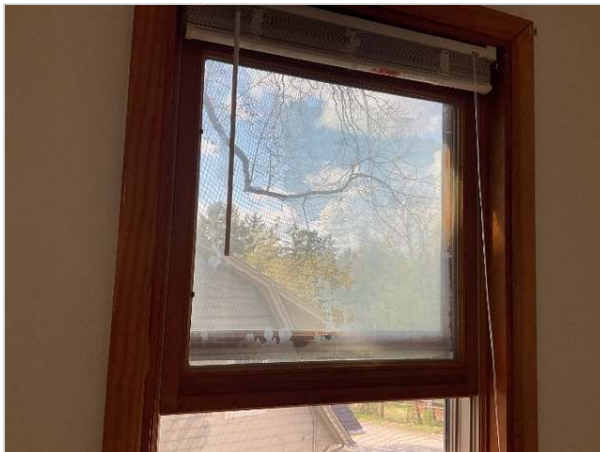
Rear bedroom

One or more of the insulated window panes throughout the home had a defective thermal seal. The window (s) were located in the bedroom. A defective thermal seal can be identified when fogging is observed between the panes of glass. This statement should not be considered all inclusive. Our ability to identify defective thermal seals is affected by dirty glass, the angle by which we can view the windows, window coverings and the direction of the sun. It is not possible to identify mild cases of fogging between glass panes given the conditions that affect our view. Repair of the thermal seal can be accomplished by replacing the affected glass panel.

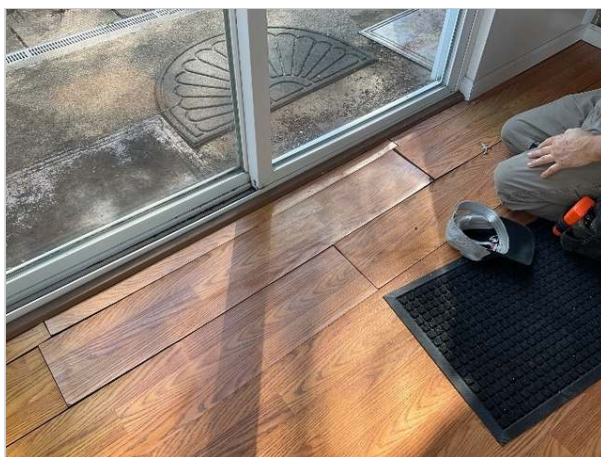
Water marks with significant surface damage was noted on the floor in the sunroom. The water marks appeared to be the result of active leaks. Consult with a qualified contractor for evaluation and repairs as required.

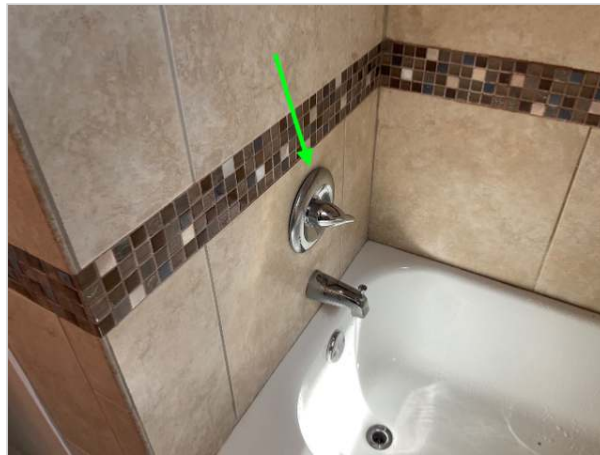
Failure to keep walls sealed can cause deterioration and extensive moisture damage including mold growth to the interior walls, which is not always visible at the time of the inspection. Some of the caulk was missing from around the tub . These areas should be re-caulked to help prevent moisture penetration.

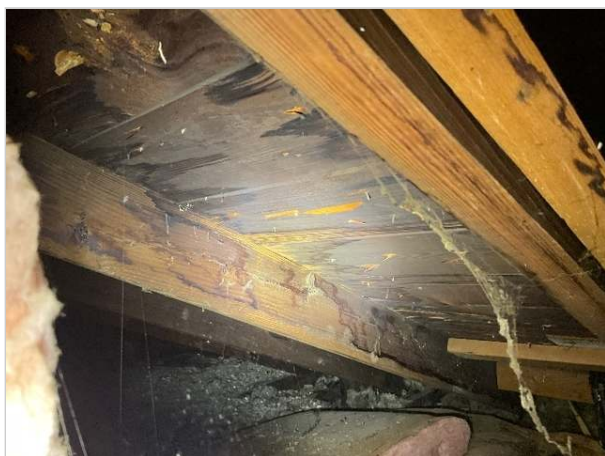
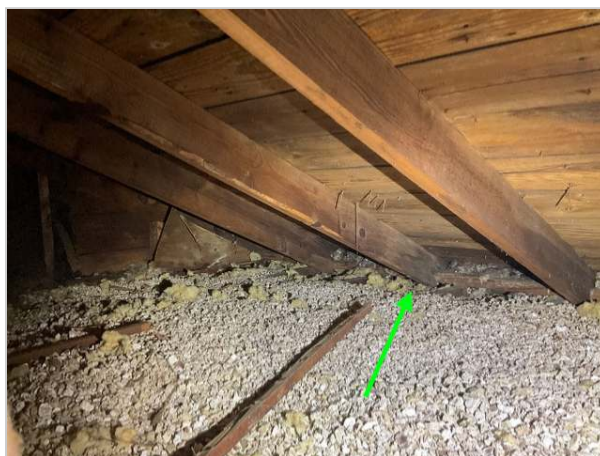
The roof deck as viewed from the attic is water marked. The cause of condition appears to be the result of questionable ventilation. Repairs to the affected areas may be required. Areas should be monitored during times of heavy rains for any changes or new watermarks.

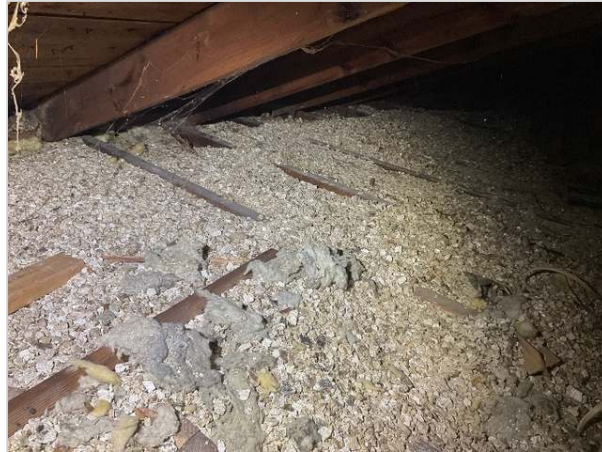
Vermiculite type insulation was noted in the attic. Vermiculite ore from some sources is known to contain asbestos minerals however, not all vermiculite type insulation contains asbestos. The presence of asbestos cannot be confirmed without professional testing. The EPA recommends that you do not disturb the insulation. Any disturbance has the

potential to release asbestos fibers into the air. Limiting the number of trips you make into the attic and shortening the length of those trips can help limit exposure. The EPA strongly recommends that homeowners make every effort not to disturb the vermiculite insulation in their attics. If you plan to remodel or conduct renovations that would disturb the vermiculite, hire professionals trained and certified to handle asbestos and safely remove the material. The U.S. Environmental Protection Agency (EPA) strongly recommends that the insulation be left alone and not disturbed. More information on vermiculite can be found on the EPA web site; <http://www2.epa.gov/asbestos/protect-your-family-asbestos-contaminated-vermiculite-insulation>

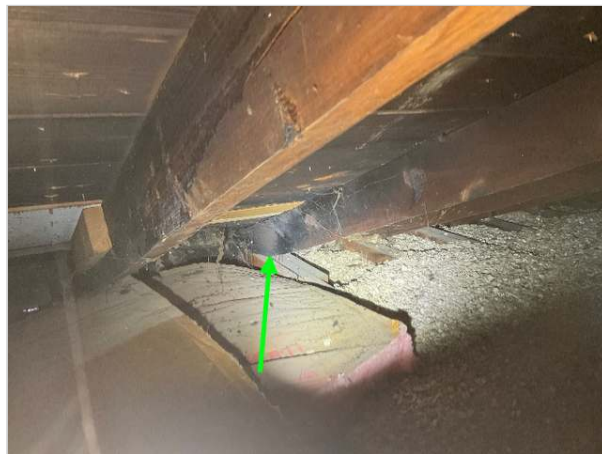
Rafter number 5 as counted from the right rear of the roof structure is split. This condition could weaken the roof structure in the affected area. Consult with a qualified contractor for evaluation and recommendations.

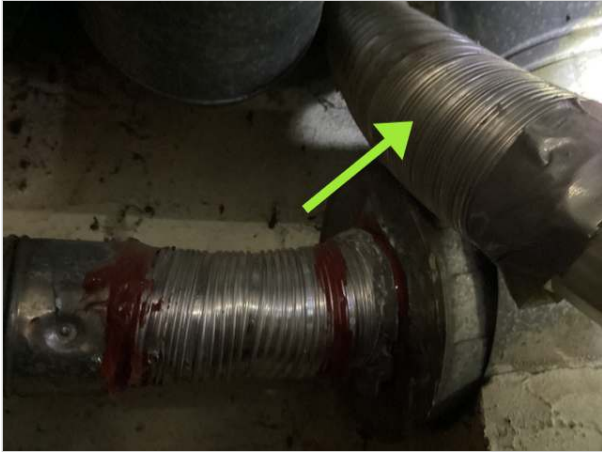
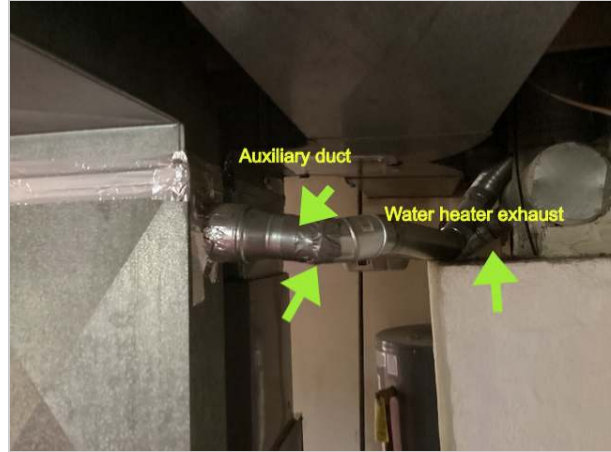
The furnace air return plenum has an augmented duct installed. We recommend it be confirmed the water heater exhaust is clear of the duct for efficiency. Consult with a qualified contractor for repair.

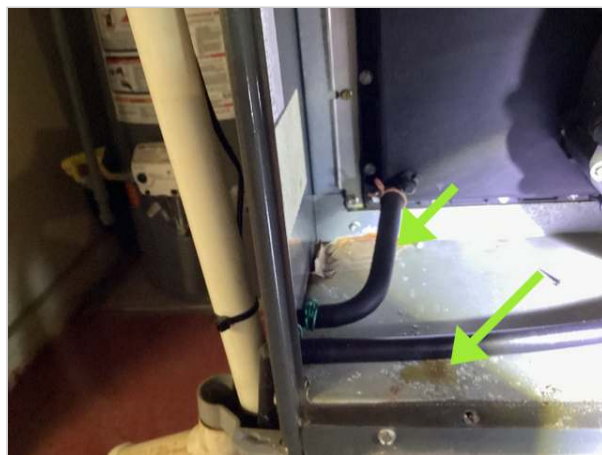
Evidence of water was noted inside the furnace compartment. The condition is most likely caused by a condensate leak in the furnace and/or air conditioning condensate drain lines. The water can also be caused by a leaking humidifier if one is installed. Water inside the furnace compartment can damage the furnace cabinet or other operational components and should be repaired. The furnace compartment was dry at the time of the inspection. Consult with a qualified heating contractor to determine the source of the water and correct the issue. Please also note that due to the seasonal use of heating and air conditioning systems, wet and dry conditions can change based on whether the inspection is performed during the heating or cooling season. The observation at the time of the inspection can be limited to seasonal conditions.

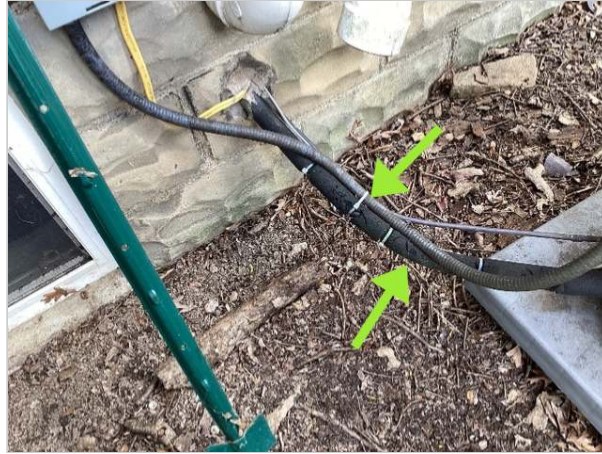
The insulation on the exterior air conditioning line set is damaged. This could affect the efficiency of the system and should be replaced.

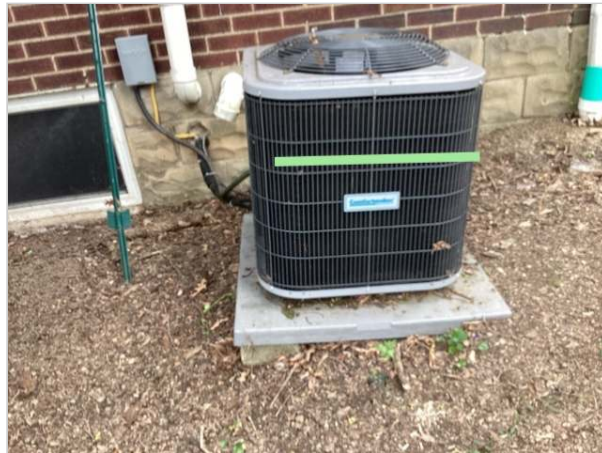
The air conditioning condensing unit is not installed level. An uneven installation can impact the unit's operational efficiency and may cause premature wear on internal components such as the compressor. A qualified HVAC contractor should evaluate and correct the installation to ensure the unit is properly leveled and operating as intended.
