INSPECTION SERVICE

571 Dewalt Dr

RE: Pittsburgh, PA 15234

Inspection #: 527-082025-6477

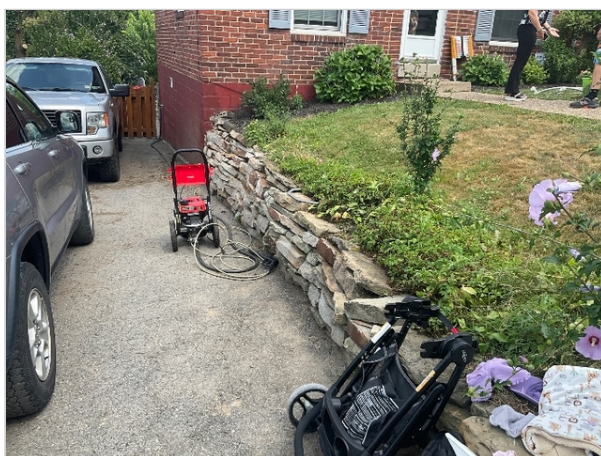
RETAINING WALL

There was one retaining wall constructed of stone. The wall was in fair condition. There were no material defects observed in the wall. We do not inspect or comment on retaining walls that are detached from the main structure of the home unless the walls function has an impact on the structure.

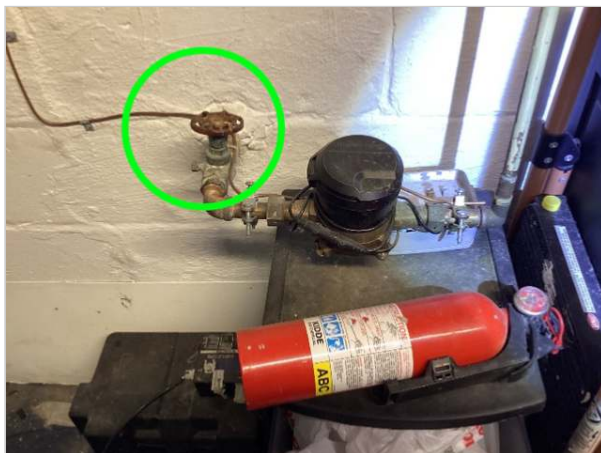
WATER-METER

The water meter was located in the basement. The main water shutoff valve for the home was located adjacent to the water service entry point in the basement. Water shutoff valves are visually inspected only. No attempt is made to operate the main or any other water supply shutoff valves during the inspection. These valves are infrequently used and could leak after being operated. The only exception to this policy is made when the main water supply valve is off upon arrival at the inspection. Since it is the buyers right to have all utilities operable for the home inspection, we will attempt to turn the main water valve on for the inspection. The HomeTeam is not responsible for leaks caused by operating the valve.
