Inspection Report

590 Kenilworth Dr.
Pittsburgh Pa 15228

A Harmony Home Inspection, LLC

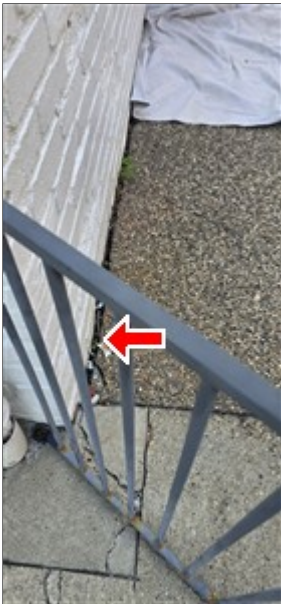
2.3 Picture 5

2.3 Vegetation was in contact with the house at areas of the exterior at the front and right sides.

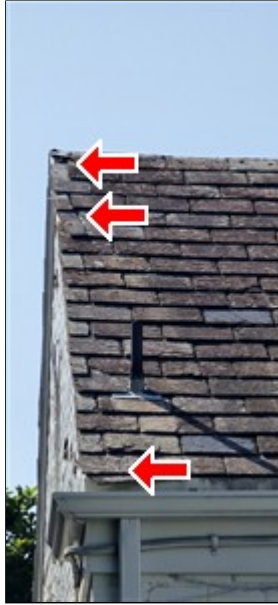
1.0 Picture 3

Areas of patches and repairs were observed at slate roof coverings.

Areas of worn, cracked, and broken slate were observed at the roof coverings.

Areas of shifted and fallen slate were observed at the right end of the roof. Some areas of exposed wood/holes in the roof coverings were observed at shifted slate.
