**317 Old Farm Rd**

**RE: Pittsburgh, PA 15228**

**Inspection #: 527-112025-6616**

### *HOME INSPECTION REPORT*

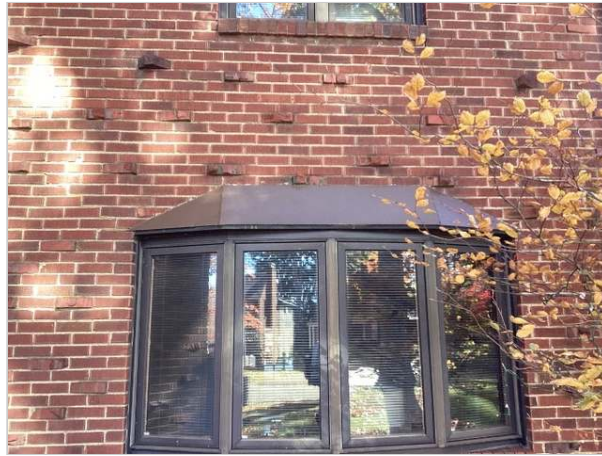
The aluminum and wood soffit and fascia was inspected and was in need of repair.

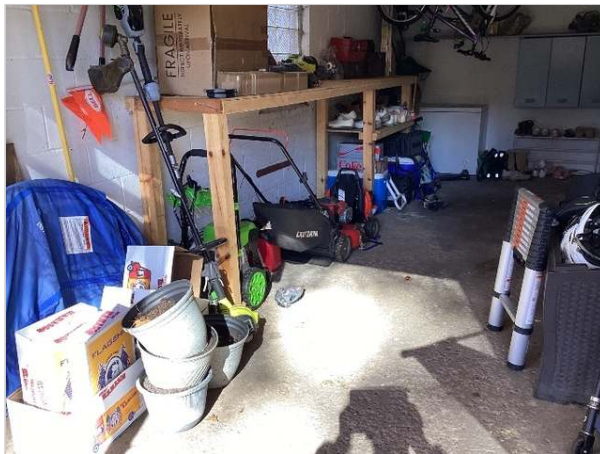
The garage was cluttered with many stored items and/or shelves at the time of inspection, therefore several areas were unable to be inspected.

The installation of safety cables in the garage door springs will prevent a breaking spring from flying and possibly damaging objects in its path. The cables are inexpensive and easy to install and can be purchased at any home improvement store.

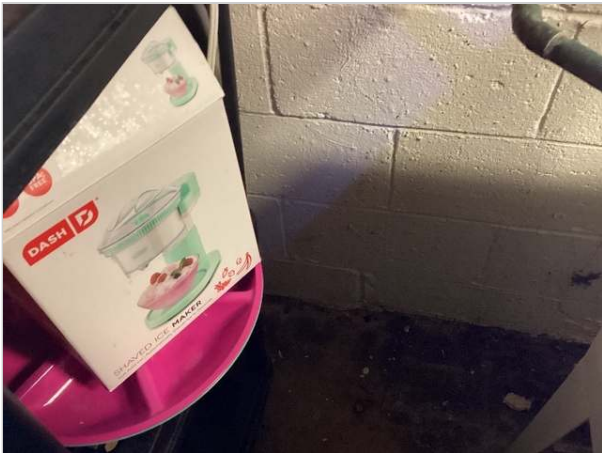
Laundry

There were signs of moisture on the front and left basement walls. The area was dry at the time of the inspection. Dampness on basement walls is not always a sign of water intrusion. The dampness can be the result of warm humid air making contact with cool walls. In many cases the humid air condenses on the wall and forms a layer of moisture. It is important to assess whether moisture on the basement walls is the result of water intrusion or condensation. In this case, the efflorescence noted on the wall appears to be the result of moisture buildup on the exterior side of the foundation. The exterior grading in the affected area is questionable. Many water intrusion problems can be controlled by improving the drainage on the exterior of the home. It is important that all roof drainage and surface water is directed away from the foundation. Any concern about this condition should be referred to a qualified contractor for evaluation and recommendations.
