**2360 W Gate Dr**

**RE: Pittsburgh, PA 15237**

**Inspection #: 527-062026-6913**

### HOME INSPECTION REPORT

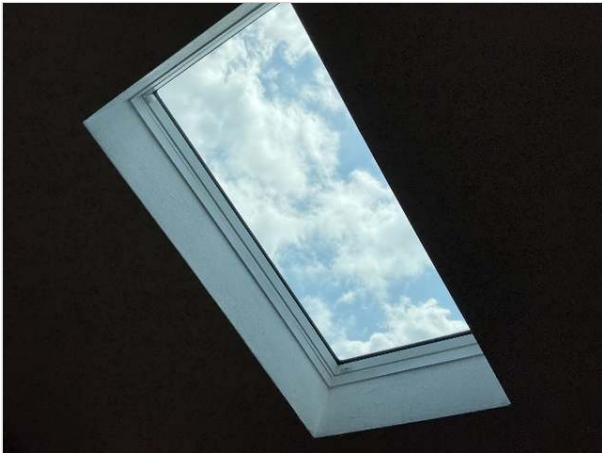
loft

There were six skylights installed. Skylights are considered roof penetrations and require water tight installation. Our ability to verify that the skylight is water tight is limited to our visual inspection. In order to ensure the unit remains water tight, we will not attempt to open units that contain this feature. Skylight lens' are made of either plexiglas, lexan or

glass. It is not always possible to identify the lens material. Plexiglas and lexan skylight lens' often develop hairline cracks as the lens material ages. This is usually a cosmetic condition and does not affect the performance of the skylight. In this case hairline cracks were not observed. The skylight lens were clear. Skylights are usually double pane. Depending upon the angle of the sun and the frosting of the glass we cannot always determine if the thermal seal is intact. There were no visual defects observed on the skylights.

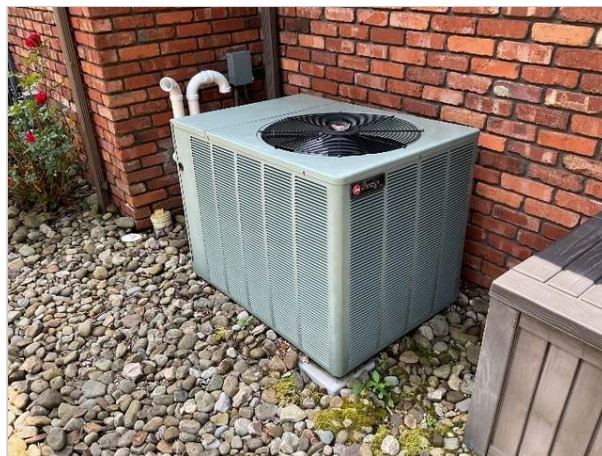
The electric outdoor air conditioner condensing unit was a Rheem, Model Number RARL-048JEZ and Serial Number 7232M260815799. The unit is located in the back of the home. This unit is approximately 16 years old. Periodic preventive maintenance is recommended to keep this unit in good working condition. The forced air cooling system was tested and found to be functional. The home inspection does not include a heat-gain analysis, cooling design or adequacy evaluation, energy efficiency assessment, installation compliance check or refrigerant evaluation.
