**727 Newport Dr**  
**RE: Pittsburgh, PA 15234**  
**Inspection #: 527-052025-6270**

### HOME INSPECTION REPORT

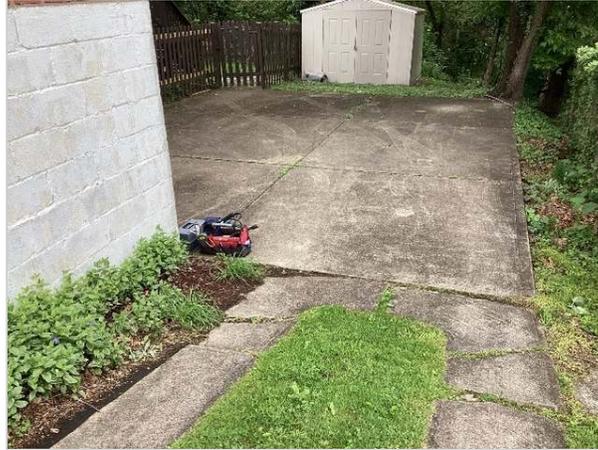
There was a concrete driveway on the right side of the home which led to the integral garage. There were notable deterioration and trip hazards noted on the driveway. Surface defects in driveways develop and progress with age and are considered normal as long as they do not create a safety hazard. There were no material defects observed in the driveway.

**SAFETY NOTE: TRIP HAZARDS:**

There were several trip hazards found on the driveway. The hazards can be repaired using a suitable or similar surfacing material to "feather" the out-of-level condition to make a smooth transition.

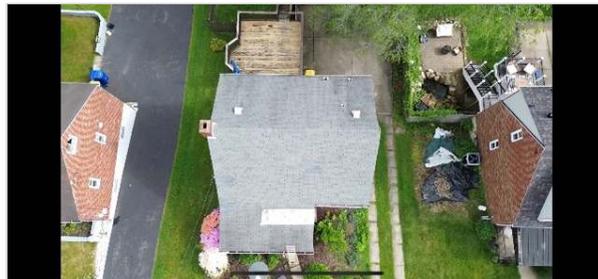
**NOTE: SOFFIT & FASCIA:**

Loose fascia was noted on the right side. Consult with a qualified contractor for repair.

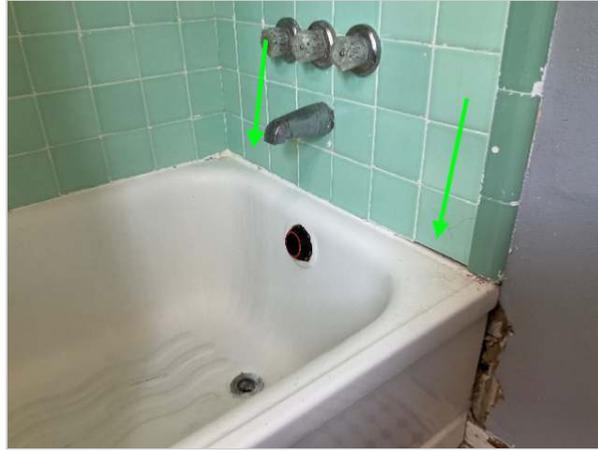
### *NOTE: TUB WALLS:*

The walls in the tub / shower area show evidence of water damage. Concealed water damage may exist behind the finished surface. Determining the existence of concealed damage or defects is beyond the scope of this visual inspection. Consult with a qualified contractor to further evaluate the area and recommend repair methods and provide estimates if applicable.

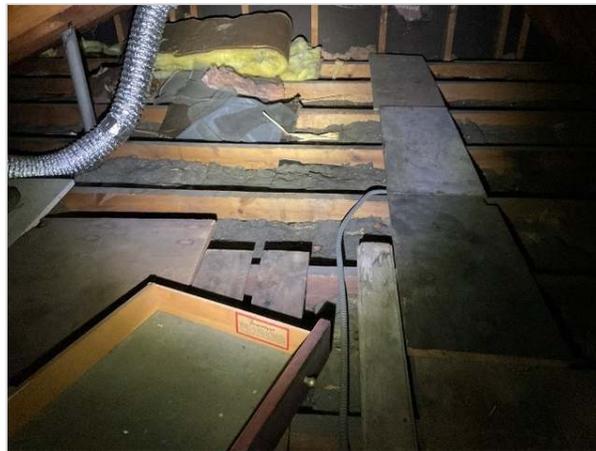
**NOTE: ROOF DECK:**

The roof deck as viewed from the attic is water marked. The cause of condition appears to be the result of previous leaks. Repairs to the affected areas are not required. Areas should be monitored during times of heavy rains for any changes or new watermarks.
