**5947 Wallace Ave**

**RE: Bethel Park, PA 15102**

**Inspection #: 527-102025-6589**

### *HOME INSPECTION REPORT*

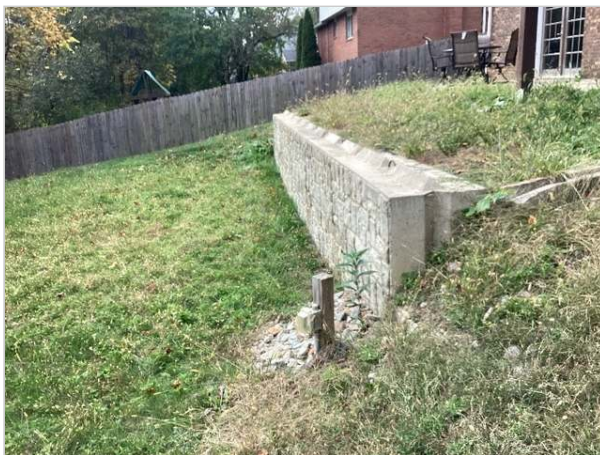
### *SAFETY NOTE: FALL HAZARD:*

There is no barrier installed on the rear retaining wall. The absence of a proper rail or barrier constitutes a fall hazard and should be corrected. Consult with a qualified contractor for installation of a proper barrier.

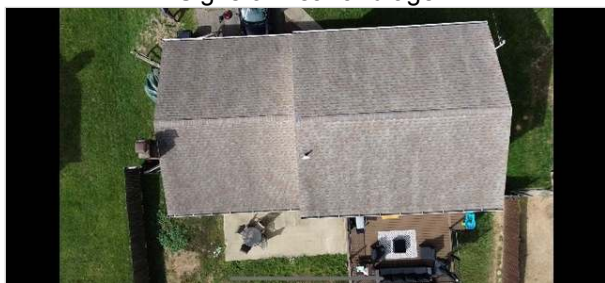
Signs of wear and age

**NOTE: ROOF SHINGLES:**

Several shingles were damaged above the gutter mounts of the roof at the time of the inspection. While this condition is not necessarily an indication of a leak, repairs should be made. Consult with a qualified roofer for repair.

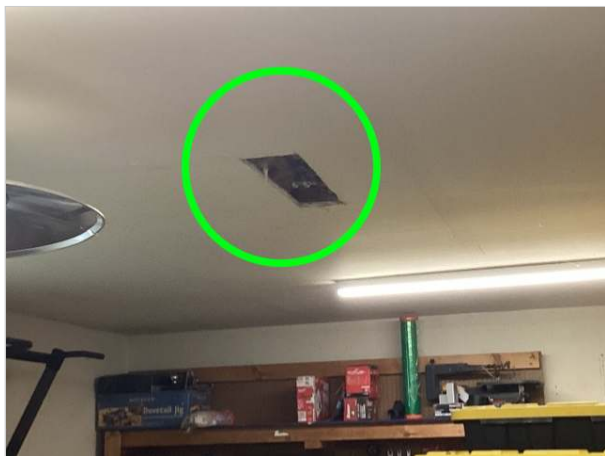
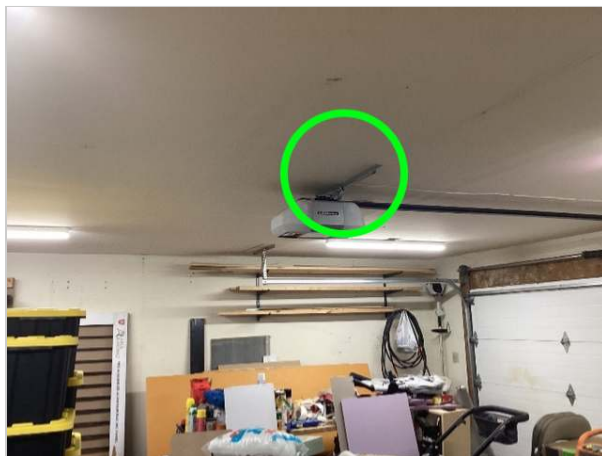
**SAFETY NOTE: GARAGE WALL / CEILING:**

The finish on the garage ceiling and any partition walls between the garage and basement or living space is designed to provide a barrier between the garage and living space in the event of a fire. One or more openings were noted in the garage ceiling. Repairs should be made to the ceiling to maintain the integrity of this important safety feature.

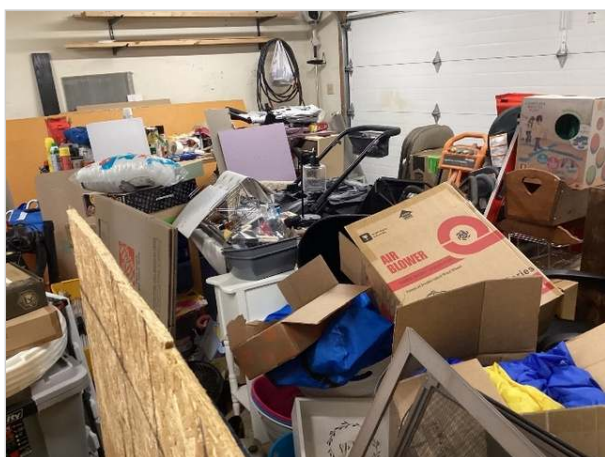
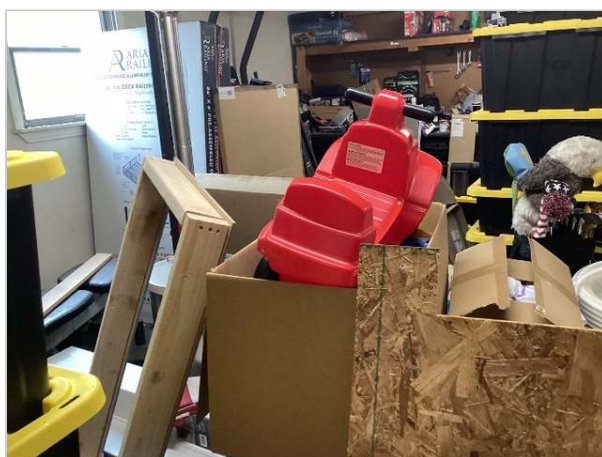
**INFORMATIONAL NOTE: GARAGE STORED ITEMS:**

The garage was cluttered with many stored items and/or shelves at the time of inspection, therefore many areas were unable to be inspected.

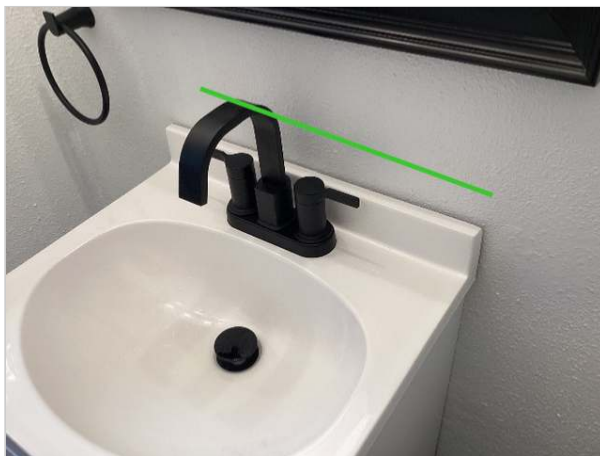
**MAINTENANCE NOTE: BATHROOM CAULKING:**

Failure to keep walls sealed can cause deterioration and extensive moisture damage including mold growth to the interior walls, which is not always visible at the time of the inspection. Some of the caulk was missing from around the sink top. These areas should be caulked to help prevent moisture penetration.

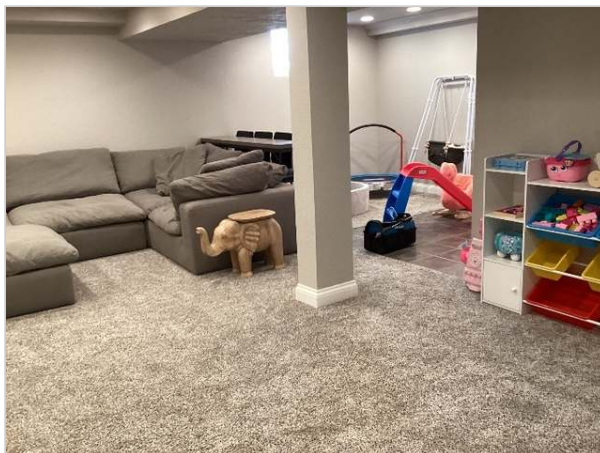
***INFORMATIONAL NOTE: BASEMENT STORED ITEMS:***

The basement was cluttered with many stored items and/or shelves at the time of inspection, therefore several areas were unable to be inspected.

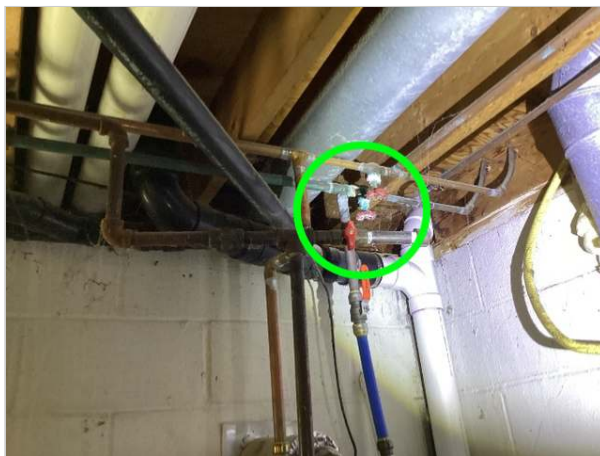
### *INFORMATIONAL NOTE: OLDER, CORRODED WATER SUPPLY VALVES:*

Older and/or corroded water supply valves were noted in the home. Water supply valves are infrequently used and often corrode on the inside and outside of the valve. This condition is common and often renders the valve inoperable. We make no attempt to test any water valves in the home regardless of their condition, because doing so could result in a leak. If this is a concern, you should consult with a qualified plumber for further evaluation and testing.

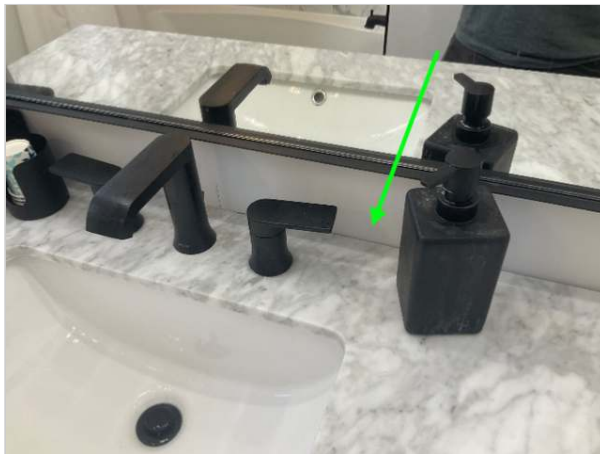
*MAINTENANCE NOTE: BATHROOM CAULKING:*

Failure to keep walls sealed can cause deterioration and extensive moisture damage including mold growth to the interior walls, which is not always visible at the time of the inspection. Some of the caulk was missing from around the sink top . These areas should be caulked to help prevent moisture penetration.

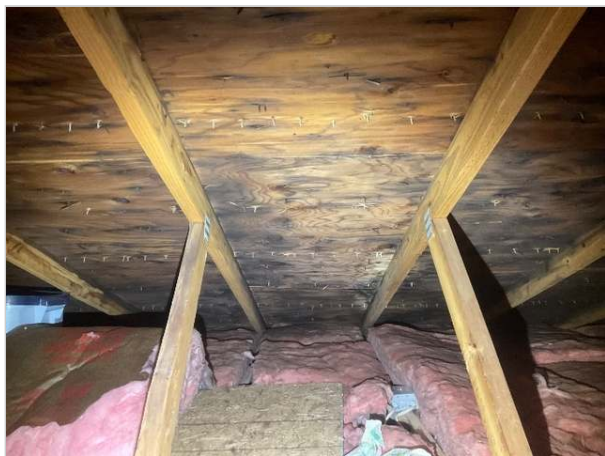
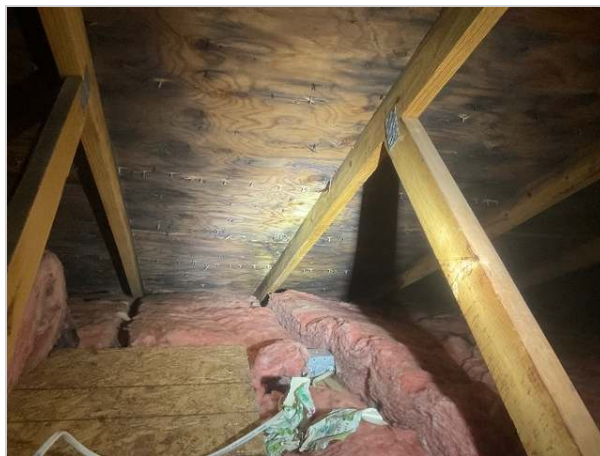
#### **NOTE: ATTIC VENTILATION:**

The attic ventilation appears to be inadequate. There were not enough vents. Proper ventilation in the summer helps extend the life of asphalt / fiberglass roofing, as well as reducing radiated heat from the attic to the living space. Proper ventilation in the winter allows heat loss from the living area to exit the home, preventing the possibility of condensation forming in the attic, which could create mold conditions. There was visual evidence of ventilation related issues in the attic at the time of the inspection. Proper attic ventilation requires creation of natural convection by not just the number of vents installed, but also the location of the vents. It is beyond the scope of the home inspection to determine the adequacy of attic ventilation. Consult with a qualified roofer for further recommendations.

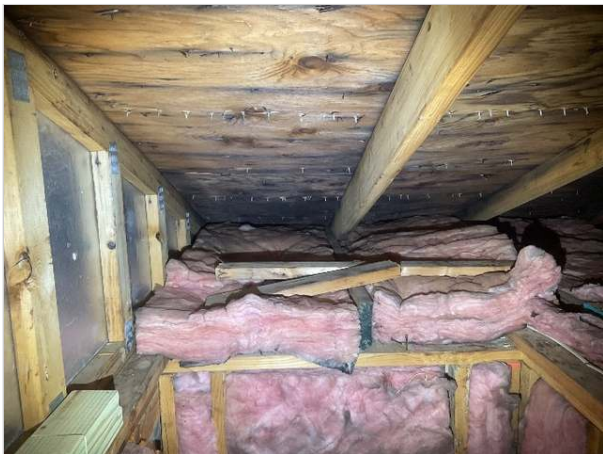
- A substance with the characteristics of mold is visible in the attic.
- The attic ventilation appears to be inadequate. There were not enough vents.
- The roof deck as viewed from the attic is water marked.
- There are areas of missing insulation installed above the second floor.

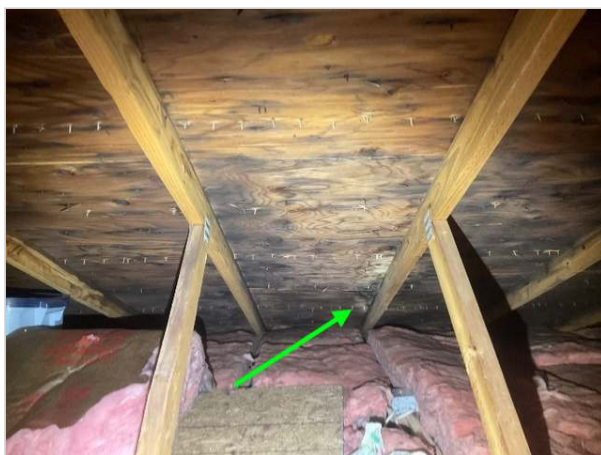
**NOTE: ROOF DECK:**

The roof deck as viewed from the attic is water marked. The cause of condition appears to be the result of questionable ventilation. Repairs to the affected areas are required. Consult with a qualified contractor for repair.

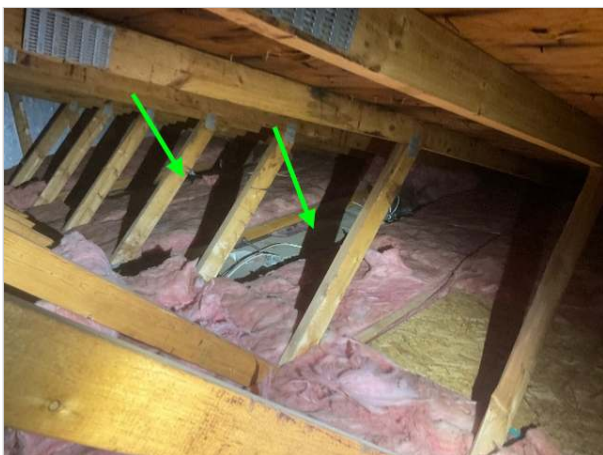
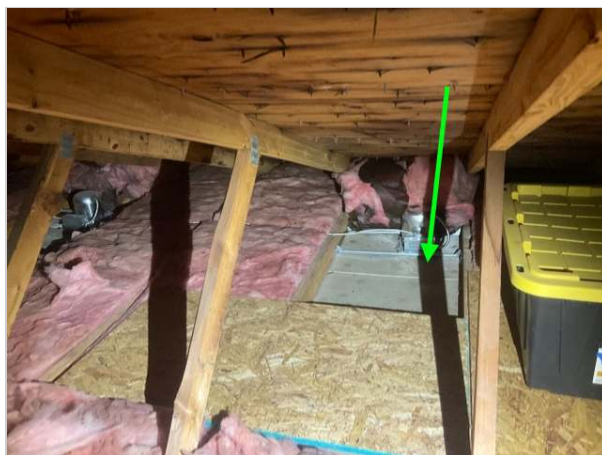
**NOTE: MISSING INSULATION:**

There are areas of missing insulation installed above the second floor. This could affect the overall comfort level in the affected area. Insulation should be installed.
