2740 Shelly St

RE: Pittsburgh, PA 15203

Inspection #: 527-062025-6372

HOME INSPECTION REPORT

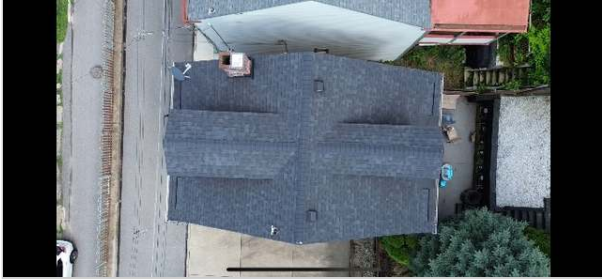
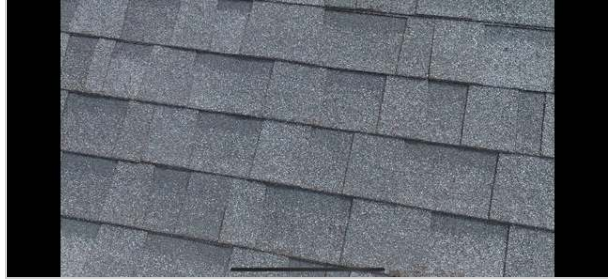
NOTE: LOOSE FLASHING:

Loose and damaged flashing was noted on the back dormer. Loose flashing could be a leak source. We cannot always determine if active leaks exist. Consult with a qualified roofer for further evaluation and repair.

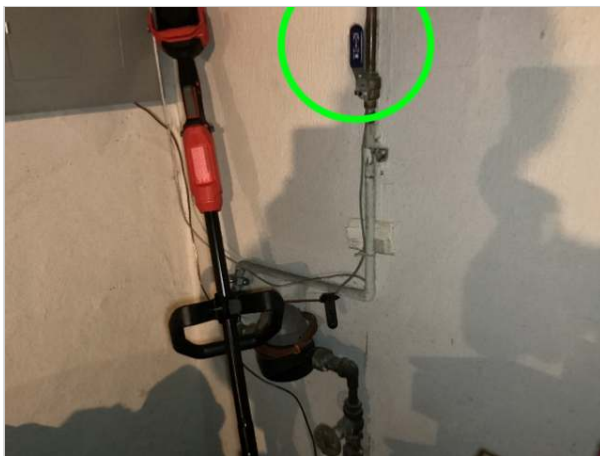
Shut off

The water meter was located in the basement. The main water shutoff valve for the home was located adjacent to the water service entry point in the basement. Water shutoff valves are visually inspected only. No attempt is made to operate the main or any other water supply shutoff valves during the inspection. These valves are infrequently used and could leak after being operated. The only exception to this policy is made when the main water supply valve is off upon arrival at the inspection. Since it is the buyers right to have all utilities operable for the home inspection, we will attempt to turn the main water valve on for the inspection. The HomeTeam is not responsible for leaks caused by operating the valve.
