**181 Macek Dr**  
**RE: Pittsburgh, PA 15227**  
**Inspection #: 527-102025-6578**

### HOME INSPECTION REPORT

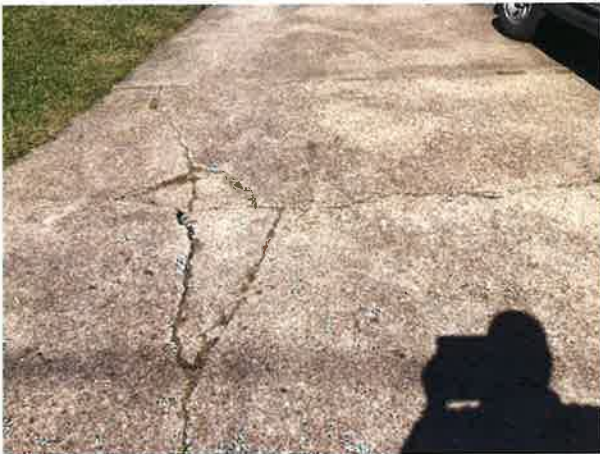
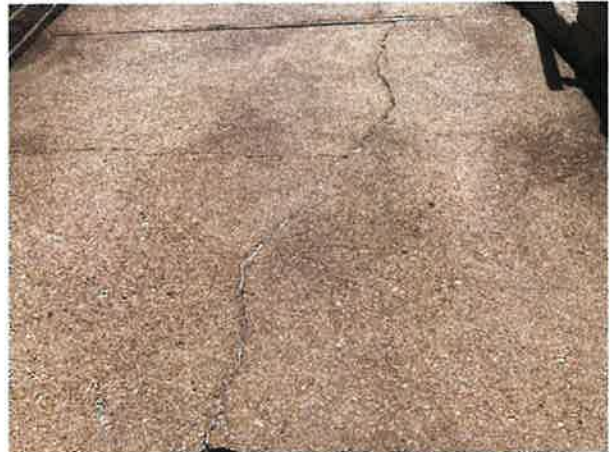
## DRIVEWAY

There was a concrete driveway in the front of the home which led to the integral garage. There were many cracks noted on the driveway. Surface defects in driveways develop and progress with age and are considered normal as long as they do not create a safety hazard. There were no material defects observed in the driveway.

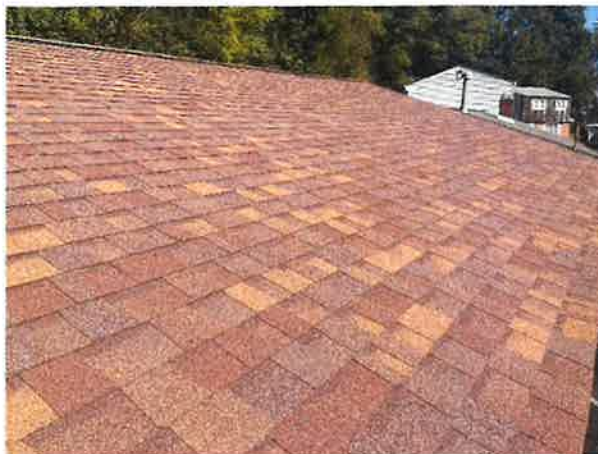
The roof was a gable design covered with asphalt/fiberglass shingles. Observation of the roof surfaces, flashing, skylights and penetrations through the roof was performed by walking on the roof. We will access the roof as long as it is dry, has a pitch that can be safely walked and accessible with the 16 foot ladder we carry. The age of the roof covering, as reported by the MLS sheet, was unknown. There was one layer of shingles on the roof at the time of the inspection. There was light curling and light surface wear observed on the roof shingles at the time of the inspection. These conditions indicate the roof shingles were in the first half of their useful life.

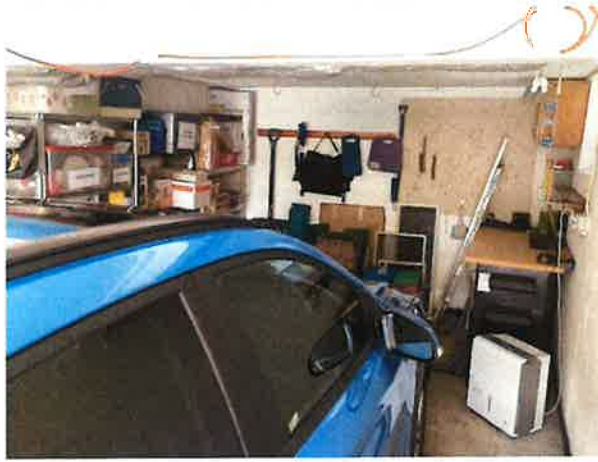
**INFORMATIONAL NOTE: GARAGE STORED ITEMS:**

The garage was cluttered with many stored items and/or shelves at the time of inspection, therefore several areas were unable to be inspected.

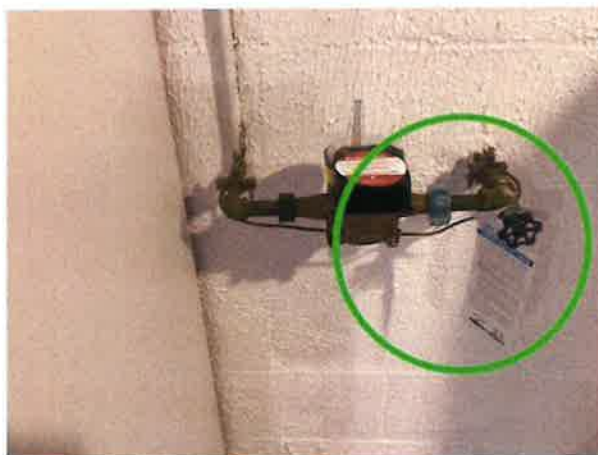
Shut off

The water meter was located in the basement. The main water shutoff valve for the home was located adjacent to the water service entry point in the basement. Water shutoff valves are visually inspected only. No attempt is made to operate the main or any other water supply shutoff valves during the inspection. These valves are infrequently used and could leak after being operated. The only exception to this policy is made when the main water supply valve is off upon arrival at the inspection. Since it is the buyers right to have all utilities operable for the home inspection, we will attempt to turn the main water valve on for the inspection. The HomeTeam is not responsible for leaks caused by operating the valve.
