**762 Lebanon Ave**  
**RE: Pittsburgh, PA 15228**  
**Inspection #: 527-072026-6971**

### *HOME INSPECTION REPORT*

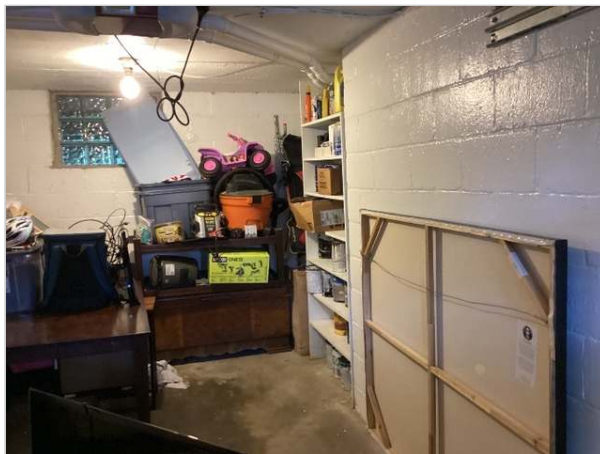
The garage was cluttered with many stored items and/or shelves at the time of inspection, therefore several areas were unable to be inspected.

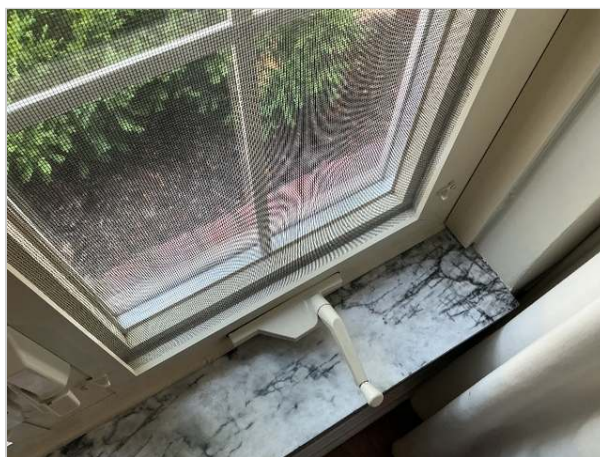
One or more of the insulated window panes throughout the home had a defective thermal seal. The window (s) were located in the living room. A defective thermal seal can be identified when fogging is observed between the panes of glass. This statement should not be considered all inclusive. Our ability to identify defective thermal seals is affected by dirty glass, the angle by which we can view the windows, window coverings and the direction of the sun. It is not possible to identify mild cases of fogging between glass panes given the conditions that affect our view. Repair of the thermal seal can be accomplished by replacing the affected glass panel.

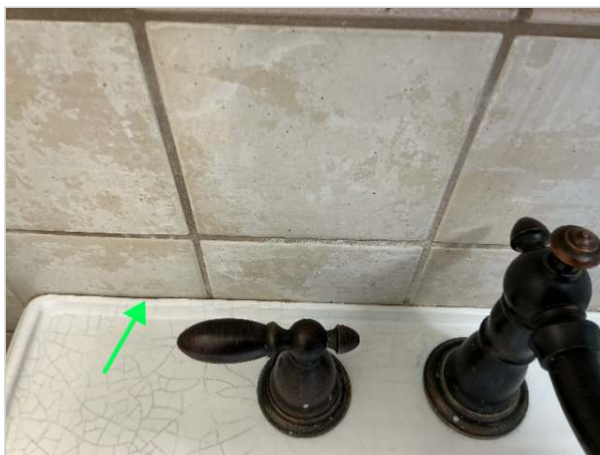
Failure to keep walls sealed can cause deterioration and extensive moisture damage including mold growth to the interior walls, which is not always visible at the time of the inspection. Some of the caulk was missing from around the sink top. These areas should be caulked to help prevent moisture penetration.

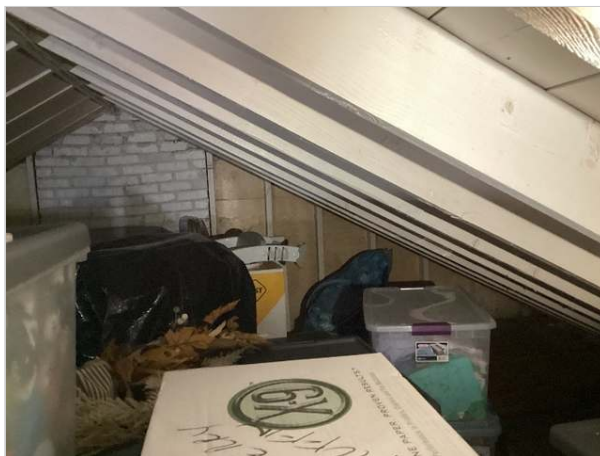
The attic was cluttered with many stored items and/or shelves at the time of inspection, therefore several areas were unable to be inspected.

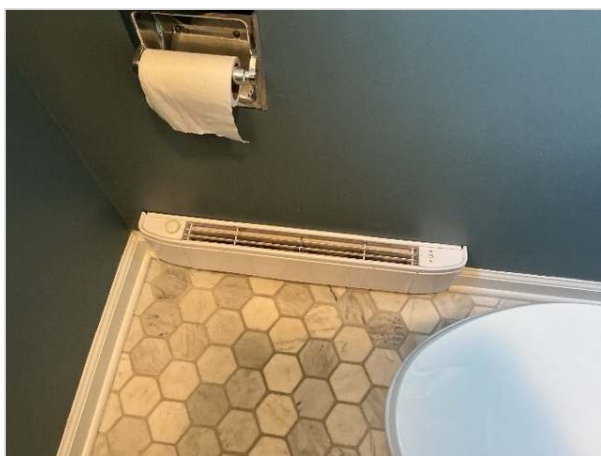
Baseboard heater 1st floor 1/2 bath

The heating system 1st floor 1/2 bath consisted of electric baseboard units controlled by either wall-or unit mounted thermostats. The thermostats were turned up during the inspection and appeared to be functional. Electrical heating units require minor servicing and upkeep. The metal fins within the units should be kept clean and the surrounding area should be left open to allow for sufficient airflow.
