WOOD DESTROYING PESTS AND ORGANISM INSPECTION REPORT

Building No. 7060	Street Via Anacapa	City San Jose	ZIP 95139	Date of Inspection 8/27/2025	Number of Pages Page 1 of 11
<div style="display: flex; align-items: center;"> <div> 510 Madera Avenue San Jose, CA 95112 (855) 331-1900 • Fax (925) 294-1818 </div> </div>					
Registration #: PR1452		HomeGuard #: 663792		Escrow #: 1115041931	
Ordered By: Omar Murillo Everhome Real Estate 40081 Mission Boulevard Fremont, CA 94539		Property Owner/Party in Interest: Sarah Mitscha 7060 Via Anacapa San Jose, CA 95139		Report Sent to:	
COMPLETE REPORT <input checked="" type="checkbox"/> LIMITED REPORT <input type="checkbox"/> SUPPLEMENTAL REPORT <input type="checkbox"/> REINSPECTION REPORT <input type="checkbox"/>					
General Description: This is a one story single family dwelling with wood exterior.				Inspection Tag Posted: Garage Other Tags Posted: None noted	
An inspection has been made of the structure(s) shown on the diagram in accordance with the Structural Pest Control Act. Detached porches, detached steps, detached decks and any other structures not on the diagram were not inspected.

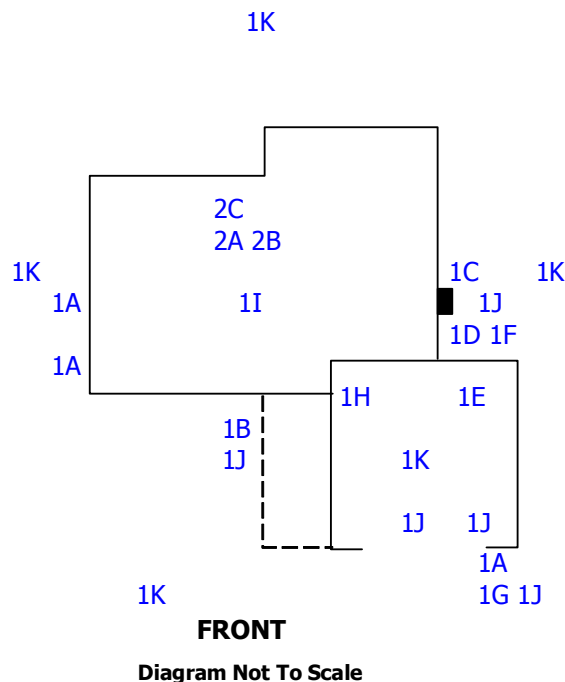
Subterranean Termites <input checked="" type="checkbox"/> Drywood Termites <input checked="" type="checkbox"/> Fungus / DryRot <input checked="" type="checkbox"/> Other Findings <input checked="" type="checkbox"/> Further Inspection <input checked="" type="checkbox"/>					
If any of the above boxes are checked, it indicates that there were visible problems in accessible areas. Read the report for details on checked items.					
Key to Items on diagram: [1] Section 1 Items [2] Section 2 Items [3] Unknown Further Inspection Items
