PROPERTY INSPECTION
REPORT

1913 N Outagamie St, Appleton, 54914 WI

DATE OF INSPECTION: 3/19/2026

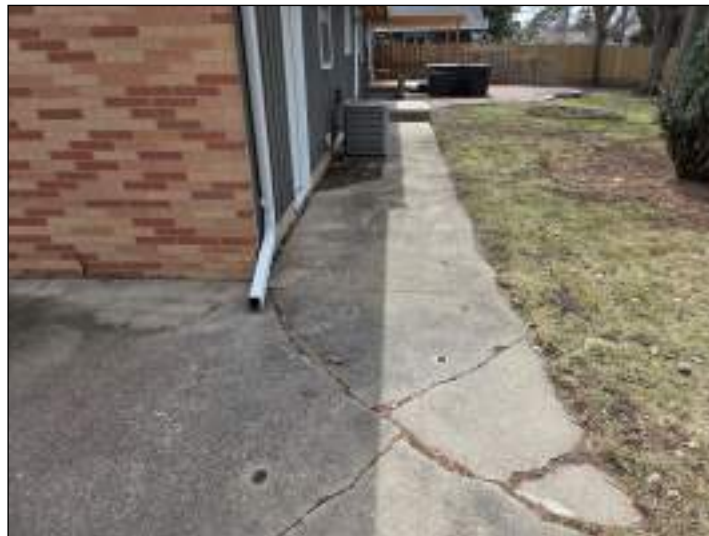
The slabs were heavily cracked in this area.

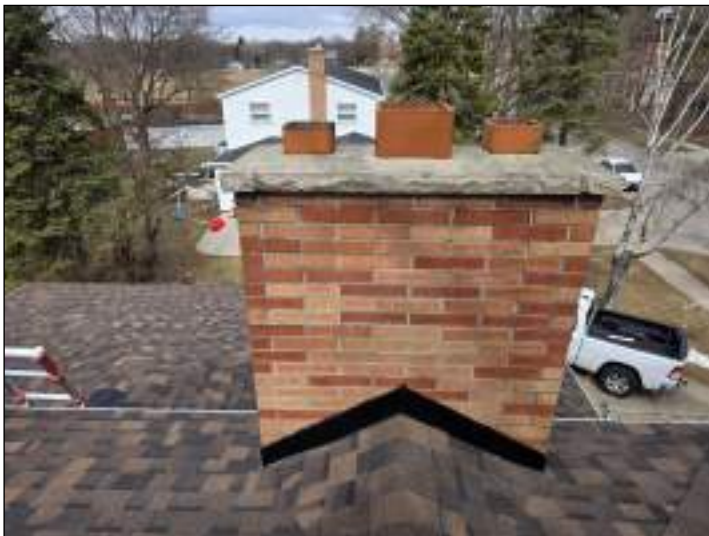
- REPAIR: The cement crown was cracked in a few areas. I recommend sealing them to prevent water from entering, which could cause further damage.
- MAINTENANCE: Chimney caps should be installed on the flue pipes to prevent water and wildlife from entering.

Example photos of the chimney.

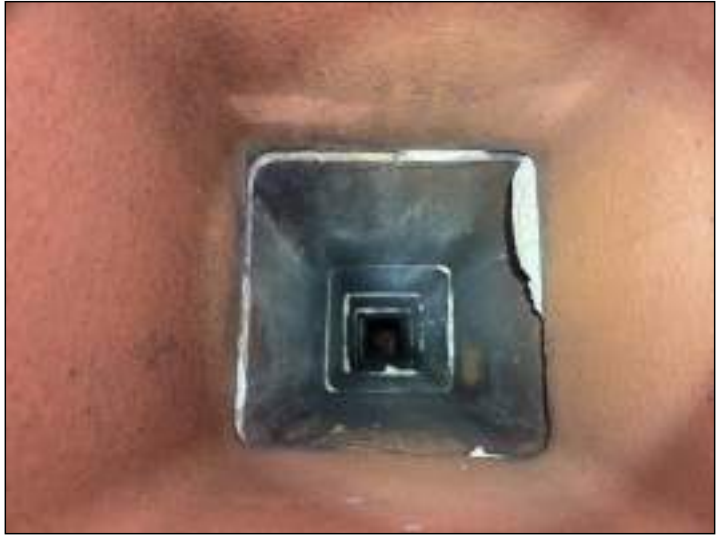
View down the flue for the fireplace.

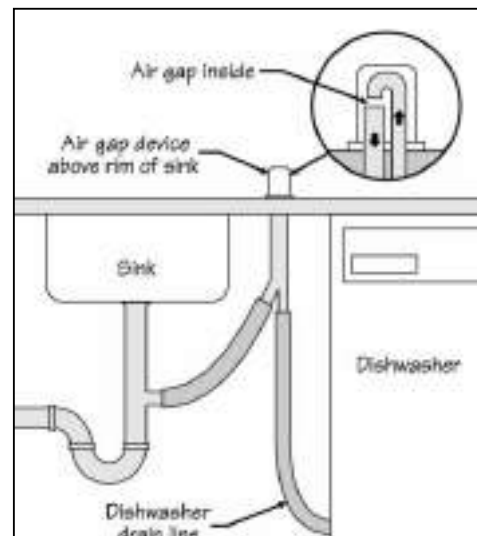
The dishwasher was missing an air gap on the drain line.

Example of an air gap device.

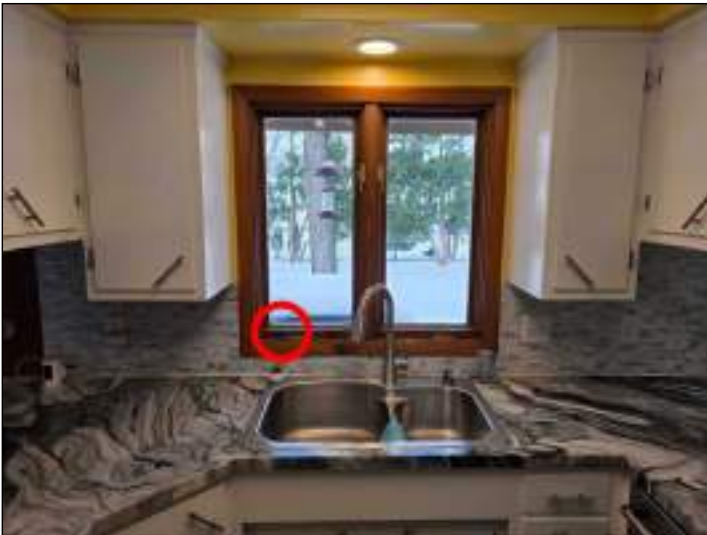
This kitchen window had a stripped crank mechanism.

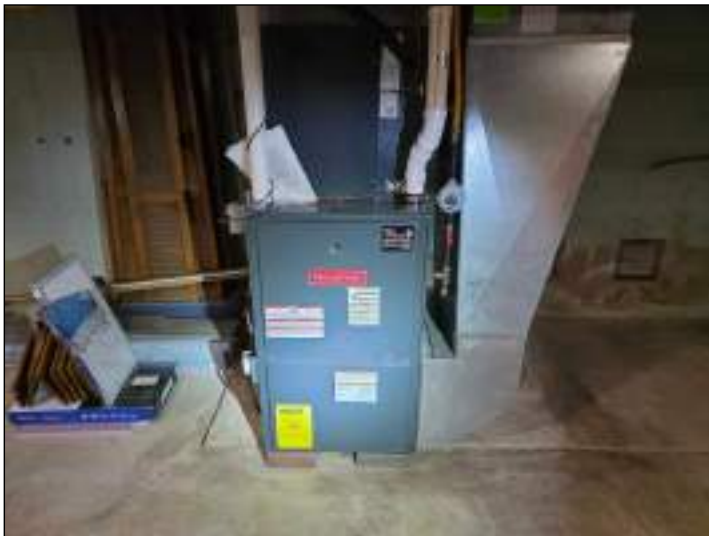
- The furnace functioned when tested using normal operating controls. NOTE: The heat exchanger was concealed on this unit and was not visible to inspect.

Forced air furnace

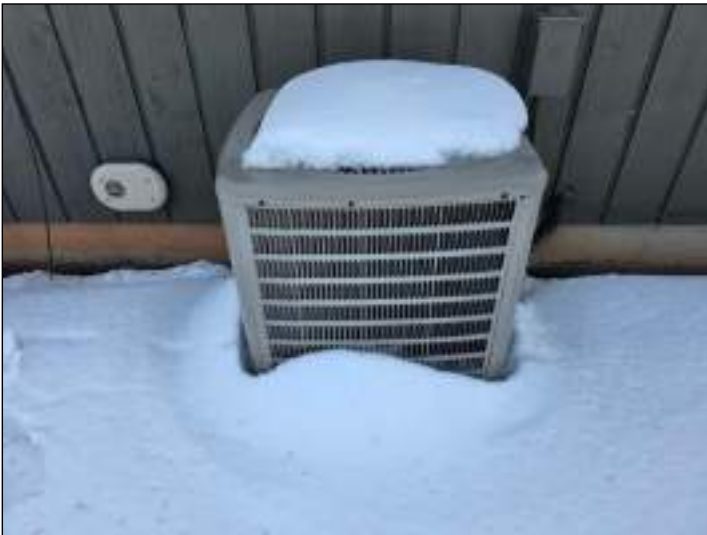
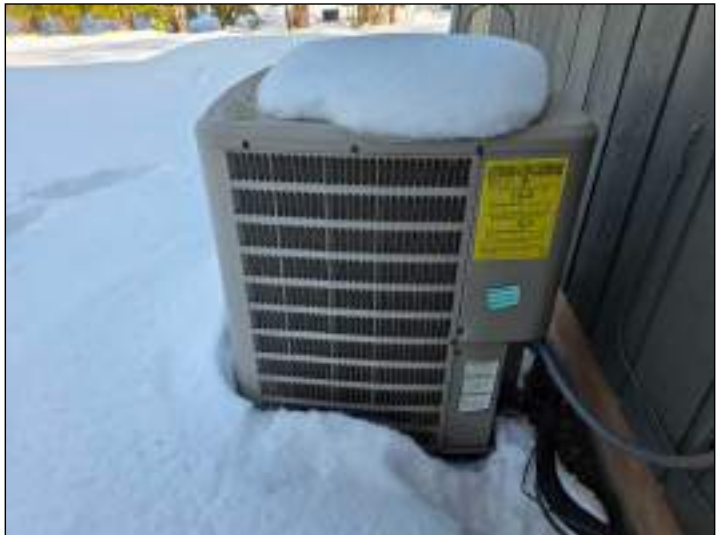
- Not Inspected: The air conditioning system was not tested because the outside temperature was too low, and running it could damage the unit.

Exterior AC compressor.

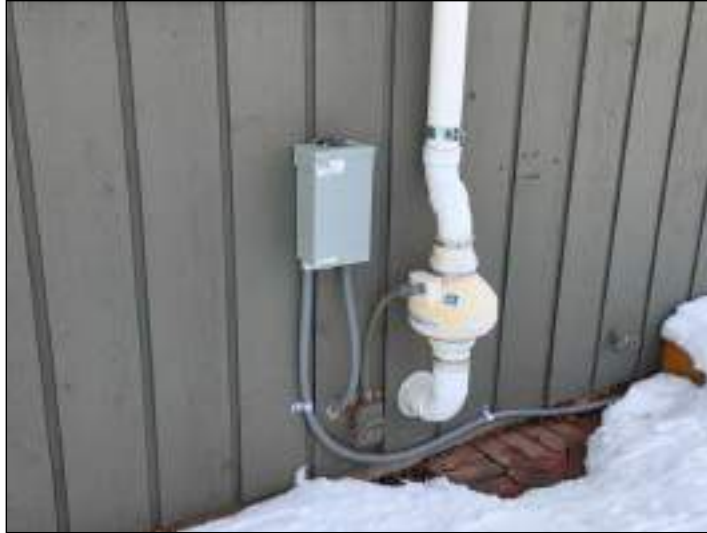
- The radon fan was operating correctly at the time of inspection. NOTE: Testing the performance of the radon system is beyond the scope of a standard home inspection.

A radon mitigation system was installed on the exterior of the house.

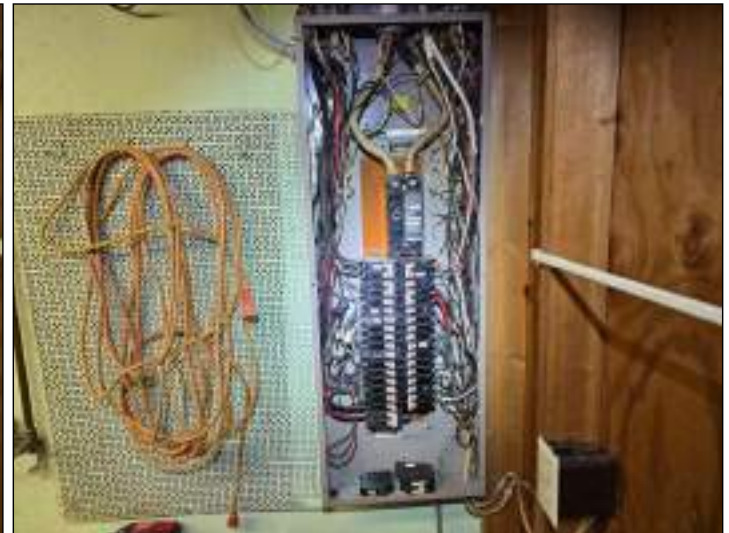
Inside view.

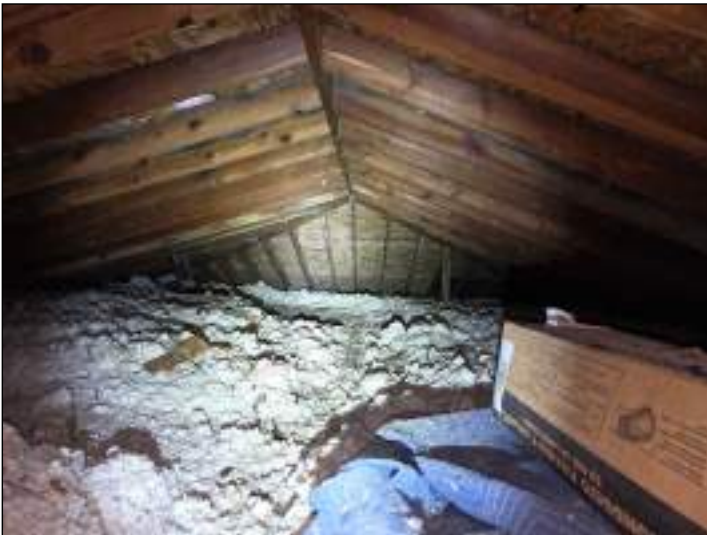
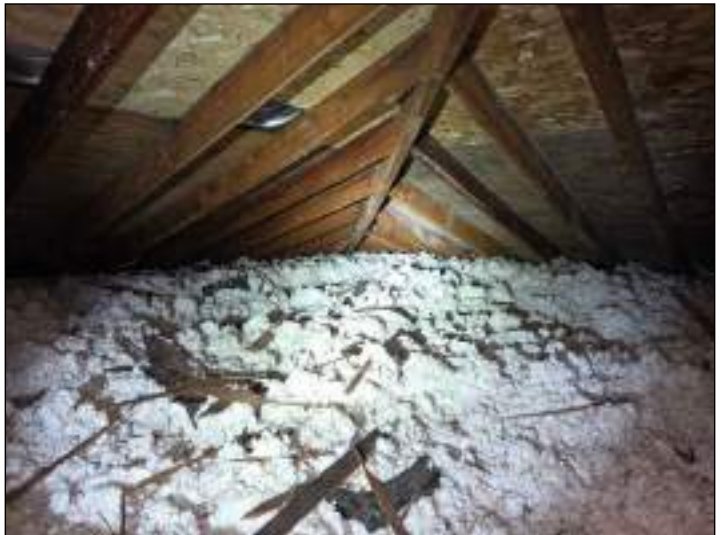
- The visible portions of the roof structure appeared functional and in satisfactory condition.

Example photos of the roof structure.

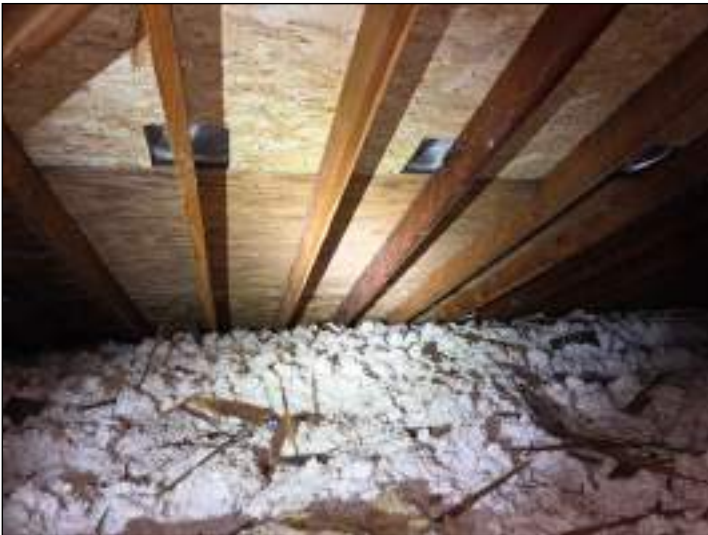
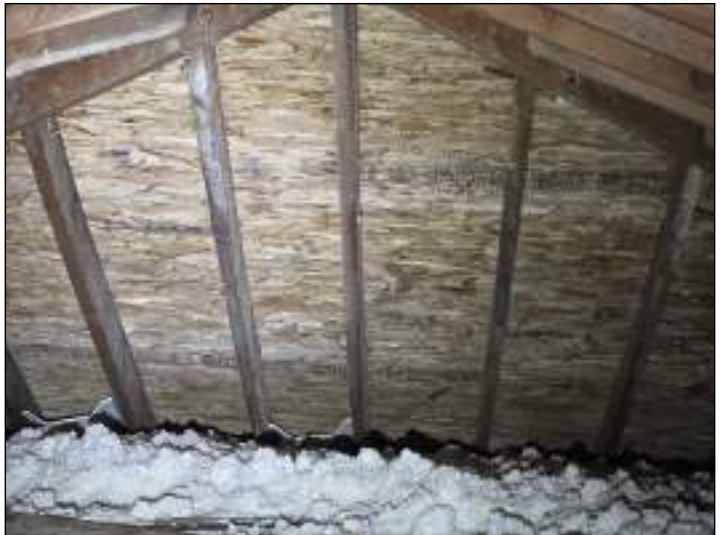
Example photos of the roof structure.

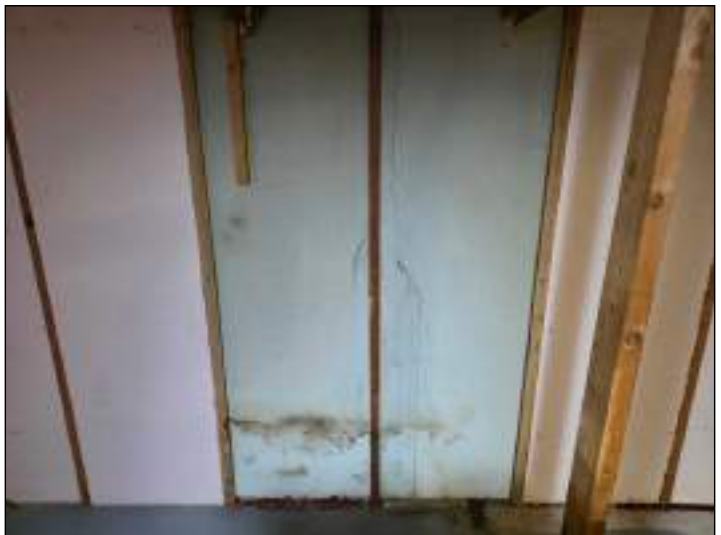
Some moisture stains were observed along the foundation walls. However, the basement was dry during the inspection. I recommended asking the seller about the foundation's history to help determine whether any problems exist or have been corrected.

Some old moisture stains were observed along the foundation walls.
