## U.S. FOREST SERVICE FLYNN RANDAL CADASTRAL SURVEY

SIUSLAW NATIONAL FOREST CONTRACT NO. 53-04HI-9-7206N SECTION 10, T. 12 S., R. 9 W., W.M., LINCOLN COUNTY, OREGON MARCH & APRIL, 1979

BY: TIMBERLAND SERVICES INC. - McCullough, Bryant & Associates, Inc. ALBANY - CORVALLIS, OREGON A JOINT VENTURE

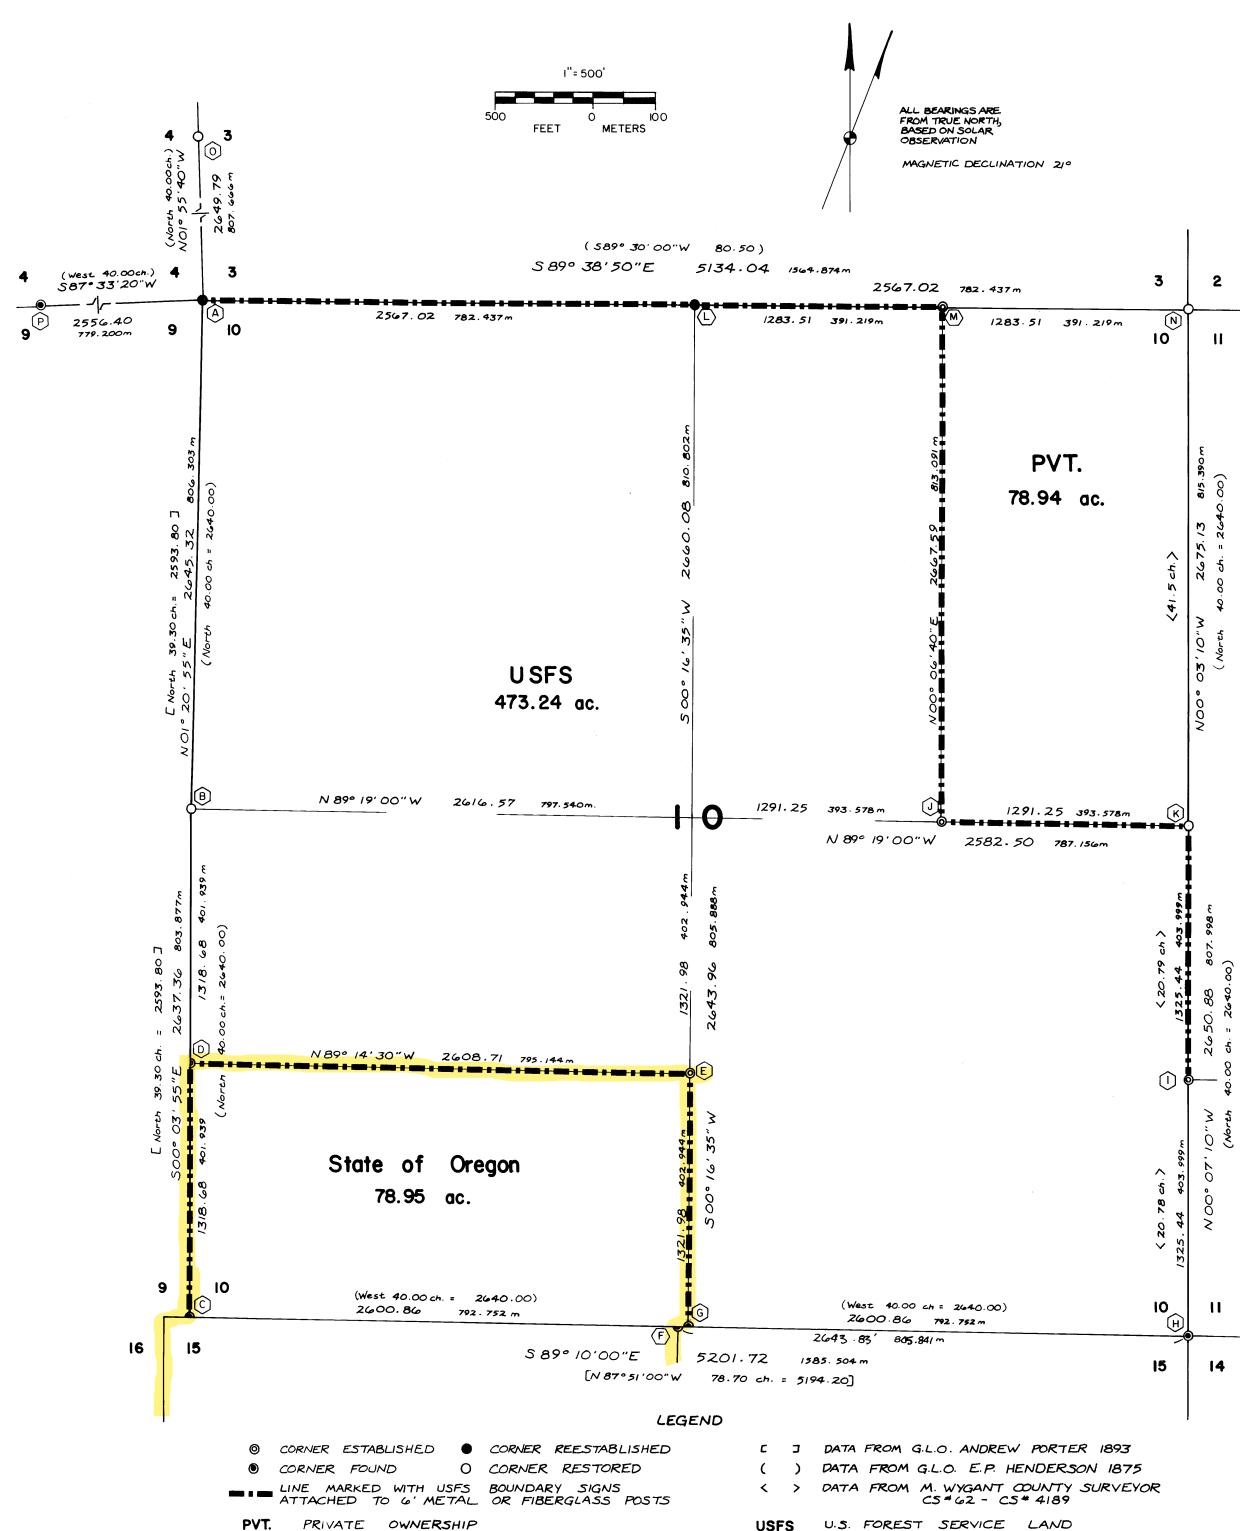
## NARRATIVE

- \* E.P.Henderson surveyed a portion of T.12S.R.9W., in 1875 under Contract No. 214, at which time he set Sec.Cor. $\frac{|Q||1}{|B||4}$ ,1/4 Cor. 10|11, Sec. Cor. $\frac{3|2}{|O||1}$ ,1/4 Cor.  $\frac{|Q|}{|D|}$ , Sec.Cor. $\frac{4|3}{|Q||2}$ ,1/4 Cor. 4|3 and 1/4 Cor.  $\frac{4}{|Q|}$

- \* Andrew L. Porter surveyed the remainder of T.12S.R.9W., in 1893 under Contract No.611 at which time he retraced the south and west boundaries of Sec. 10. He found Sec.Cor.  $\frac{910}{15}$ ,  $\frac{1}{1}$ 4 Cor.  $\frac{9}{10}$ 10, Sec.Cor.  $\frac{43}{910}$  and Sec.Cor.  $\frac{1011}{1514}$ .

- \* Under CS8367, we restored Sec.Cor. $\frac{|O||11}{|D||14}$ , Sec.Cor. $\frac{9||O|}{|D|}$ , reestablished 1/4 S10 and
- \* We found and restored 1/4 Cor. 10 11, Sec.Cor.  $\frac{3}{10}\frac{2}{11}$ , 1/4 Cor. 9 10, 1/4 Cor. 4 3 and 1/4 Cor. #.

- \* We reestablished Sec. Cor.  $\frac{4|3}{9|10}$  and 1/4 Cor.  $\frac{3}{10}$  by proportional measurement.
- \* We established E 1/16  $\frac{3}{10}$ , S1/6 10 11, CE1/16 10, CS1/16 10 and S1/16 10 by proportional measurement.

Survey was performed using a 1" Kern Theodolite, Tellurometer EDM, Wild T16 Theodolite, Wild DI3S EDM, 200' Steel Tape and HP3800 EDM.

FOUND: 3/4" galvanized iron pipe with threaded cap and bearing trees of unknown origin S31°57'10" West 81.78ft.

B. 1/4 Cor. 9 10 FOUND: 26"Alder NO3°W 37.9ft (NO3°W 50LKS) with bark scribing of several ages and a distinct face. 20" Alder staub NO3°E 37.9ft (NO3°E 55LKS) Creek flows NE and passes 10 feet South of bearing trees with dry channel on north side of BT's. SET: Cap marked "T12SR9W1/4 9 10 1979 RPLS 1068" MARKED: 36"D.Fir N70°E 106.3ft "174S10" "BT"

- C. Sec.Cor.  $\frac{9 \mid 10}{15}$  FOUND: Aluminum cap and bearing trees per CS8367.
- D. S1/16 10 SET: Cap marked "T12SR9W51/165101979 PLS 1068" MARKED: 26" D.Fir S40°E 24.6ft "S1/16S10" "BT" 14" D.Fir N89°W 14.3ft "S1/16S 9" BT"

- F. 1/4 Cor. 15 FOUND: Aluminum cap and bearing trees per CS8367.
- G. 1/4 Cor. 10 FOUND: Aluminum cap and bearing trees per CS8367.
- H. Sec.Cor. 15|14 FOUND: Aluminum cap witness corner, corner stump and bearing trees

- K. 1/4 Cor. 10 | 11 FOUND: 16" Alder NOJ°W 14.6ft (NOI°W 15ft Udell) with visible scribing. 21" D.Fir SO3°E 19.8ft (SO3°E 20ft Udell) with good face. M. Wygant found original scribed post in CS#62, Now CS#4189. Udell found remains of Wygant's new post in 1954 and knife scribed above bearing trees. SET: Cap marked "T12SR9W

- N. Sec.Cor Oli FOUND: 3/4" galvanized iron pipe with scribed pitch stake alongside per CS7884. Rotted D.Fir stump N65°E 52.8ft (N65°E 80LKS)
  Rotted D.Fir stump S65°W 69.0ft (S65°W 100LKS) 12" D.Fir N40°W 30.7ft with visible scribing
  12" D.Fir S45°W 17.7ft with visible scribing
  12" D.Fir S62°E 4.1ft with visible scribing
  14" D.Fir N68°E 12.9ft with visible scribing
  SET: Cap marked "T12SR9W \$3152 RLS 1068 1979" in place of 3/4" GIP.

- O. 1/4 Cor. 4|3 FOUND: Remains of rotted and burned 45° D.Fir snag N78°W 9.4ft (N70°W 12LKS). Remains of rotted and burned 55" D.Fir snag S41°E 27.5ft (S40°E 40LKS). SET: Cap marked "T12SR9W1/4S4|S3 1979 PLS 1068". MARKED: 12" D.Fir S70°E 6.8ft "1/4S3" "BT". 12" D.Fir S76°W 4.3ft "1/4S4" "BT".

- P. 1/4 Cor.  $\frac{4}{9}$  FOUND: 50" D.Fir snag N87°W 92.4ft (N87°W 140LKS) Ridge call east 2 chains. SET: Cap marked "T12SR9W1/4 $\frac{4}{9}$  1979 RLS 1068" MARKED: 48" D.Fir N10°W 122.6ft "1/4S4" "BT". 16" Alder N63°E 108.0ft "1/4S4" "BT"
