WOOD DESTROYING PESTS AND ORGANISMS INSPECTION REPORT

Firm Registration No. PR 2980	Report No. 36914	Escrow No. _____	
Ordered By: RED OAK REALTY 1891 Solano Avenue Berkeley CA 94707 Mark Lederer	Sample Report	Report Sent To: RED OAK REALTY 1891 Solano Avenue Berkeley CA 94707	
COMPLETE REPORT <input checked="" type="checkbox"/> LIMITED REPORT <input type="checkbox"/> SUPPLEMENTAL REPORT <input type="checkbox"/> REINSPECTION REPORT <input type="checkbox"/>			
General Description: Single story wood frame with stucco and vinyl siding exterior.		Inspection Tag Posted: Garage _____ Other Tags Posted: _____	
An inspection has been made of the structure(s) shown on the diagram in accordance with the Structural Pest Control Act. Detached porches, detached steps, detached decks and any other structures not on the diagram were not inspected.

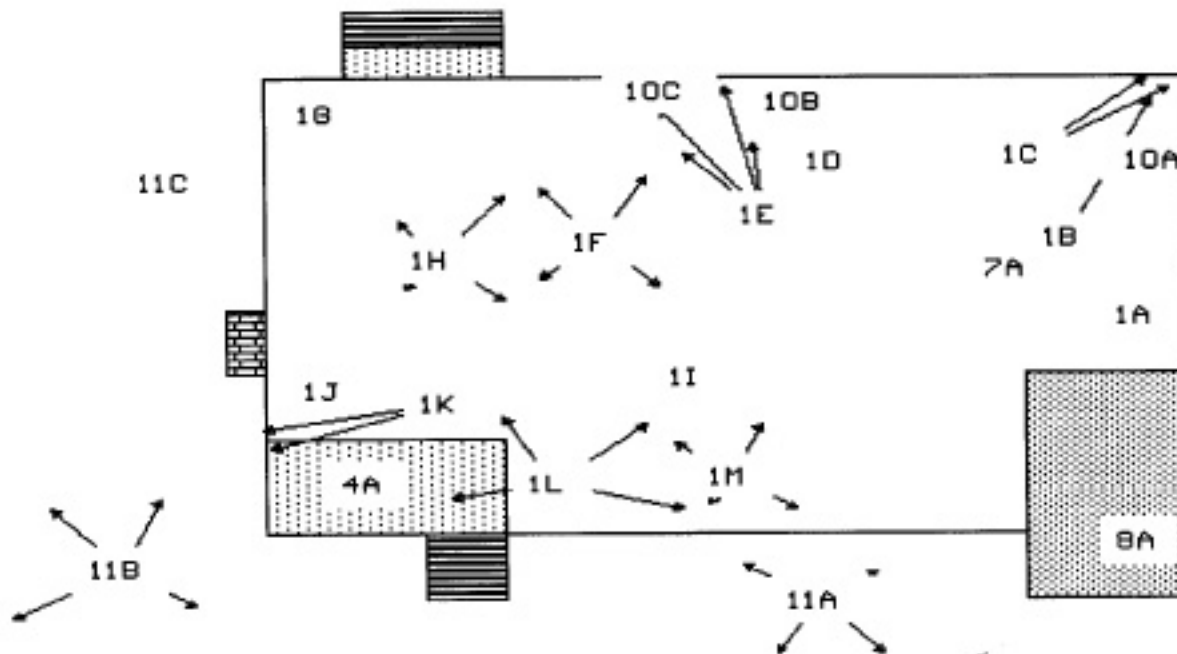
NOT TO SCALE

FRONT

- Item 1A: There is a plumbing leak noted in the subarea in the area noted on the diagram from a water valve. RECOMMEND THAT owner contact licensed plumbing contractor to repair the leak.
